## ATTACHMENT 1

### LICENSEES’ RESPONSES TO FERC’S FEBRUARY 23, 2021 SCHEDULE A – REQUESTS FOR ADDITIONAL INFORMATION

SOUTH SWP HYDROPOWER RELICENSING  
 FERC PROJECT NO. 2426

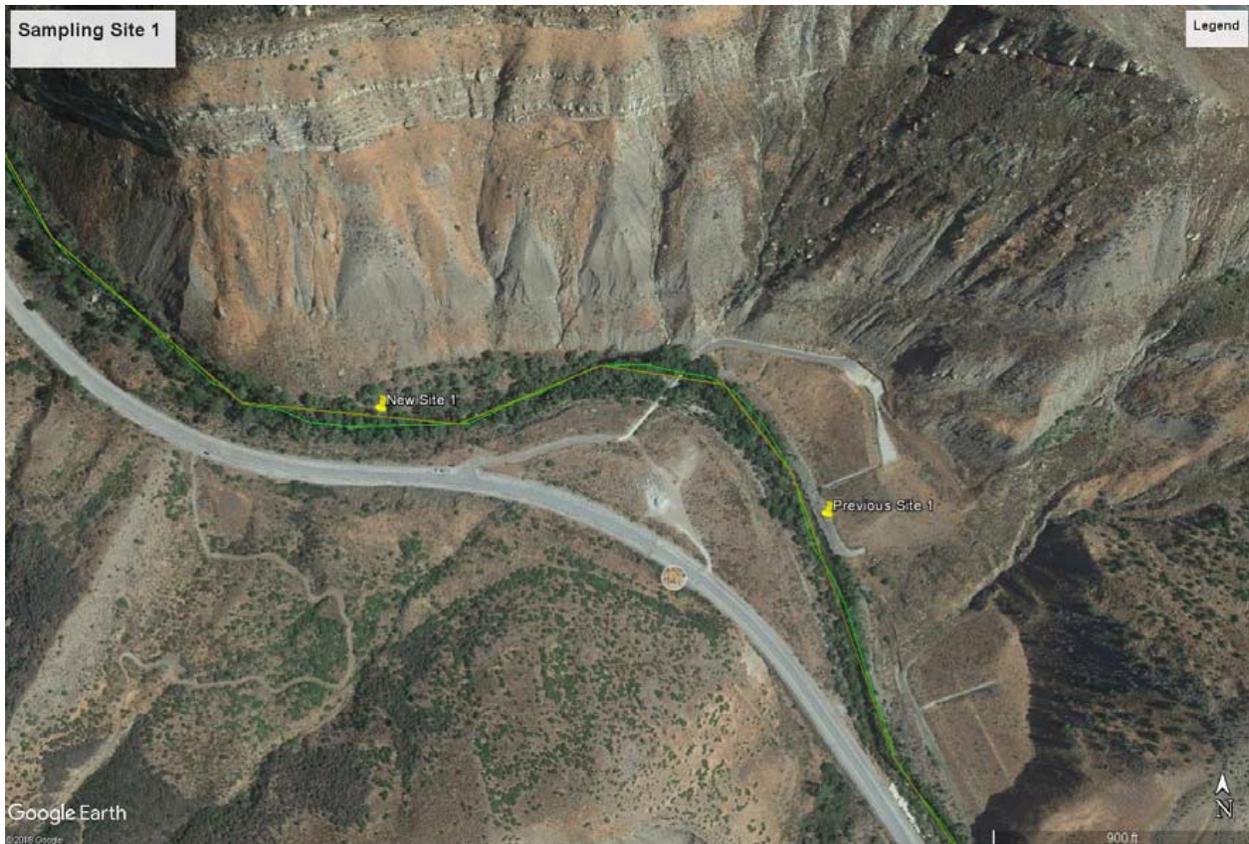
**Photo A-1. Stream Fish & BMI Sampling Site 1**

*Note: This aerial image was provided to the agencies in an email in June 25, 2018, to document the changes in Sampling Sites 1 and 3. Sampling Site 2 was unchanged.*

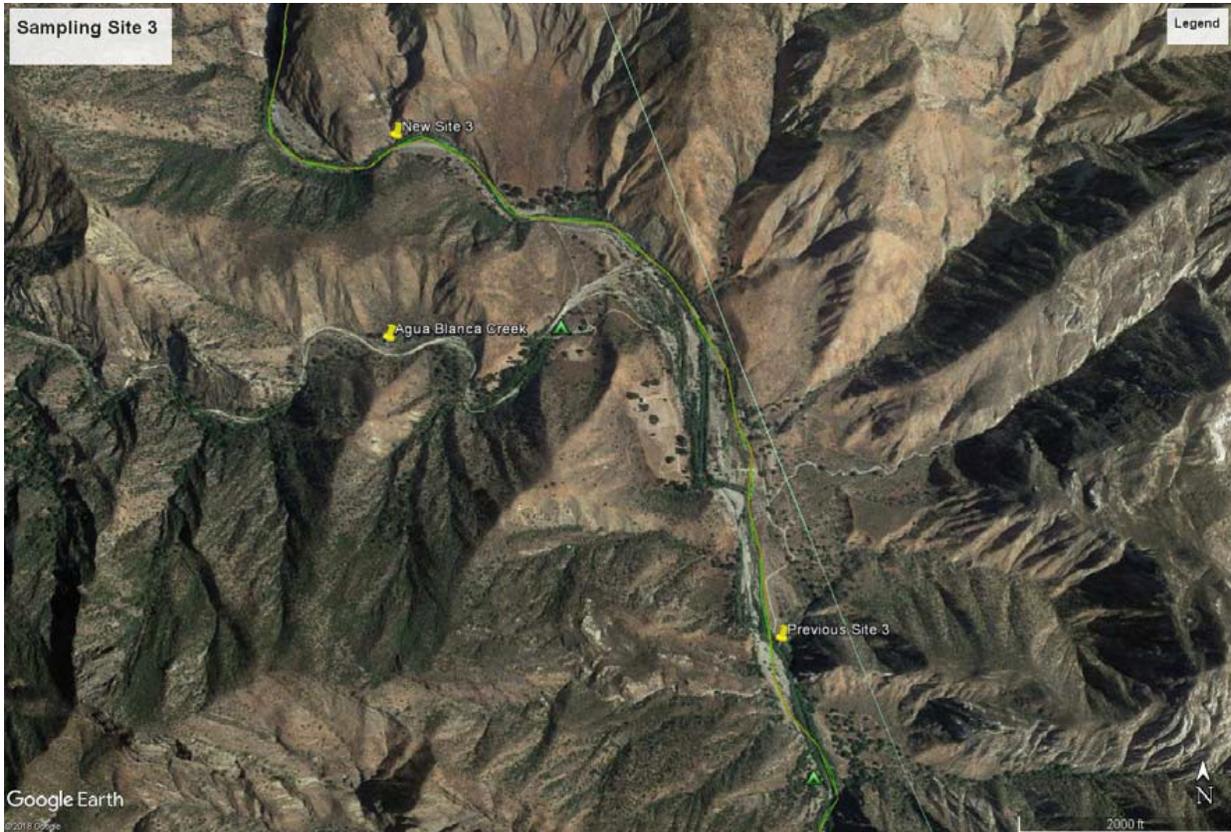
**Photo A-3. Stream Fish & BMI Sampling Site 3**

*Note: This aerial image was provided to the agencies in an email in June 25, 2018, to document the changes in Sampling Sites 1 and 3. Sampling Site 2 was unchanged.*

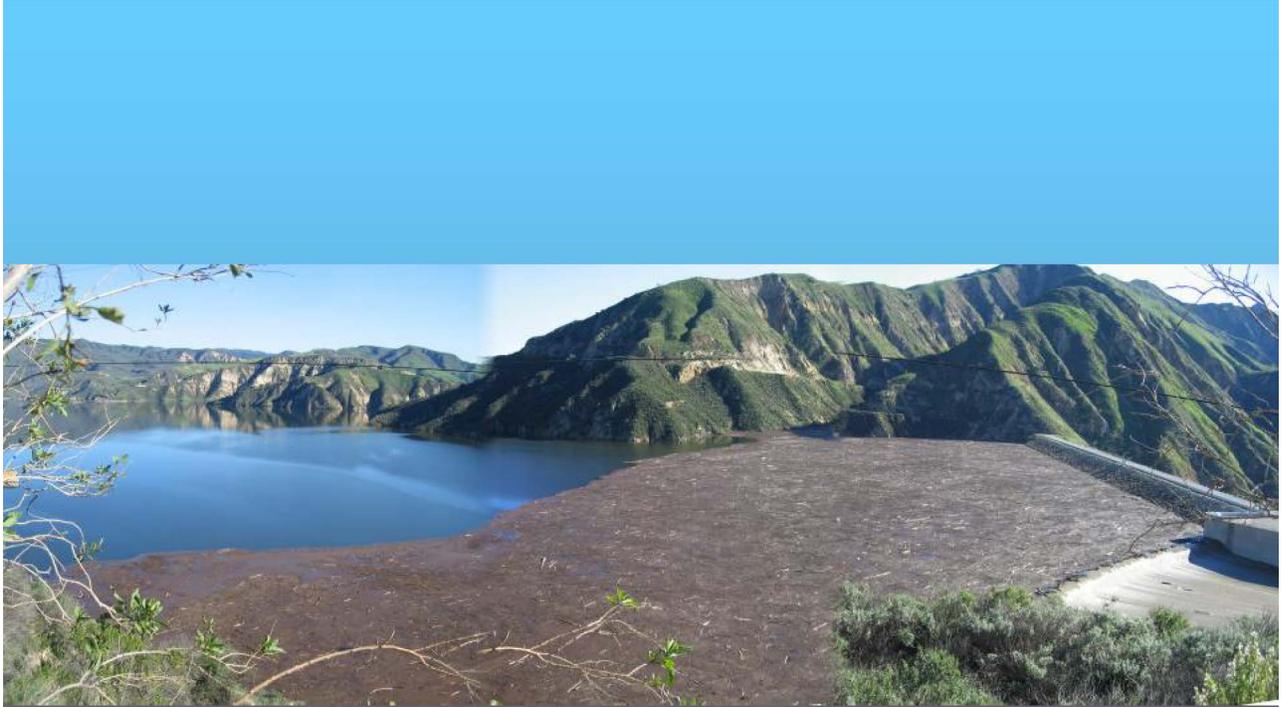
**Photo C-1. Debris on Lake Piru, 2004, following the Piru Fire**

## Debris on Lake Piru, 2004 following the Piru Fire.

Additionally, in the United States Department of Agriculture, Forest Service (USFS) Burn Area Emergency Response (BAER) presentation on the 2006 Day Fire, the USFS illustrated that after the 2004 Piru Fire, Lake Piru accumulated woody debris, which entered the lake, mostly through Pyramid reach. A photo of the accumulated wood debris after the 2004 Piru Fire is provided in Appendix C to this attachment. This accumulation of woody debris is likely to occur in the future following similar fire events.

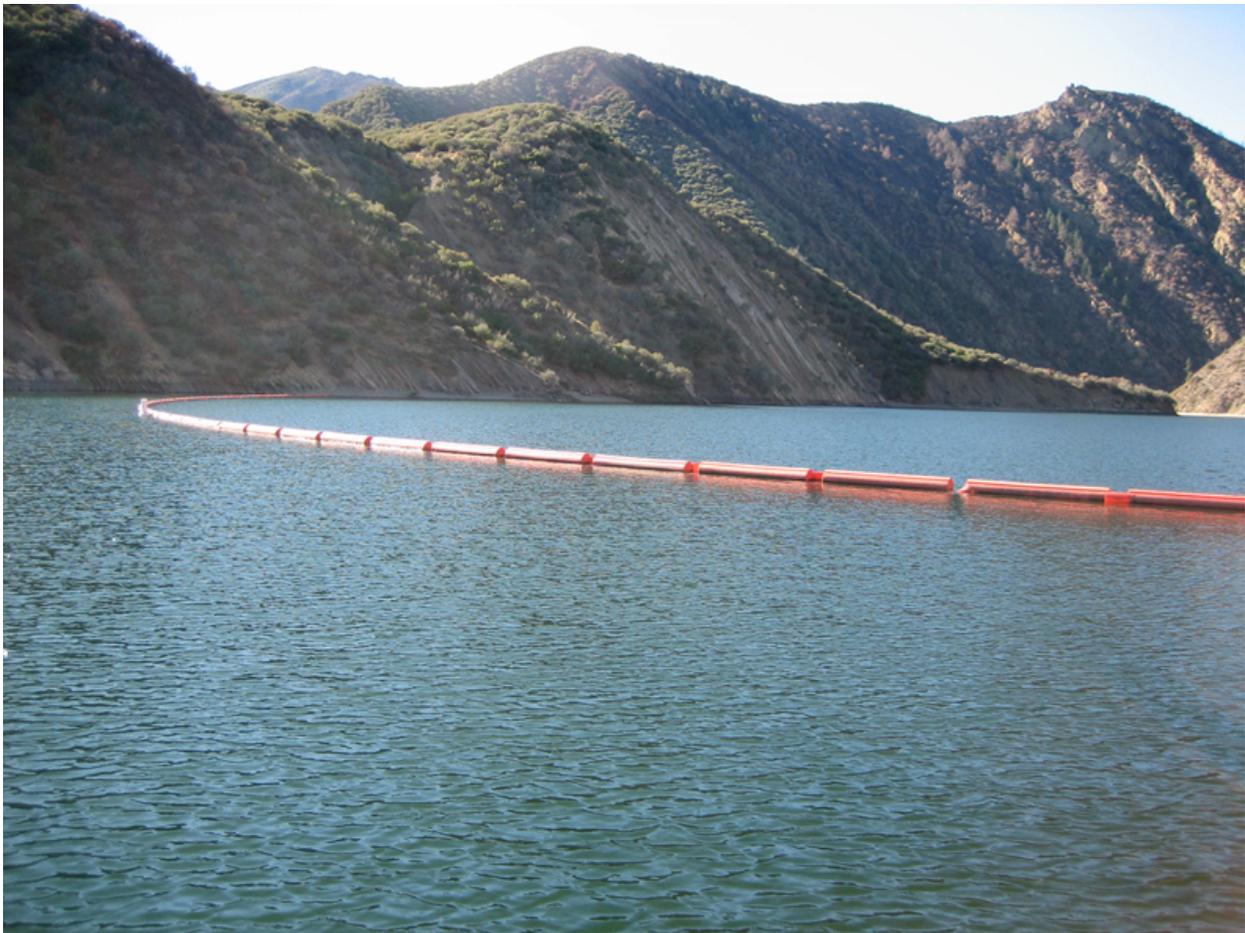
**Photo C-2. Debris boom placed at the Piru Creek arm of Pyramid Lake to collect potential floating debris (photo source: Jim Gleim, DWR 10/13/2006)**

Appendix C includes Slide 14 of 32 from the United States Department of Agriculture, Forest Service, Burn Area Emergency Response, 2006 Day Fire Presentation showing debris on Lake Piru following the 2004 Piru Fire and photographs and aerials of DWR deployed debris booms in Pyramid Lake across the Piru Creek arm of the reservoir after the 2006 Day Fire. These debris booms were installed prior to the winter seasons of 2006/2007 and 2007/2008.

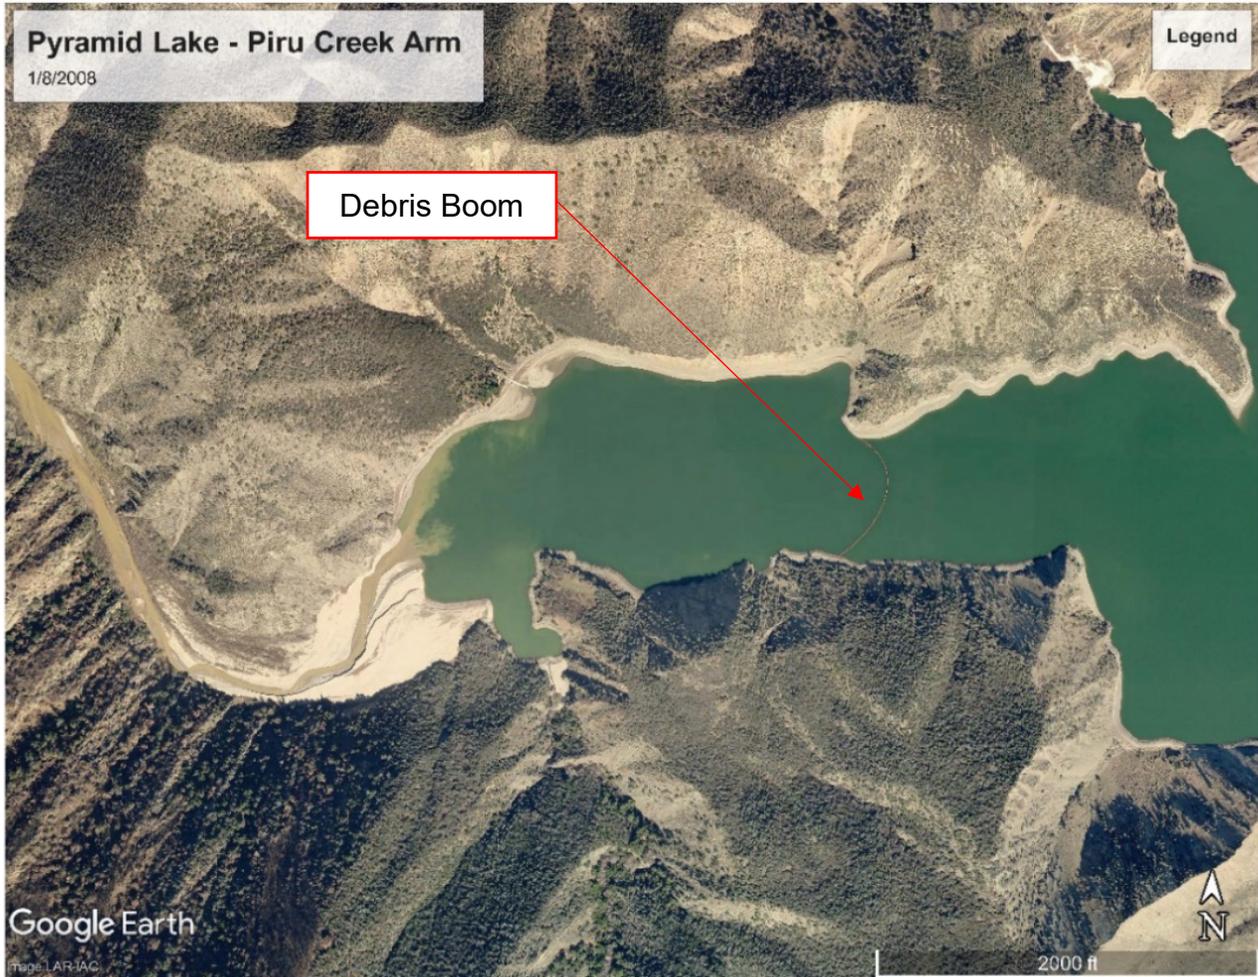
**Photo C-3. Aerial view of debris boom placed at the Piru Creek arm of Pyramid Lake to collect potential floating debris (photo source: Google Earth 1/8/2008)**
