SSWP Pyramid Lake Recreation Area Buildings

The following lists of buildings were provided to the Licensees' by USFS in April 2017. Throughout field survey's the field researchers found that all buildings listed were owned by the Nation Forest and all buildings served as a service, office, storage, or an industrial purpose to the Recreation site. Please see the two lists below of buildings identified by the field researchers and those not located.

**Table 4.1-10. Buildings Within the Recreation Study Area**

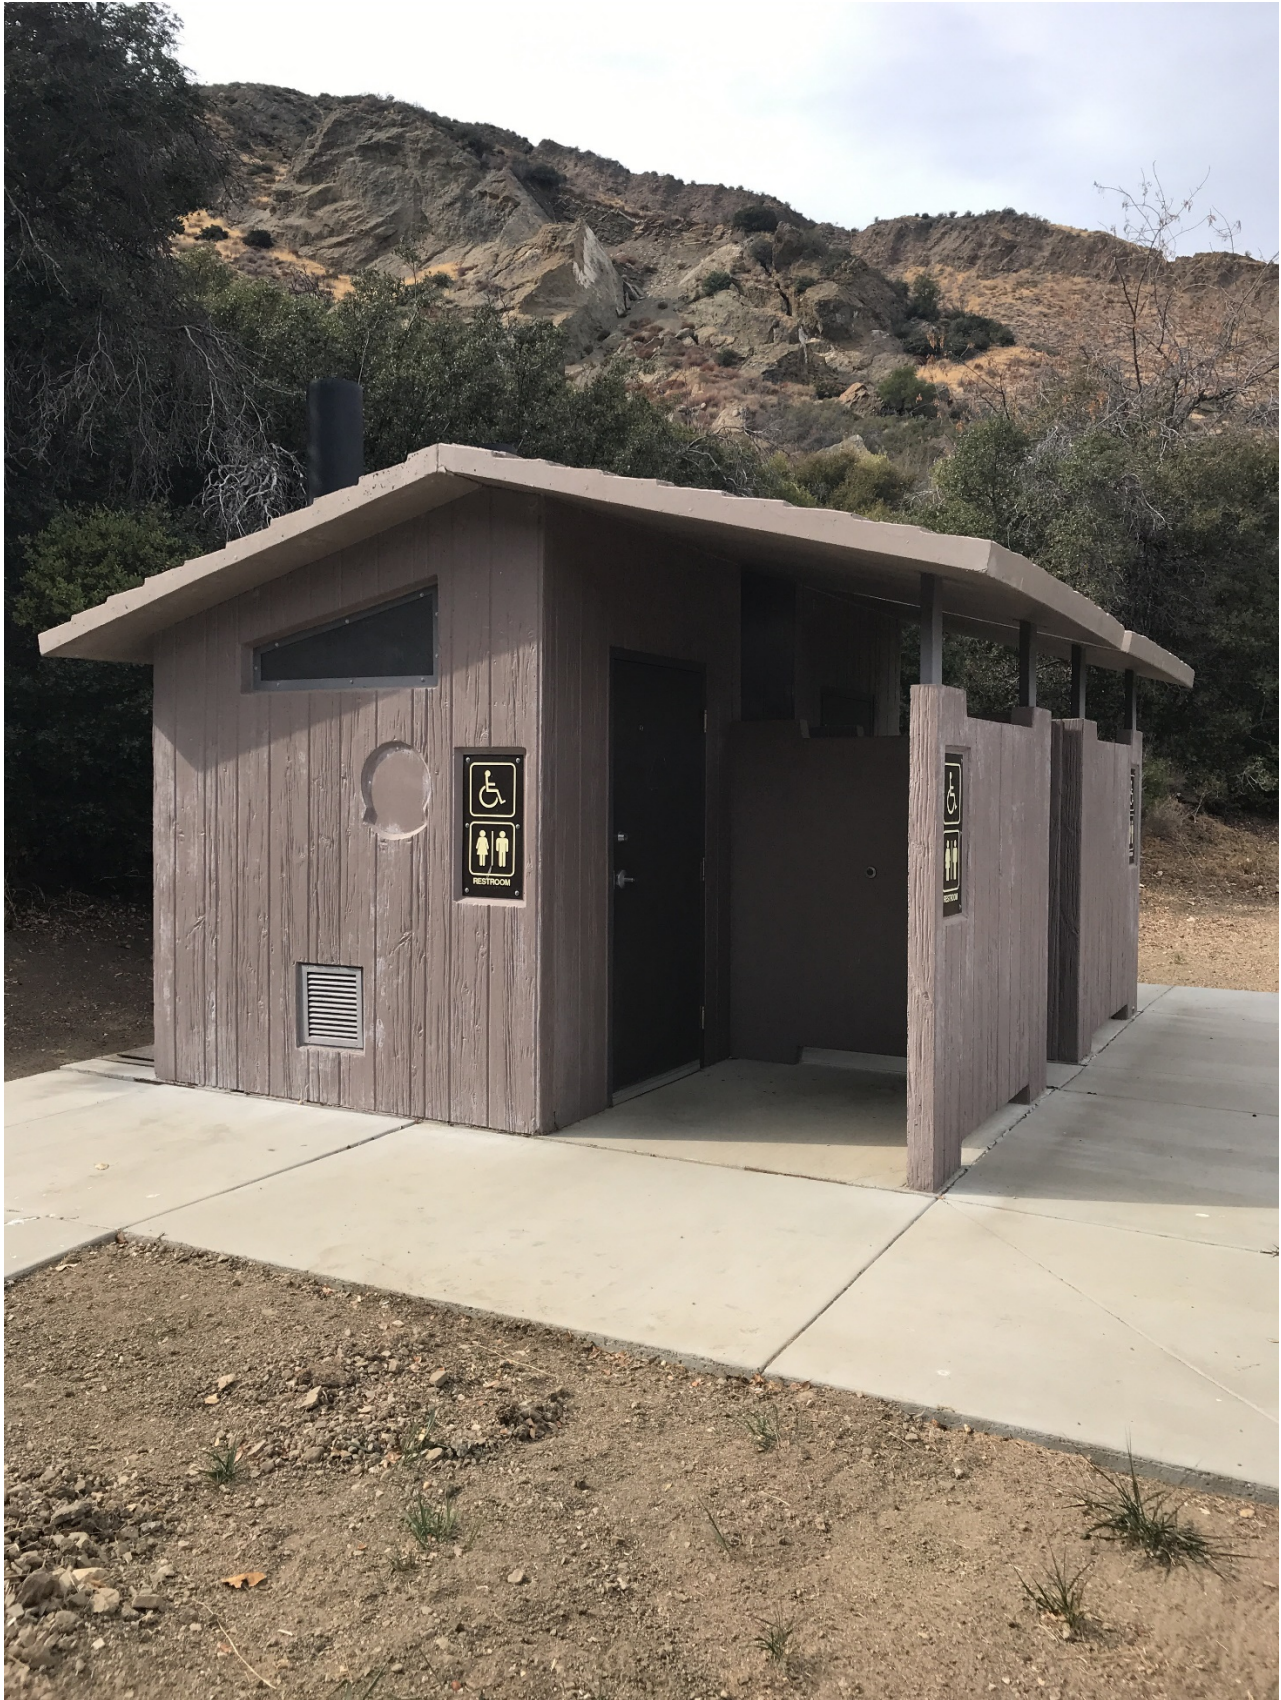
**Building A3017R:** Bear Trap Boat-In Site Restroom, approx. 55sq. ft, built in 1974, and photo taken from Northwest corner

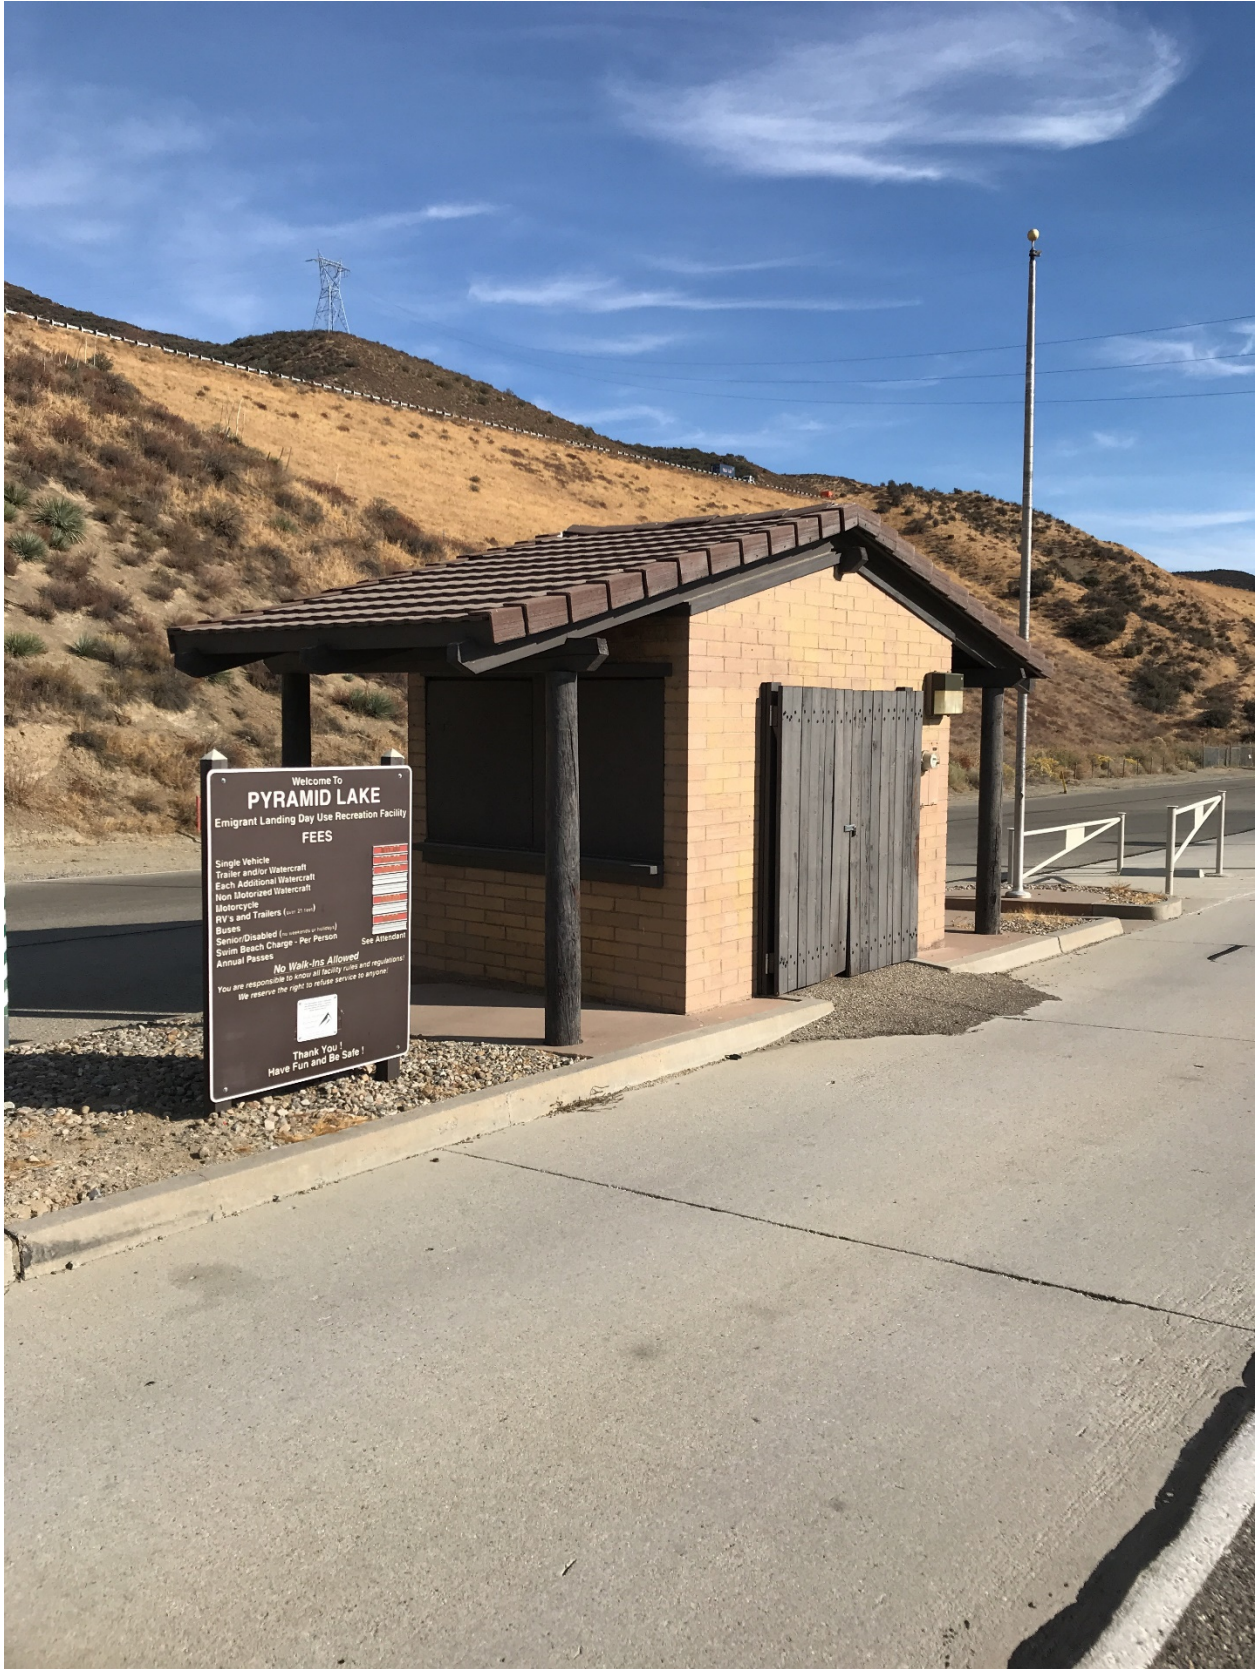
Building A3019ES: Emigrant Landing Entrance Station, Approx. 267sq. ft, built in 1984, and photo taken from North West corner

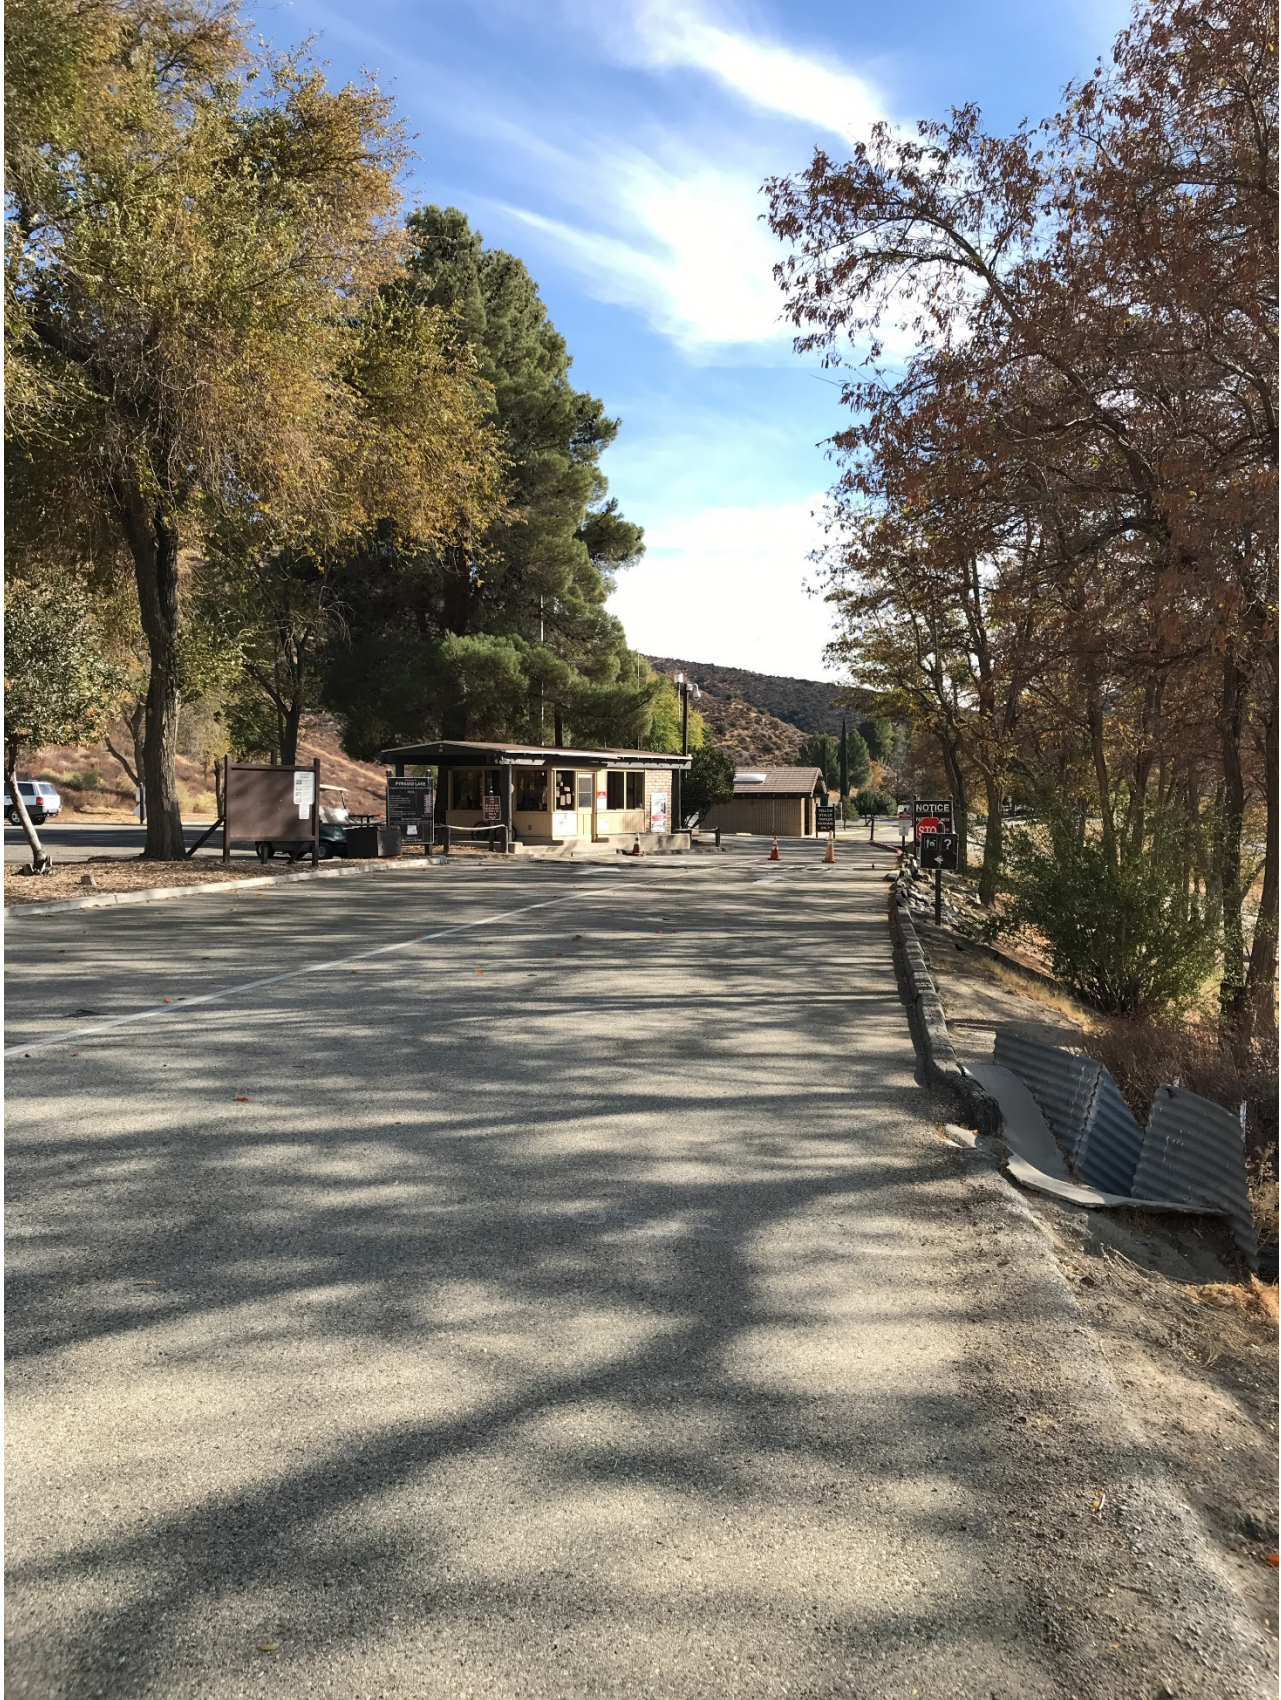
**Building A3019K:** *Emigrant Landing Kiosk Building, Approx. 110sq. ft, built in 1975, and photo take from North West corner*

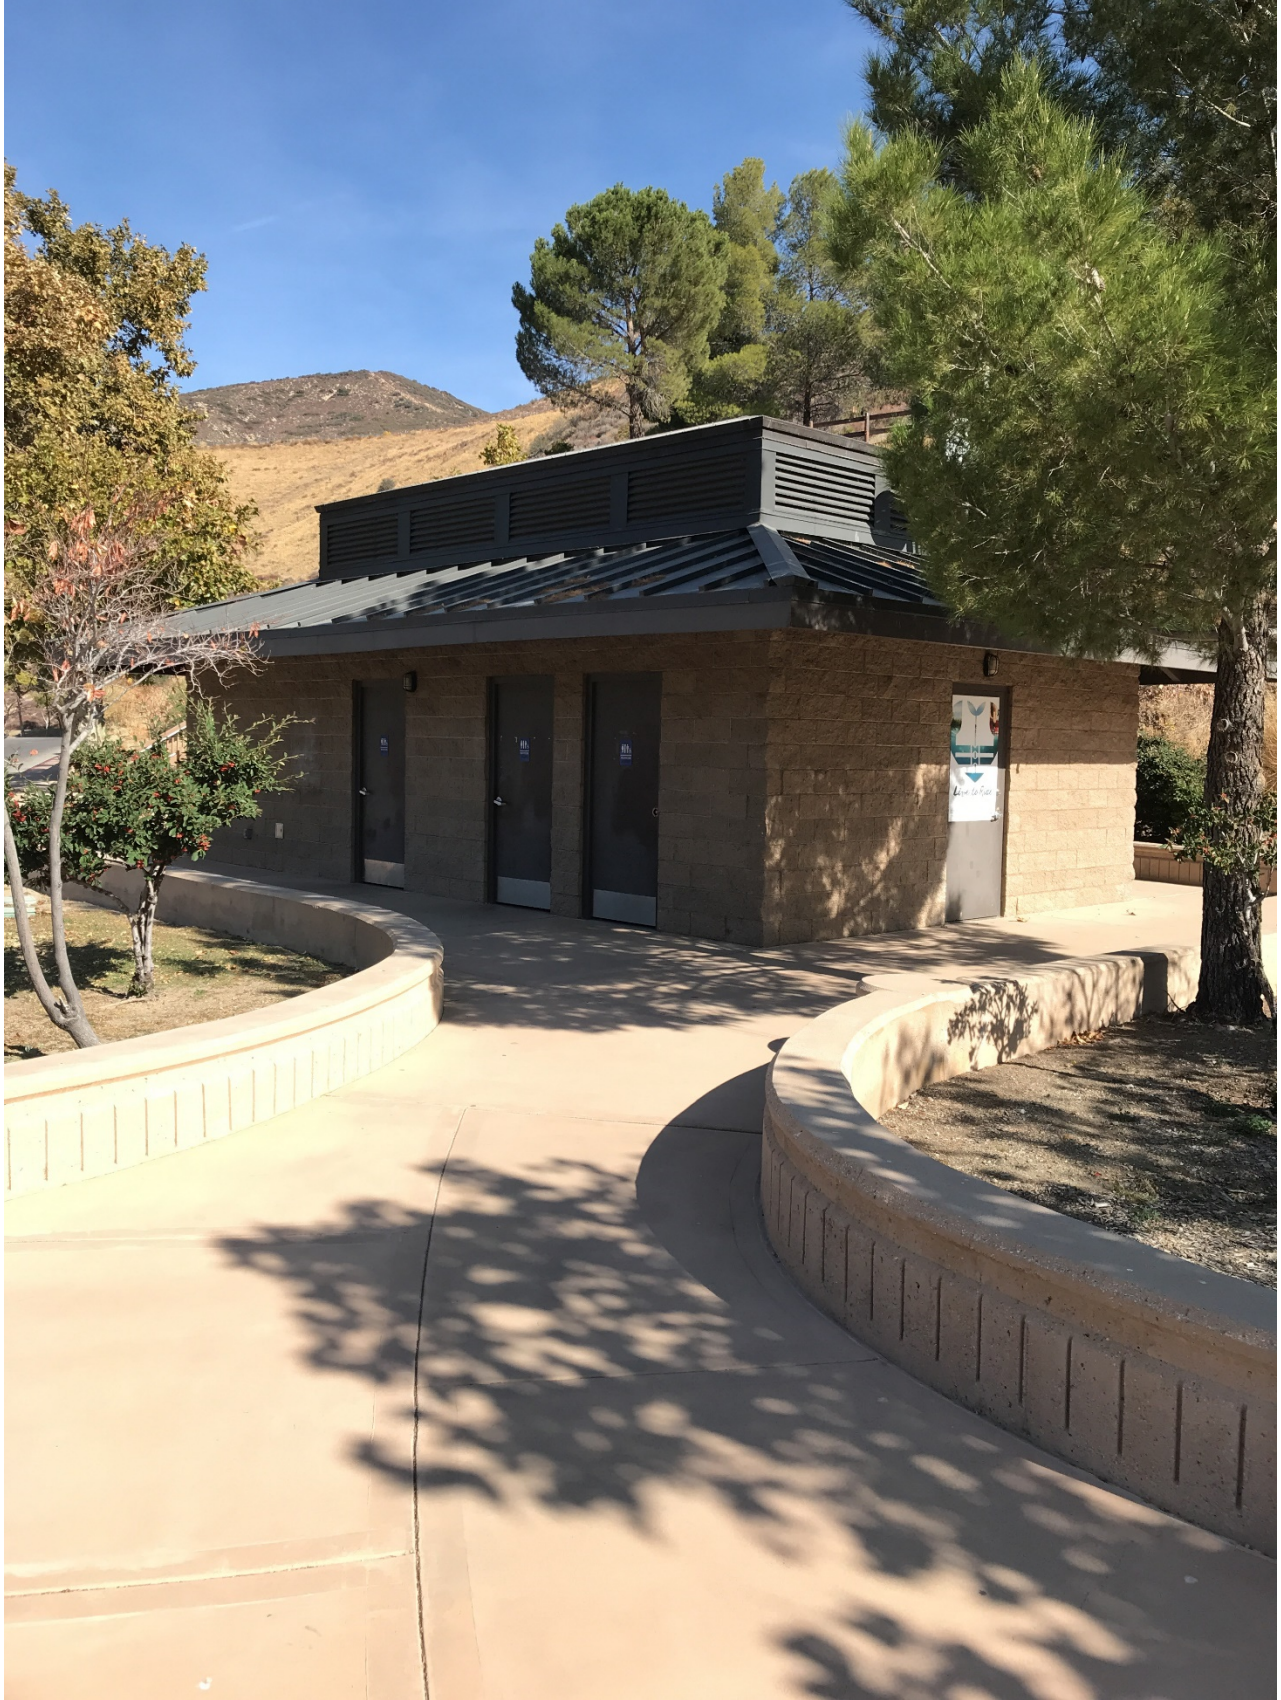
A3019R9 Emigrant Landing Lower Parking Lot Restroom 9 Service Complex National Forest (FS)

A3019R9	Emigrant Landing Lower	660	2001	Emigrant Landing Boat Launch	Compliant	CMU	Good	Good	Potential	There was no posted name posted for this building, a better name may be: Emigrant Landing Boat Launch Restroom.

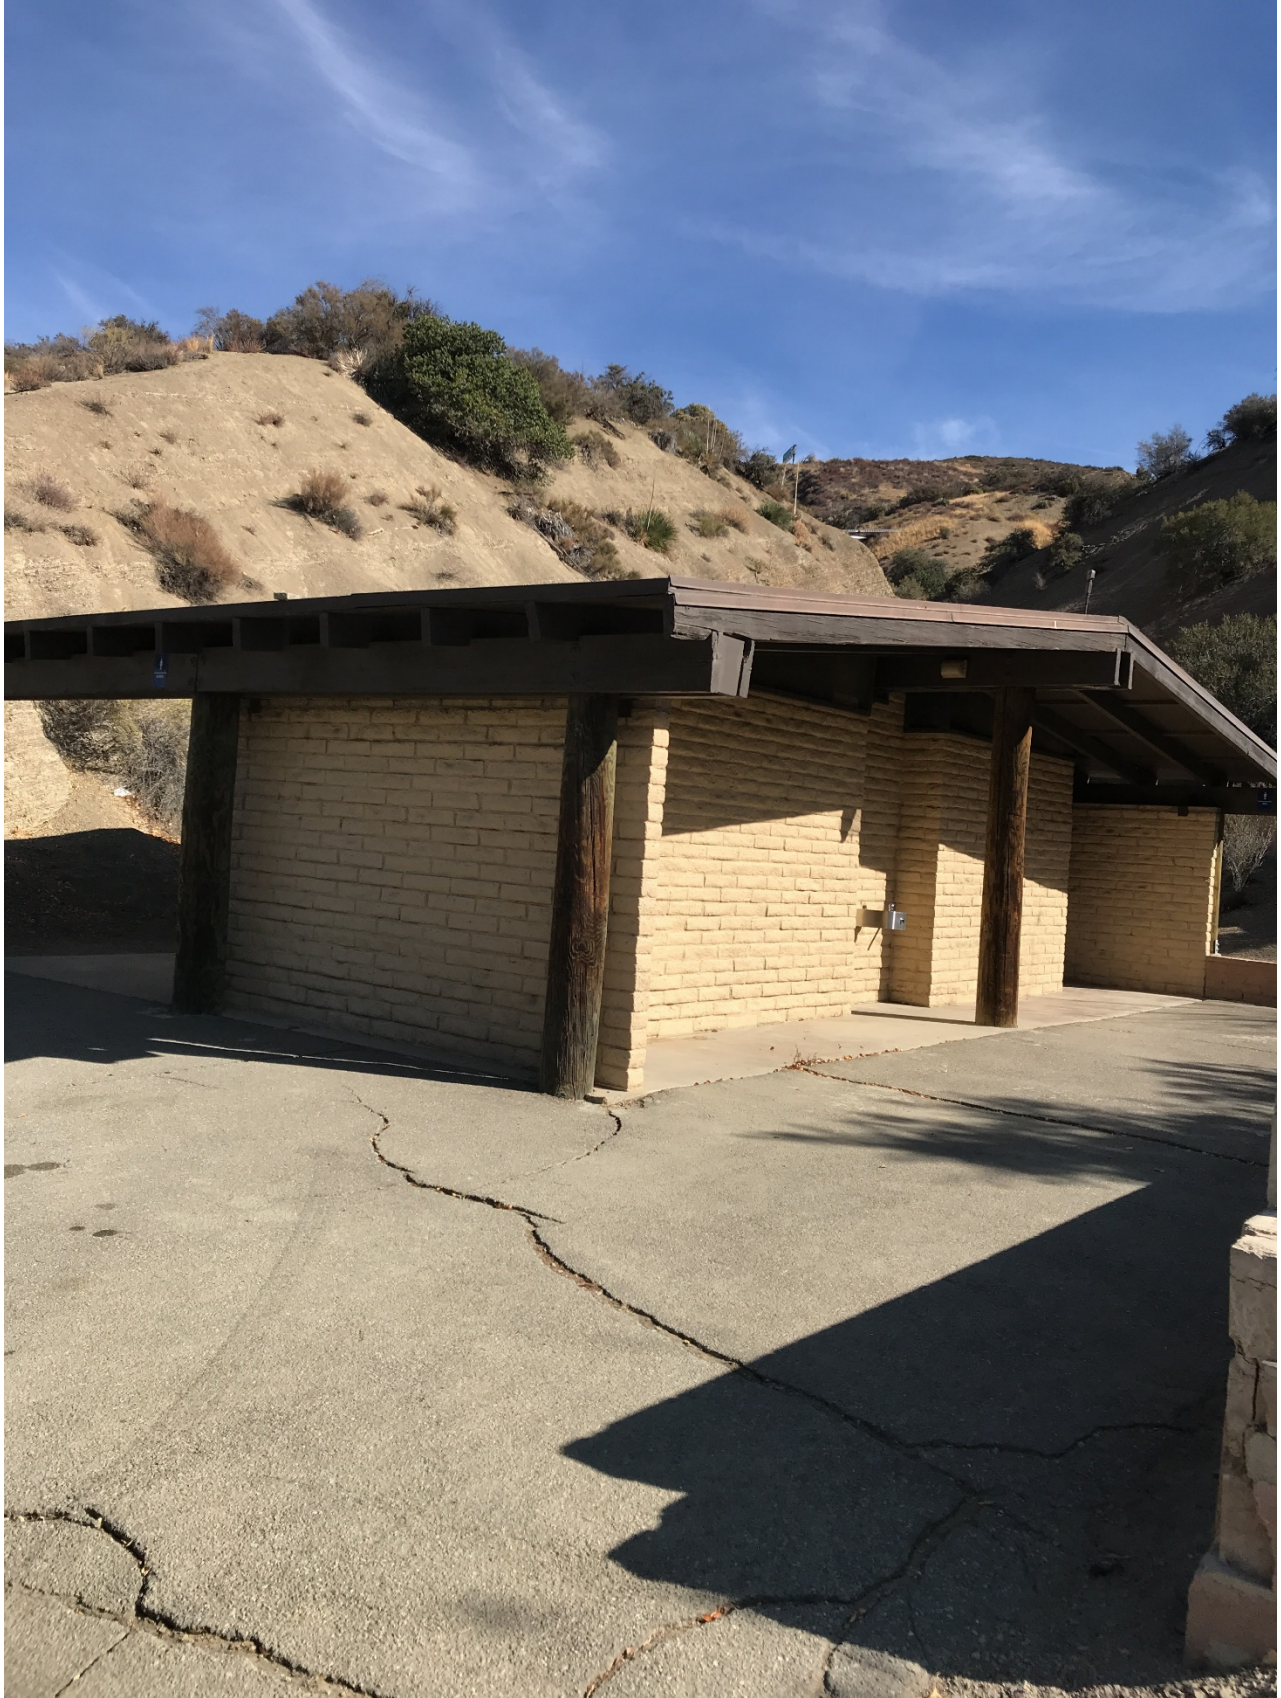
A3019R7 Emigrant Landing Restroom 7 Service Complex National Forest (FS)

A3019R7	Emigrant Landing Restroom 7	120	1974	Emigrant Landing Swim and Picnic Area	Not accessible from parking area. No ADA compliance within restroom.	CMU	Fair	Good	Potential	There was no posted name posted for this building, a better name may be: Emigrant Landing Swim and Picnic Area Restroom. Dimensions: 22'-6" x 36'-3"
A3019R5	Emigrant Landing Upper Parking Lot Restroom 5	375	1974	Emigrant Landing Swim and Picnic Area	No ADA compliance within restroom.	CMU	Fair	Good	Potential	There was no posted name posted for this building, a better name may be: Emigrant Landing Upper Parking Lot Restroom 2. Dimensions: 36' x 22'-6"
A3019R6	Emigrant Landing Upper Parking Lot Restroom 6	375	1974	Emigrant Landing Swim and Picnic Area	No ADA compliance within restroom.	CMU	Fair	Good	Potential	There was no posted name posted for this building, a better name may be: Emigrant Landing Upper Parking Lot Restroom 2. Dimensions: 36' x 22'-6"

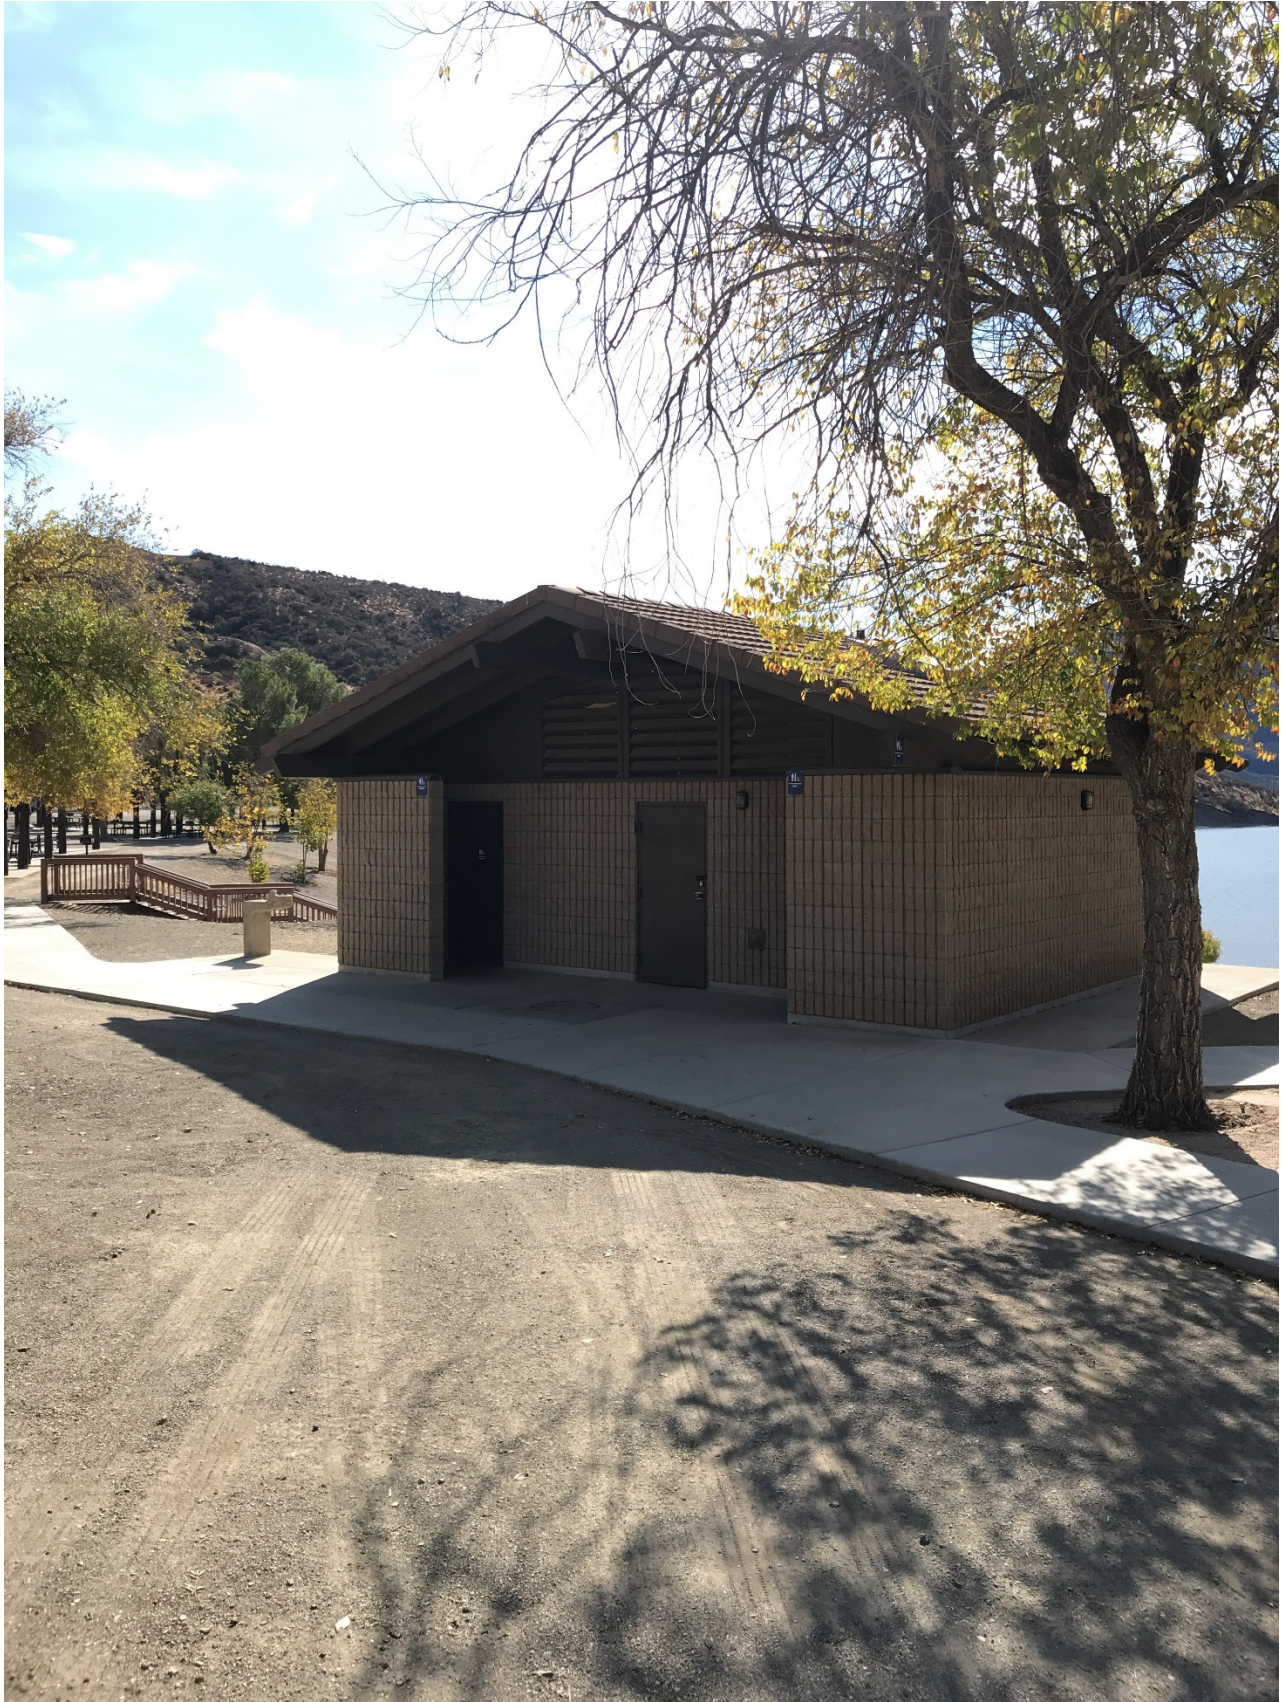
A3019R4 Emigrant Landing Upper Parking Lot Restroom 4 Service Complex National Forest (FS)

A3019R4	Emigrant Landing Upper Parking Lot Restroom 4	440	1974	Emigrant Landing Picnic and Fishing Area Two	Both woman's and men's ADA toilet too close to the wall, toilet paper dispenser too far from front of toilet.	CMU	Good	Good	Potential	There was no posted name posted for this building, a better name may be: Emigrant Landing Upper Parking Lot Restroom 1. Dimensions: 26'-9" x 20'
A4013R1	Lake Restroom 1 (floating)	154	1927	Not part of a recreation site	Nothing observed, it is a floating restroom.	Wood	Fair	Fair	No

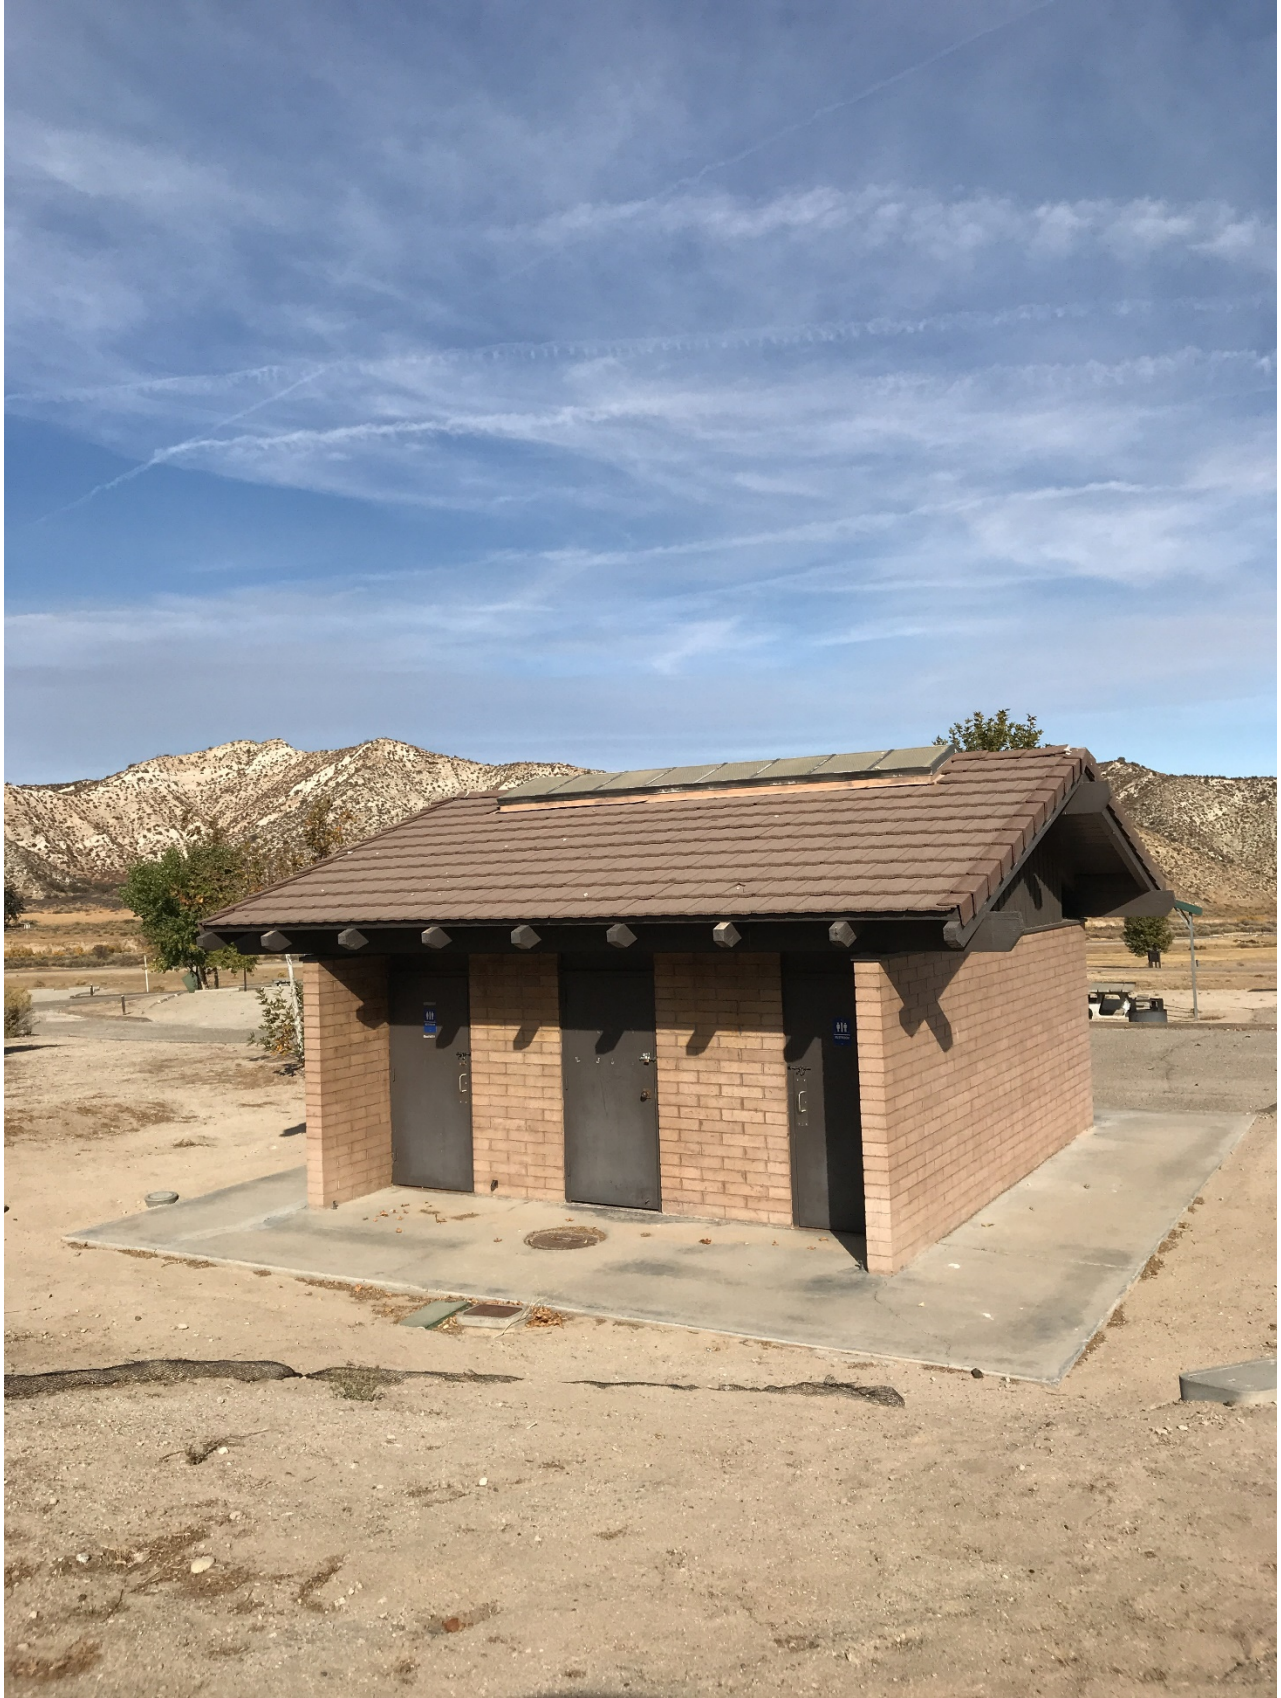
A3011R3 Los Alamos Campground Restroom 3 Service Basic National Forest (FS) 270 1974

A3011R3	Los Alamos Campground Restroom 3	270	1974	Los Alamos Campground	ADA toilets too far from wall. Not sufficient clear space in front of toilet.	CMU	Good	Good	Potential	There was no posted name posted for this building, a better name may be: Los Alamos Campground Loop 3 restroom. Dimensions: 21'-4" x 18'-8"
1697	Los Alamos Chlorine/Pump House	80	1983	Not part of a recreation site	N/A	Various	Good	Good	No	Not a public facility
2523	Los Alamos Gas House	240	1983	Not part of a recreation site	N/A	CMU	Good	Good	No	Not a public facility
A3020R1	Los Alamos Group Campground	270	1984	Los Alamos Group Campground	ADA toilet distance from wall/grab bar exceeds 18".	CMU	Good	Good	Potential	There was no posted name posted for this building, a better name may be: Los Alamos Group Campground restroom. Dimensions: 20'-5" x 18'-8"
2340	Los Alamos Office / Garage	2814	1983	Not part of a recreation site	N/A	CMU	N/A	Good	Potential	Not a public facility and not part of the Project Boundary

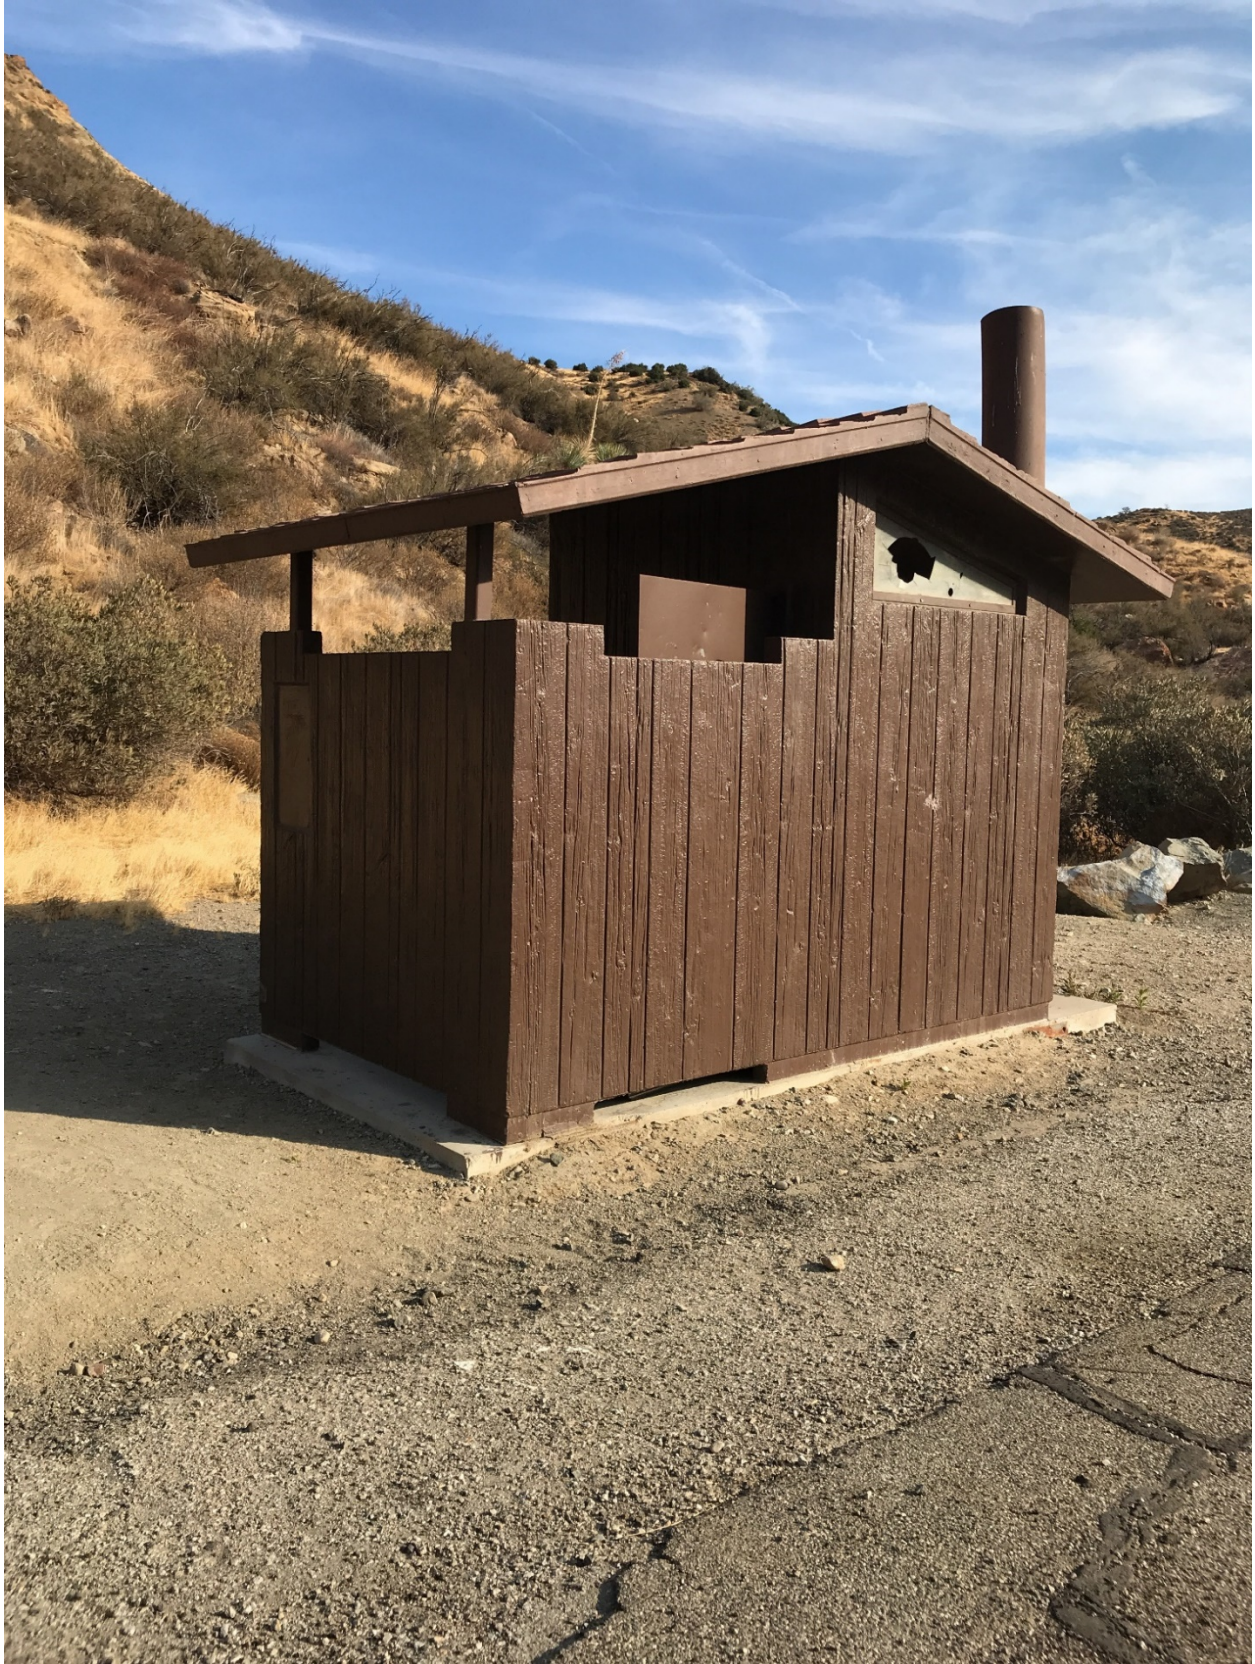
A3035R1	Piru Ponds Interp. Site Restroom (non-project maintained by USFS)	47	1994	Frenchman Flat	No accessible route to door.	Wood	Poor	Poor	No	There was no posted name posted for this building, a better name may be: Frenchman's Flat Highway Restroom. Dimensions: 12' x 6'

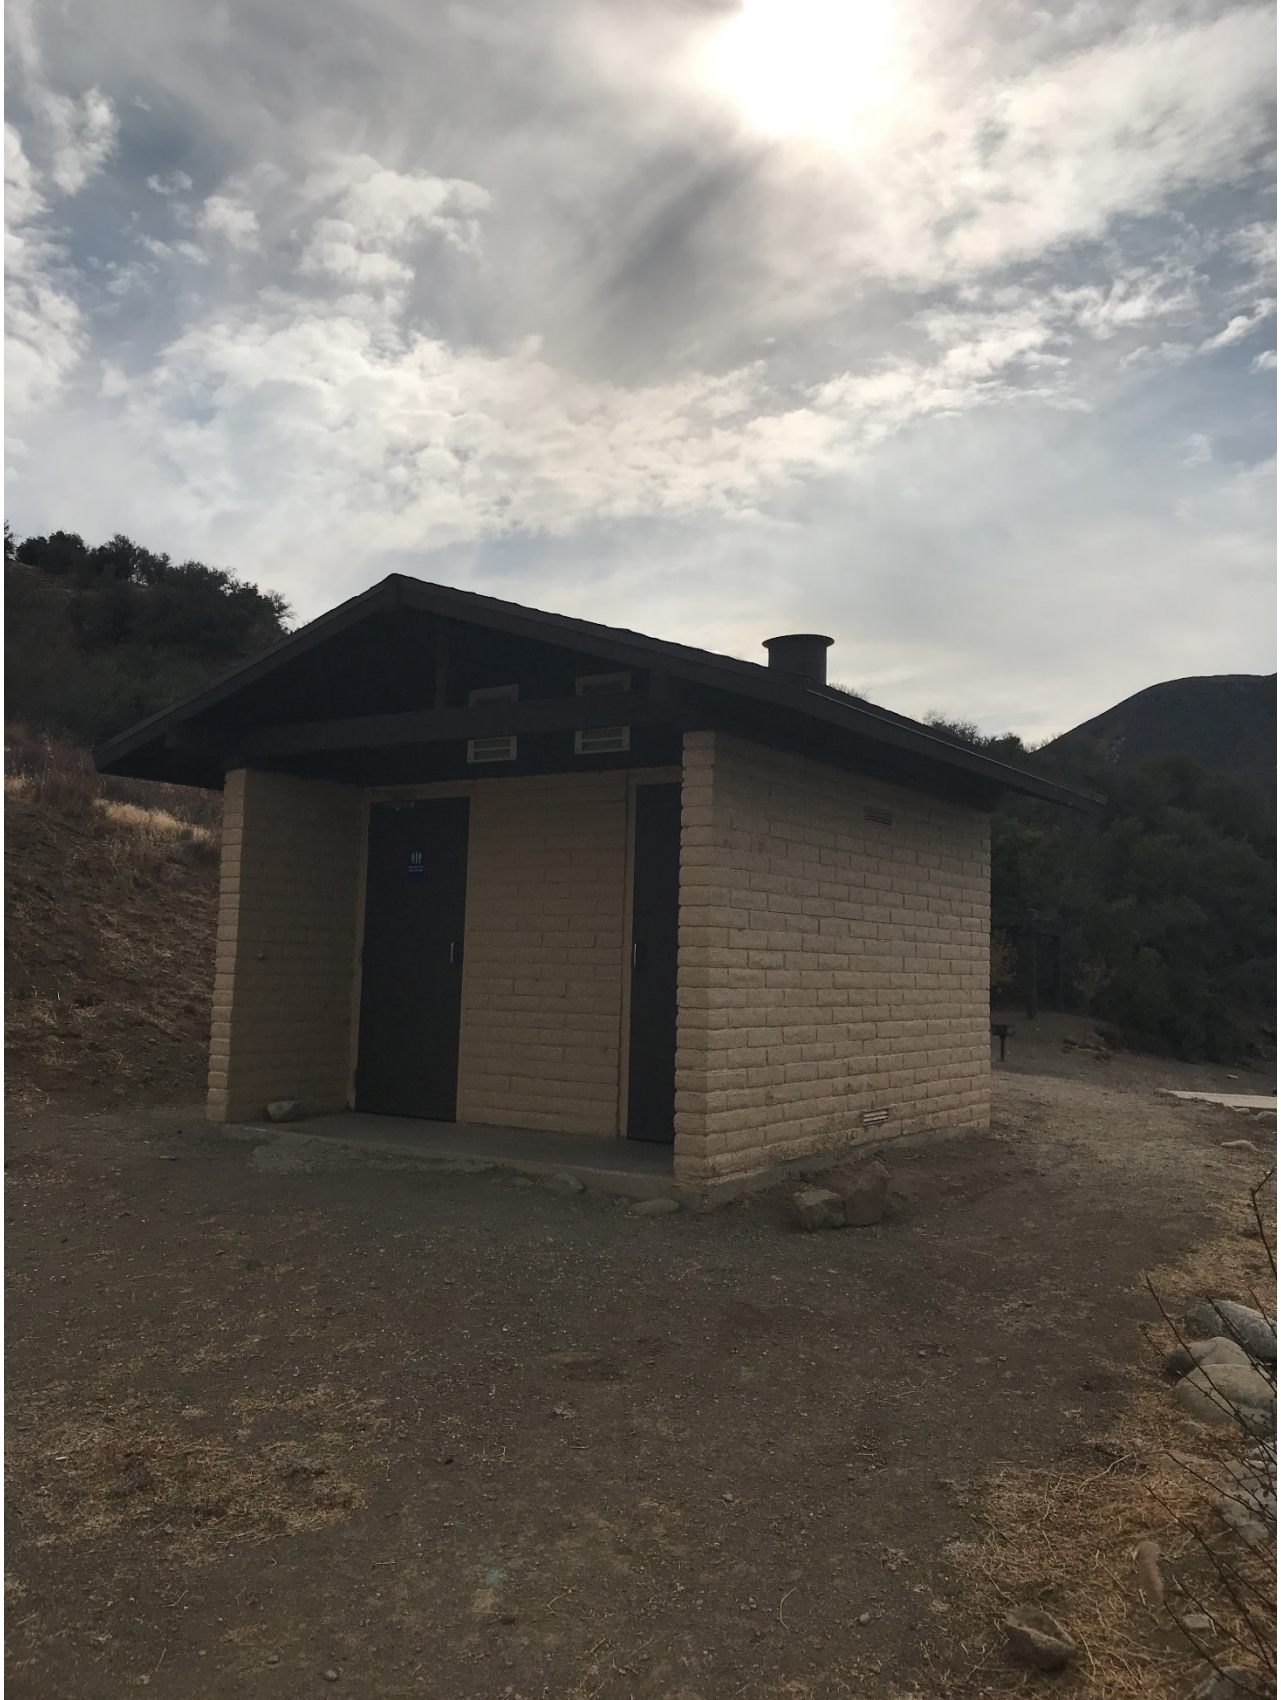
1692 Pyramid Lake Treatment Industrial Complex National Forest (FS) 200 1974

<sup>1</sup> USFS Building ID	<sup>1</sup> USFS Building Name	<sup>1</sup> Square Feet	<sup>1</sup> Year Constructed	Recreation site association	Accessibility/ADA notes	Material	Condition	H&S	Energy efficiency	Notes
1692	Pyramid Lake Treatment	200	1974	Emigrant Landing Picnic and Fishing Area One	N/A	CMU	Good	Good	No	Not a public facility
A3018R	Serrano Boat In Site	55	1974	Serrano Boat-in Picnic Area	No accessible route to bathroom.	CMU	Good	Good	Potential	There was no posted name posted for this building, a better name may be: Serrano Boat in Restroom. Dimensions:13'-4" x 12'
A3014R	Spanish Point Restroom	540	1973	Spanish Point Boat-in Picnic Area	No accessible route to restroom.	CMU	Good	Good	Potential	Dimensions: 26'-9" x 20'
A3034ES	Vaquero Entrance Station	96	1997	Vista del Lago Visitor Center	N/A	Wood	Good	Safe	Yes	Dimensions: 12' x 8'-4"
A3034R1	Vaquero Restroom	240	1997	Vaquero Day Use Area	One accessible stall each side. 57" x 72" clear space, men's sink 33"h, woman's sink 37" h.	CMU	Good	Safe	Potential	Dimensions: 20' x 24'

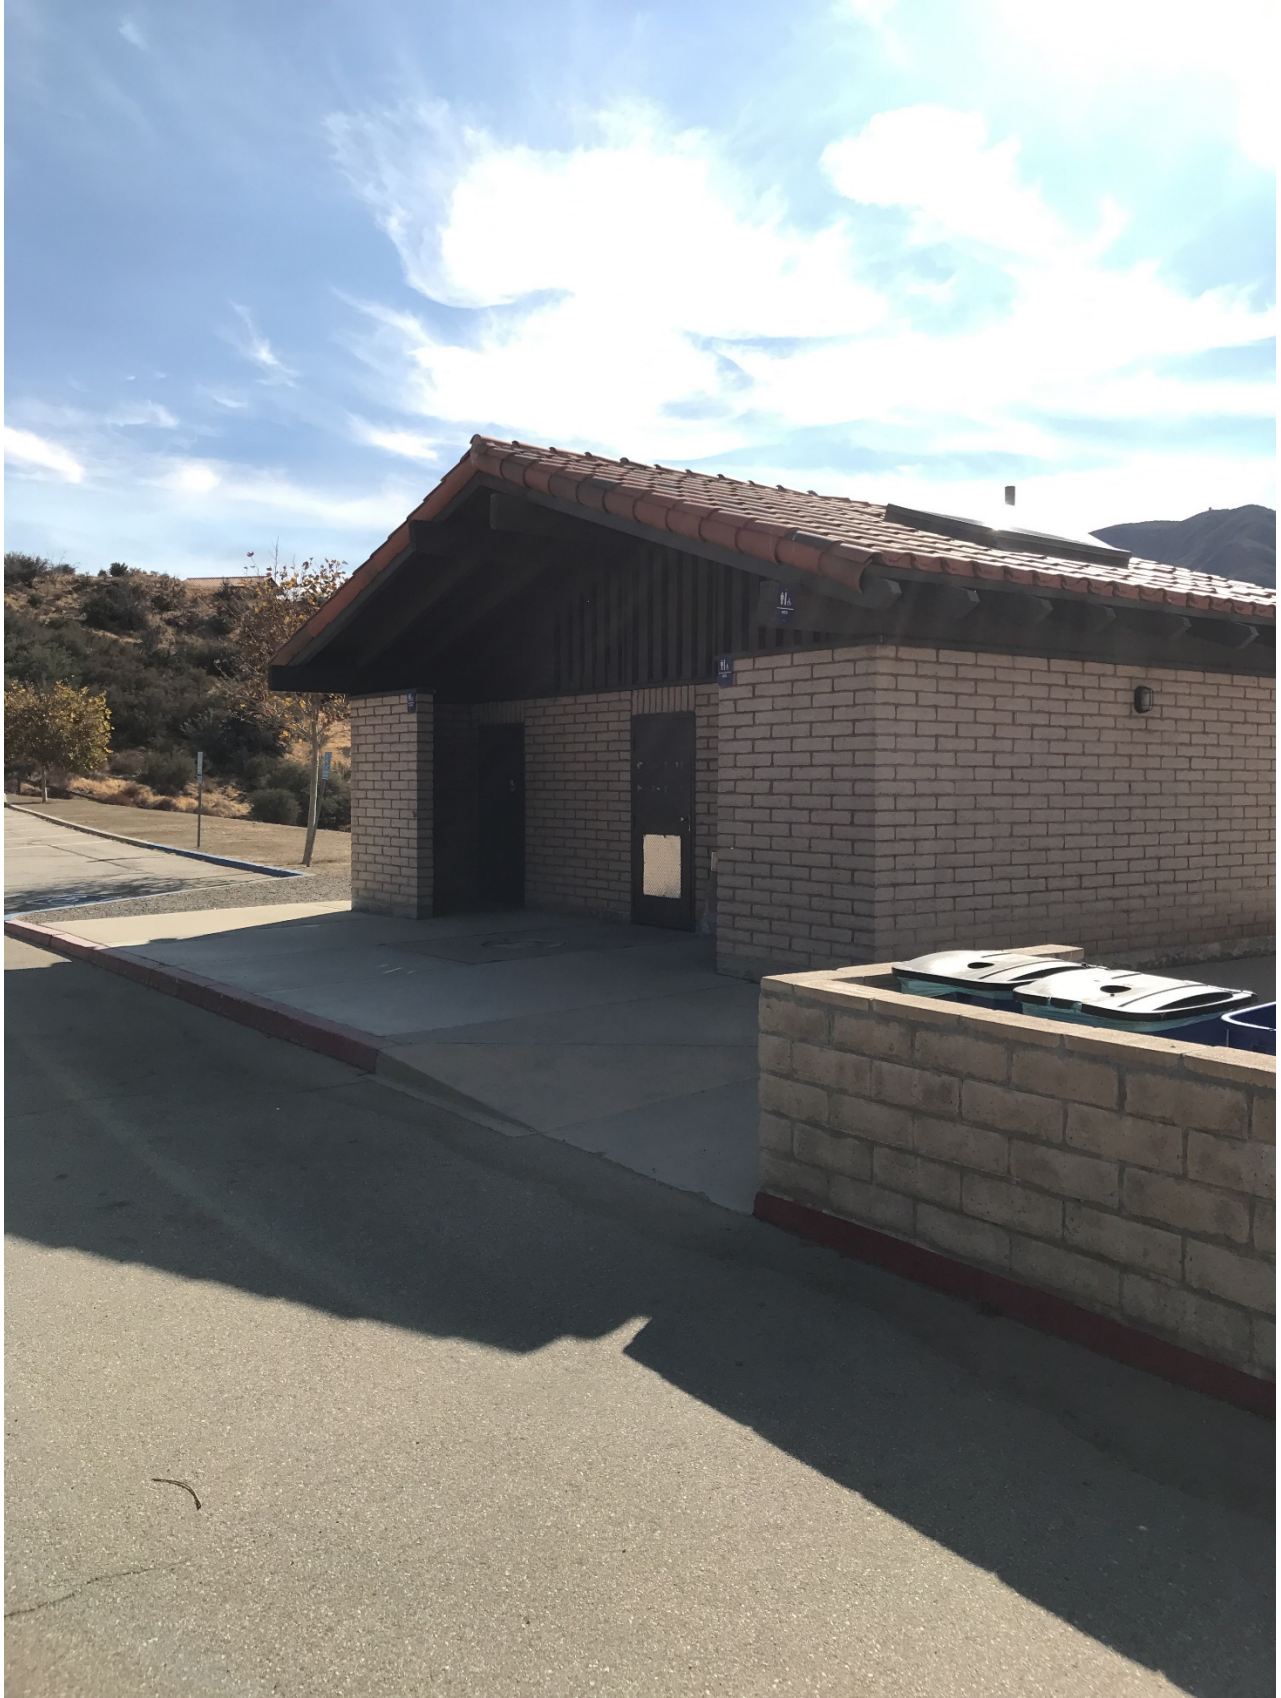
A3034R2 Vaquero Restroom Service Basic National Forest (FS) 240 1997

A3034R2	Vaquero Restroom	240	1997	Vaquero Day Use Area	Accessibility braille located at 7' above ground.	CMU	Excellent	Safe	Potential	Dimensions: 26'-8" x 20'
A3034ST	Vaquero Storage	161	1997	Vaquero Day Use Area	Nothing observed, it is a storage yard.	N/A	N/A	N/A	N/A	
A3015R	Yellow Bar Restroom	55	1974	Yellow Bar Boat-in Picnic Area	Compliant.	Wood	Excellent	Safe	Potential	Dimensions: 6'-6 x 12'-7"
