SSWP Pyramid Lake Recreation Area Buildings

The following lists of buildings were provided to the Licensees' by USFS in April 2017. Throughout field survey's the field researchers found that all buildings listed were owned by the Nation Forest and all buildings served as a service, office, storage, or an industrial purpose to the Recreation site. Please see the two lists below of buildings identified by the field researchers and those not located.

**Table 4.1-10. Buildings Within the Recreation Study Area**

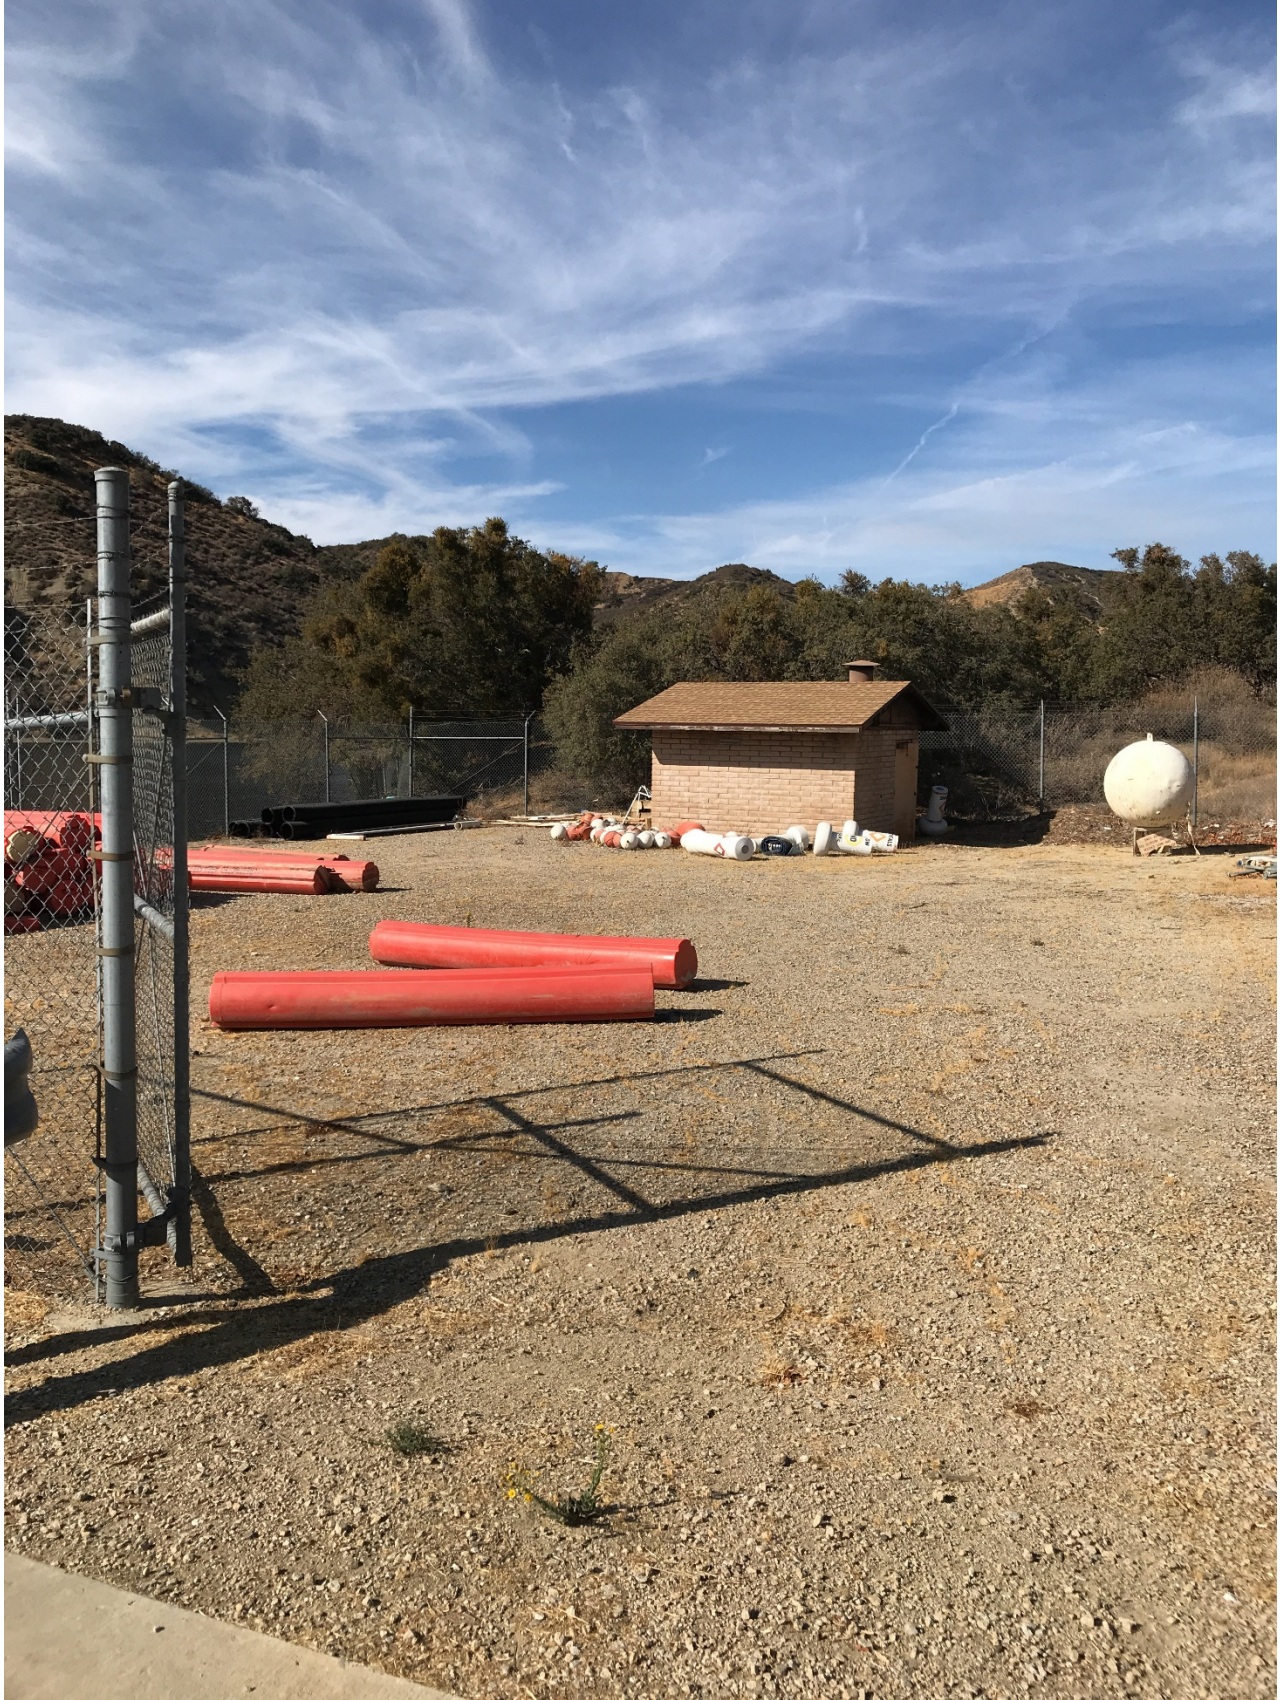
A3034R2 Vaquero Restroom Service Basic National Forest (FS) 240 1997

A3034R2	Vaquero Restroom	240	1997	Vaquero Day Use Area	Accessibility braille located at 7' above ground.	CMU	Excellent	Safe	Potential	Dimensions: 26'-8" x 20'
A3034ST	Vaquero Storage	161	1997	Vaquero Day Use Area	Nothing observed, it is a storage yard.	N/A	N/A	N/A	N/A	
A3015R	Yellow Bar Restroom	55	1974	Yellow Bar Boat-in Picnic Area	Compliant.	Wood	Excellent	Safe	Potential	Dimensions: 6'-6 x 12'-7"
