South SWP Hydropower Relicensing, FERC Project No. 2426 Whitewater Study Field Reconnaissance Summary

Reconnaissance Details

**Representative photos for 15 mile
section of Pyramid reach from
Frenchman's Flat to Blue Point
Campground from January 9 – 10,
2019**

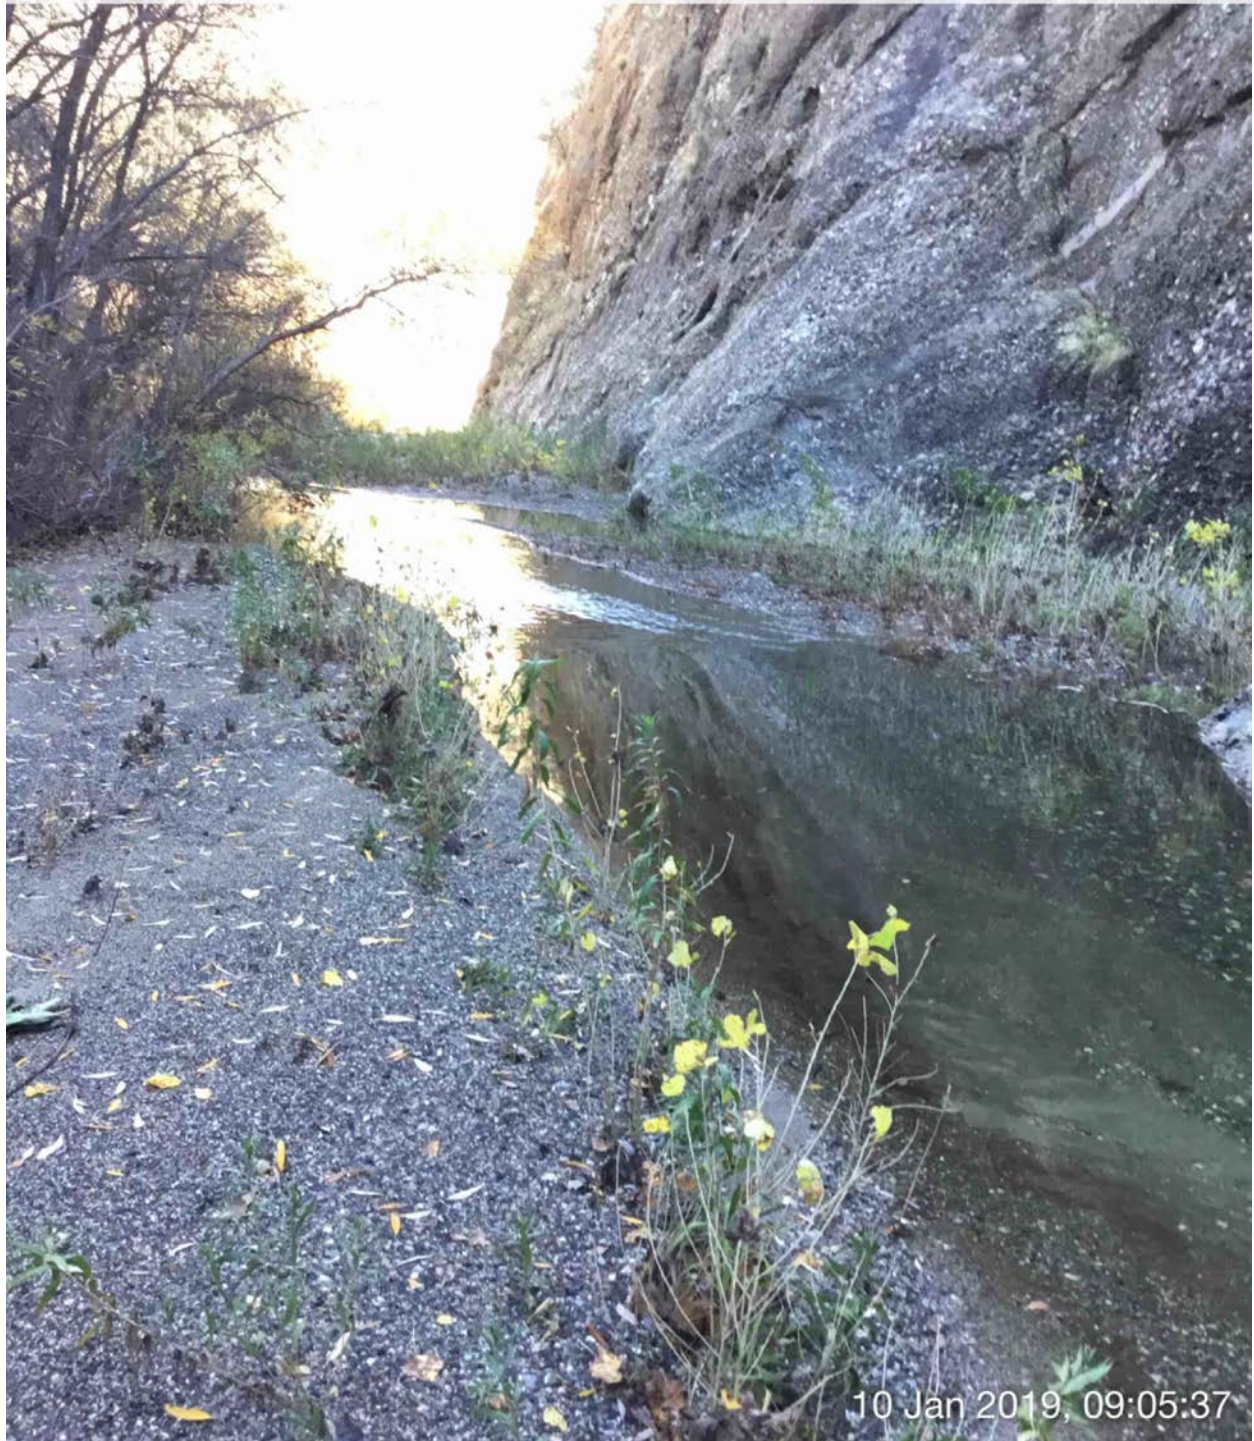
☀ 76°E (T) ● 34°32'48"N, 118°46'18"W ±98.4ft ▲ 1197ft

Lower portion of Pyramid reach looking down stream. Slow moving water with steep canyon on one side and a wide sand bed on the other.

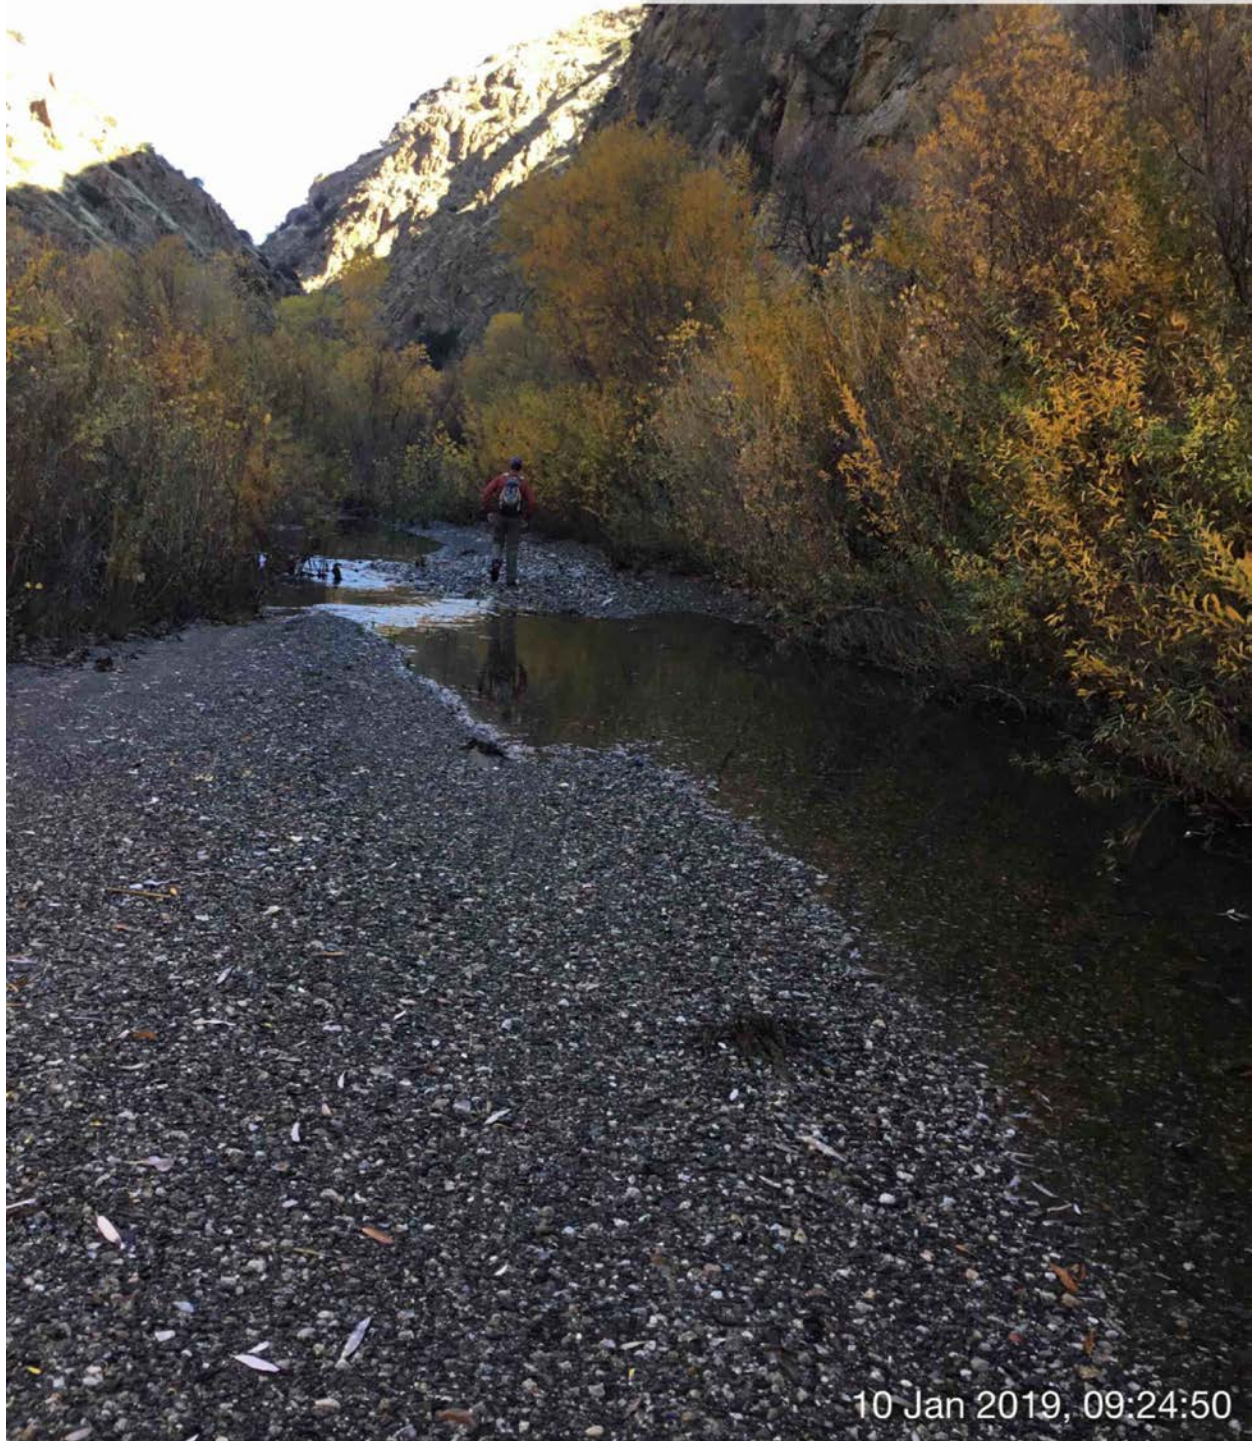
☉ 43°NE (T) ● 34°32'56"N, 118°46'30"W ±16.4ft ▲ 1005ft

Lower portion of Pyramid reach looking downstream. Wide open stream bed with slow moving water.

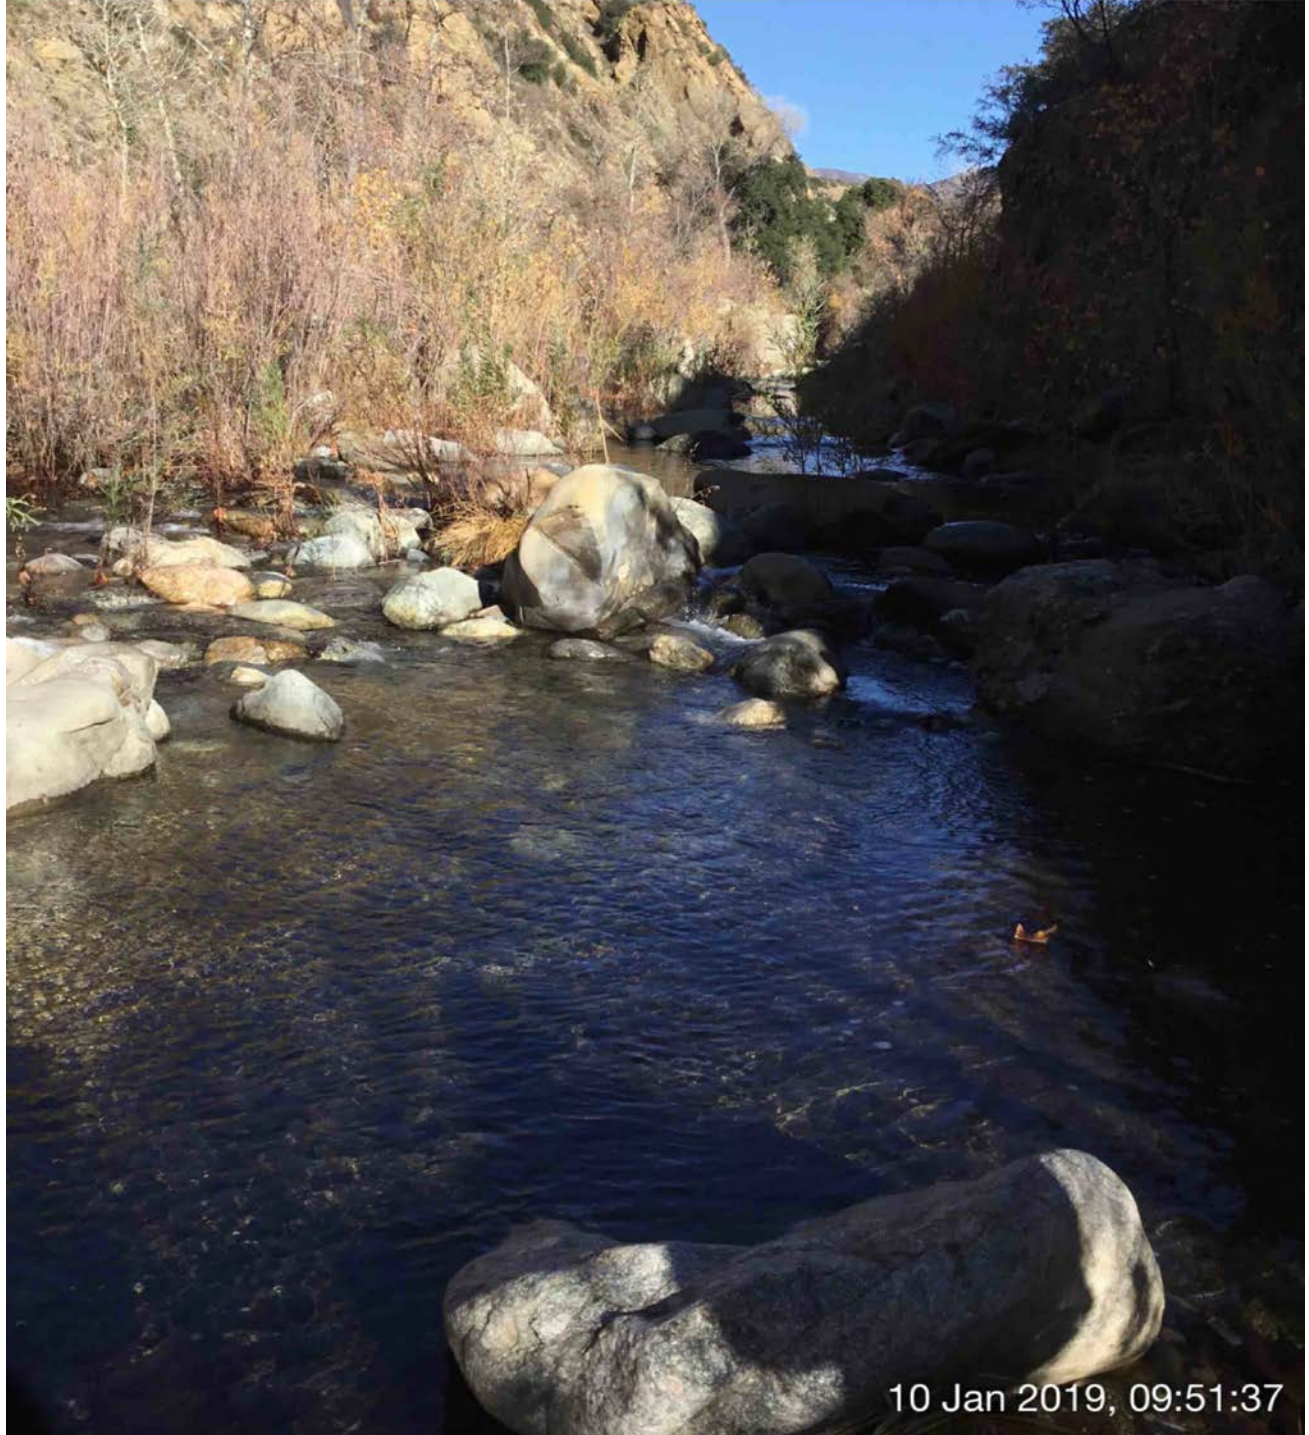
☉ 347°N (T) ● 34°33'17"N, 118°46'32"W ±32.8ft ▲ 1171ft

Lower portion of Pyramid reach looking upstream. Small and Light rapids with low cfs. Potential for class III or IV rapids with higher flows.

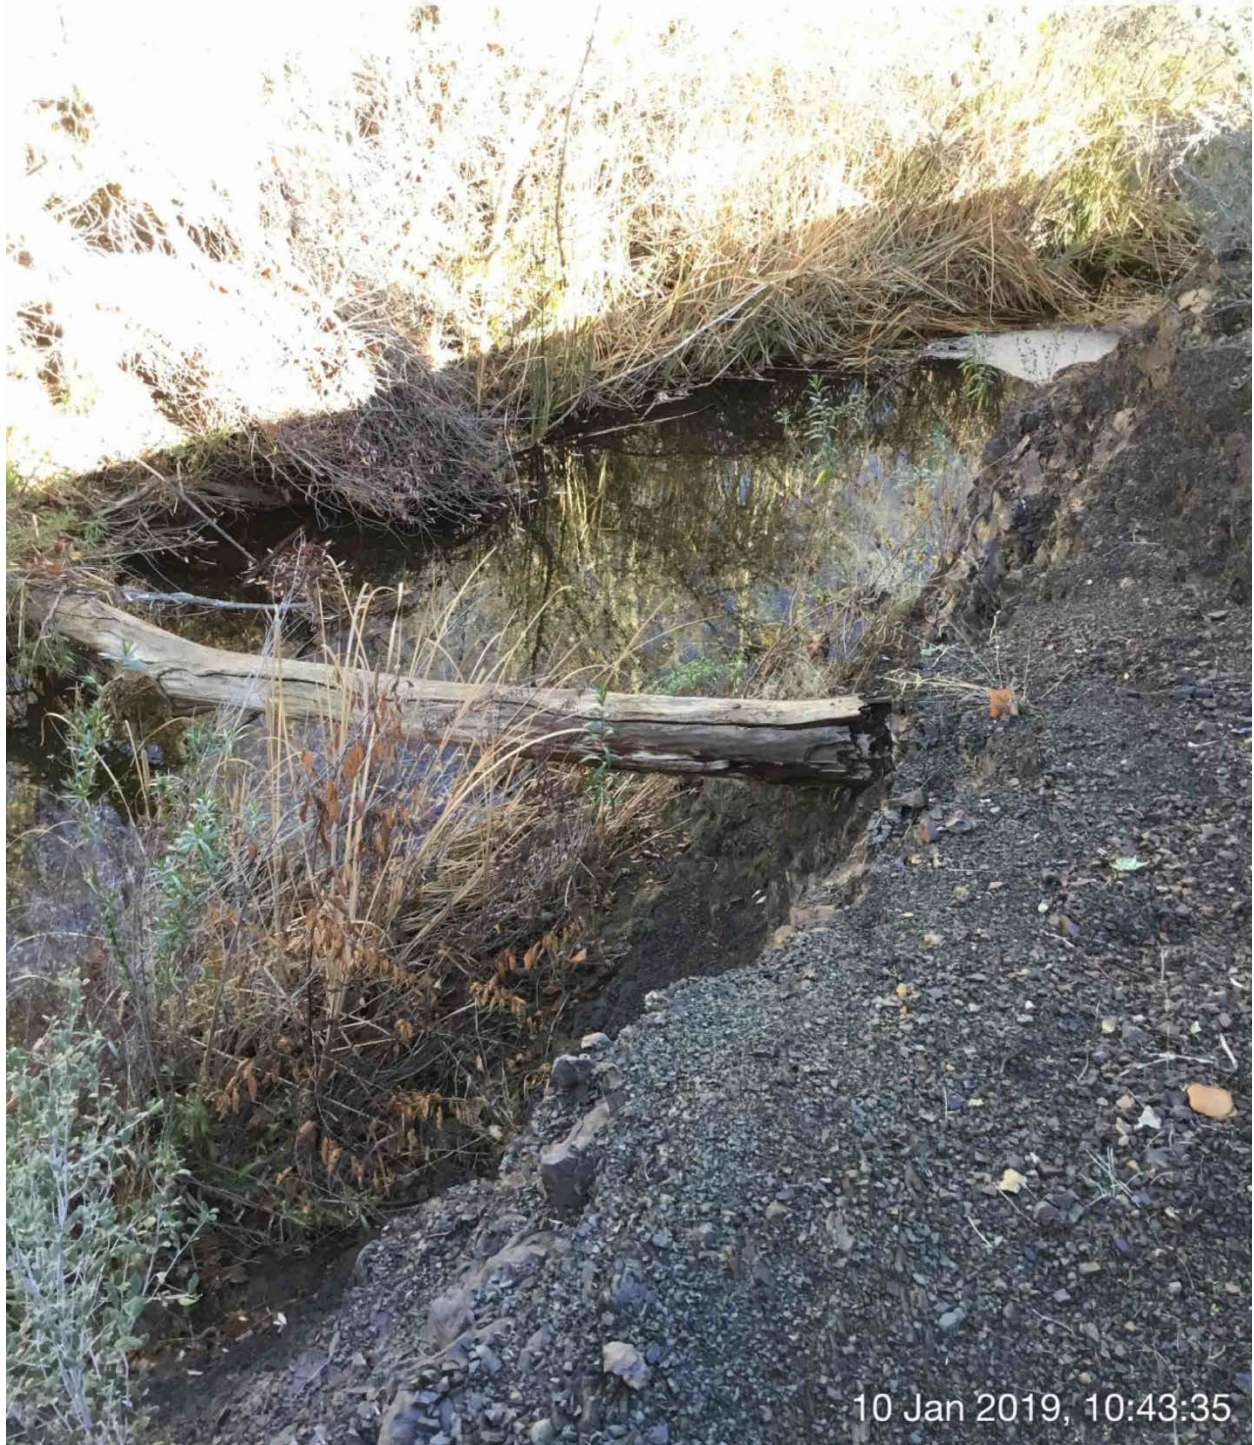
☉ 37°NE (T) ● 34°33'58"N, 118°46'40"W ±16.4ft ▲ 1199ft

Fallen trees in the channel were observed that could represent another hazard boaters would have to watch carefully for. At times the fallen trees were strung across the reach and it is unclear whether the water at 200cfs would clear the height of the laying logs.

Lower portion of Pyramid reach looking downstream. Debris blocking travel downstream.

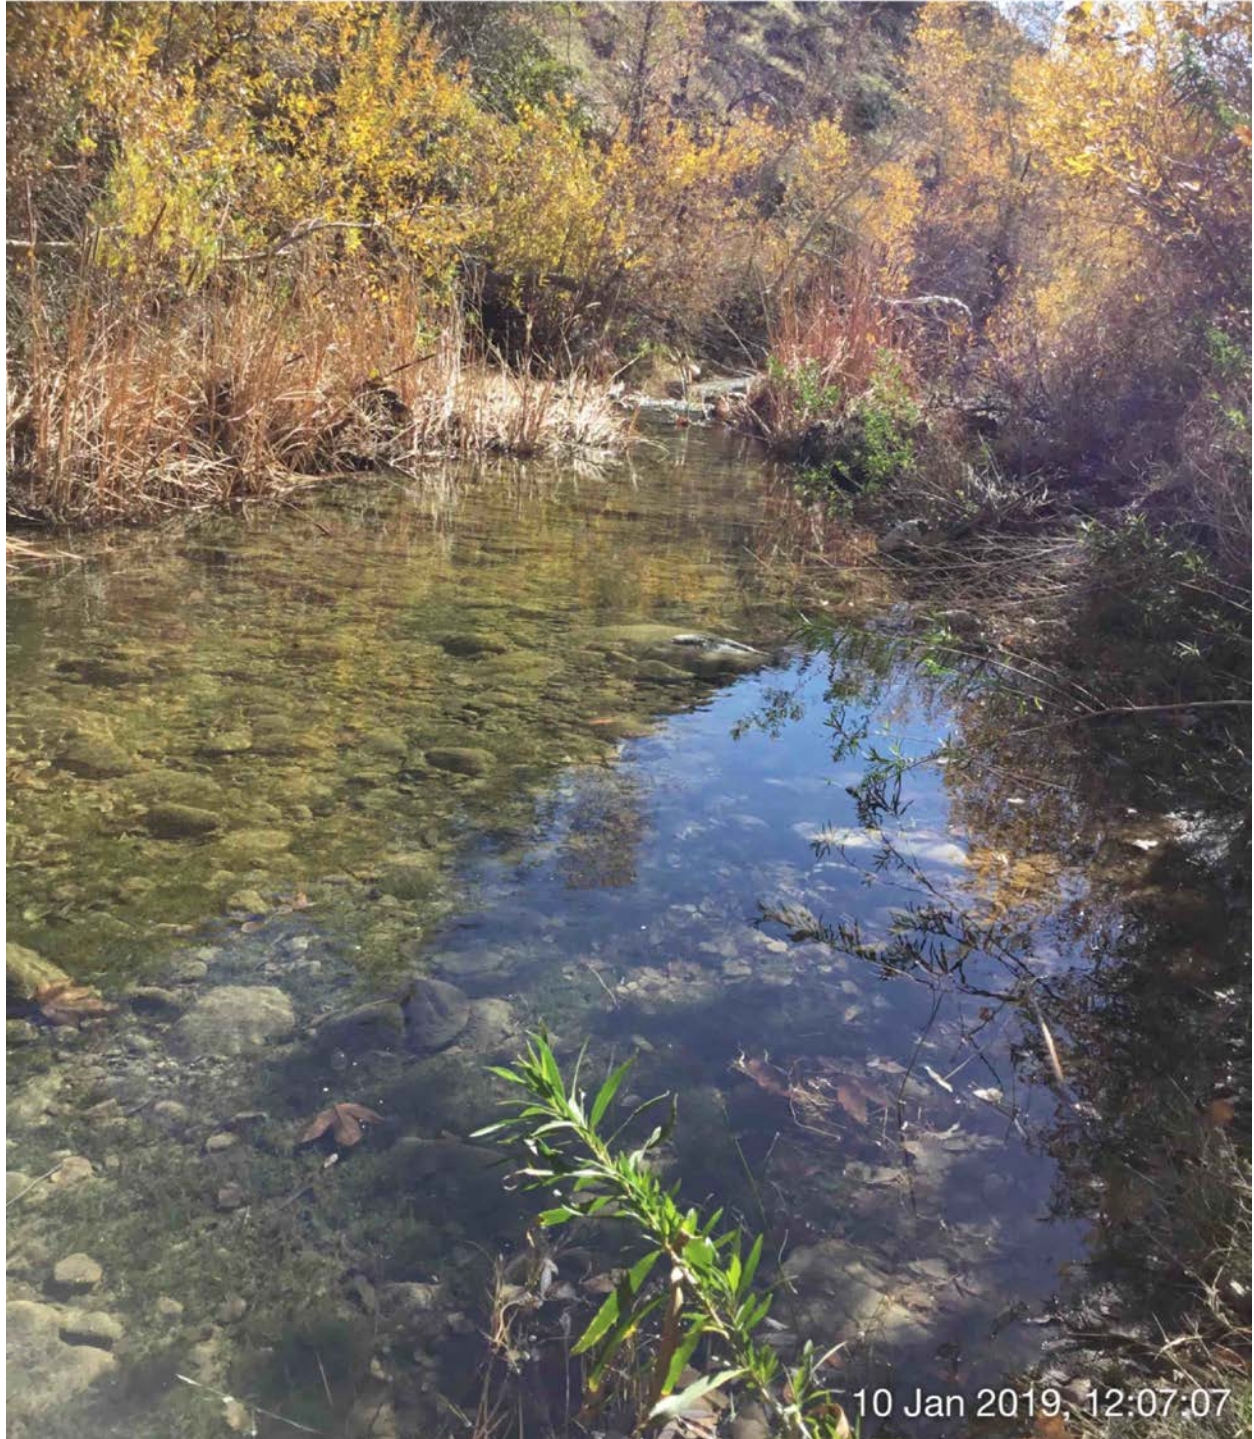
🌀 149°SE (T) 📍 34°34'41"N, 118°46'34"W ±16.4ft ▲ 1304ft

Lower portion of Pyramid reach looking downstream. Slow and steady moving water a class II for whitewater boaters.

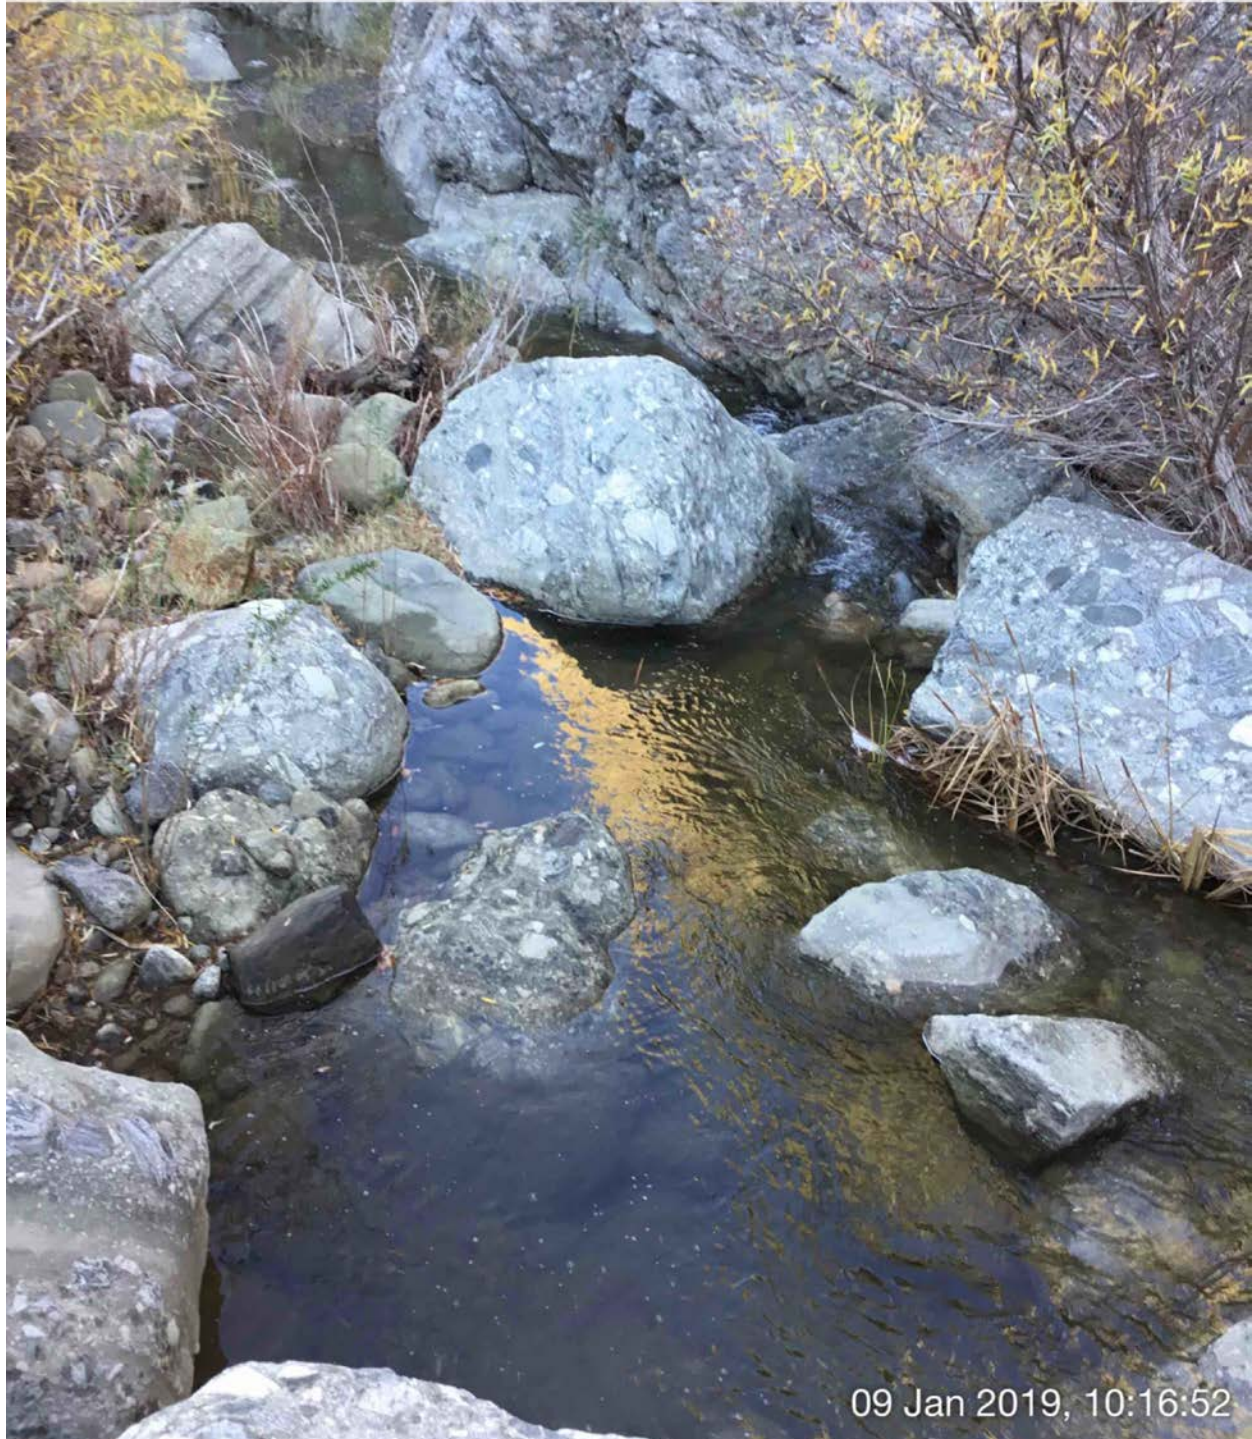
🌀 278°W (T) 📍 34°36'37"N, 118°45'4"W ±32.8ft ▲ 2003ft

Upper portion of Pyramid reach looking downstream. Small waterfall looks impossible to boat with low flows but can be a good size drop with higher flows.

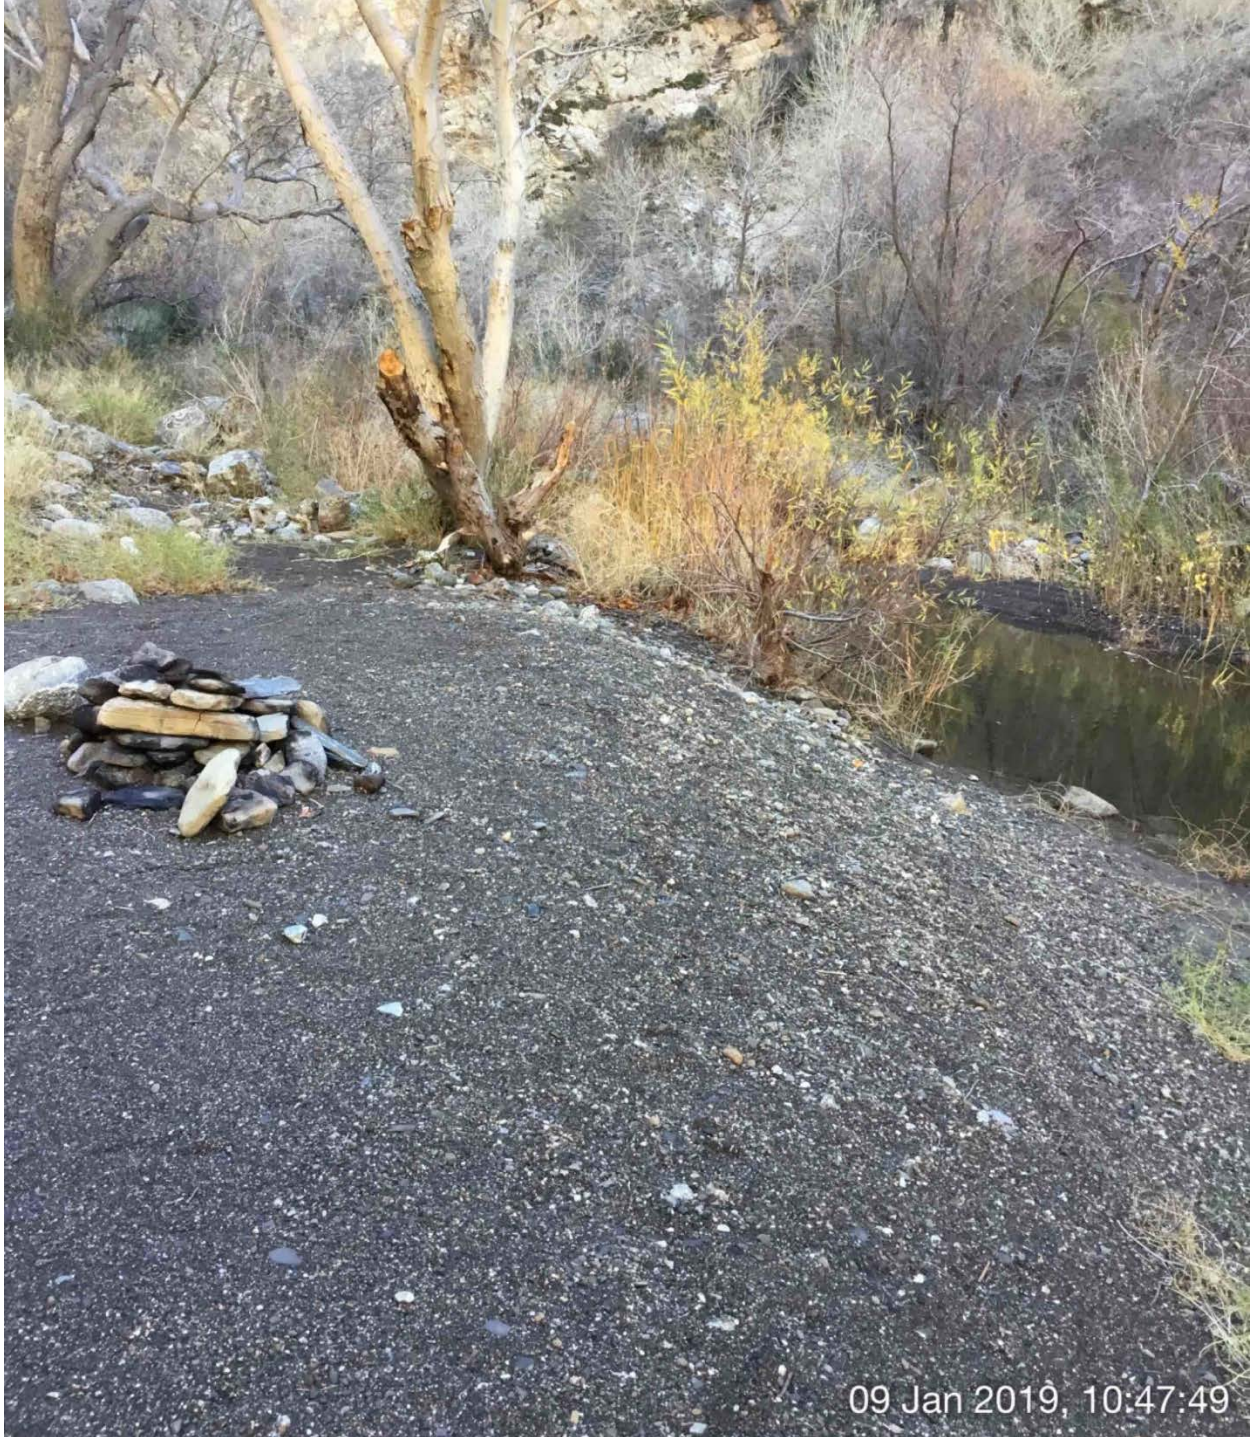
☀ 167°S (T) ● 34°36'31"N, 118°45'41"W ±32.8ft ▲ 1987ft

Throughout this portion Piru Reach there is evidence of well-established campsites with fire pits. Recreationalist, probably anglers and others that enjoy hiking are walking through the canyon on shoreline and creek channel trails and setting up camps. Fishing seemed to be the most likely activity being done in the area. Evidence of fishing was found with old fishing rods and associated gear being tangled up in tree debris or up against the rock walls.

Upper portion of Pyramid reach looking upstream. Evidence that people camp in this reach along the wide sand banks.
