SOUTH SWP HYDROPOWER FERC PROJECT NO. 2426-227

Updated Study Report

From May 1, 2018 through April 30, 2019

**State of California
California Natural Resources Agency
DEPARTMENT OF WATER
RESOURCES
Hydropower License Planning and
Compliance Office**

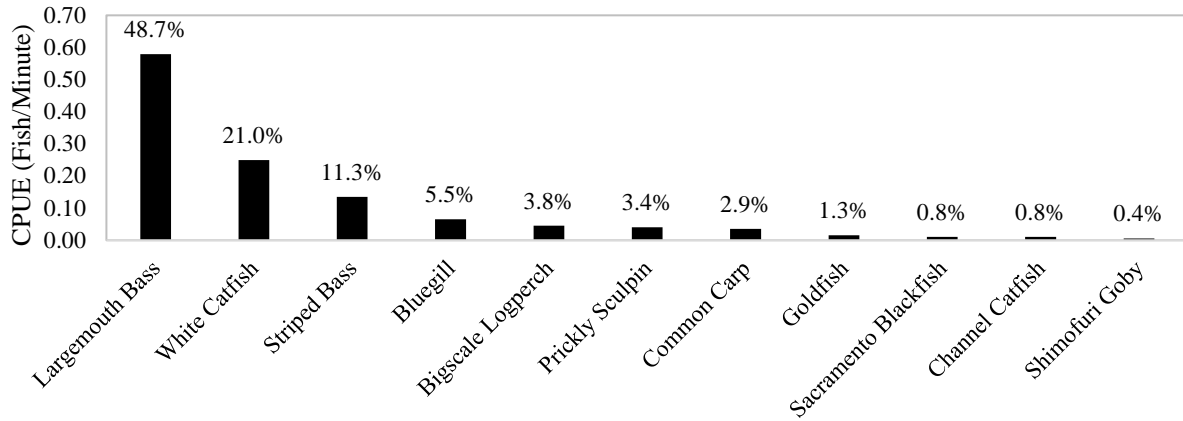
Figure 2.2-1. Overall CPUE (Fish Per Minute) with Composition of Species Collected During Boat Electrofishing on Quail Lake

Sampling results are presented in Table 2.2-1, and overall catch per unit effort (CPUE, fish per minute of electrofisher operation) and species composition are provided in Figure 2.2-1. Table 2.2-1 lists the 13 fish species collected and observed; Figure 2.2-1 lists only the 11 fish species collected (excludes threadfin shad and inland silverside).

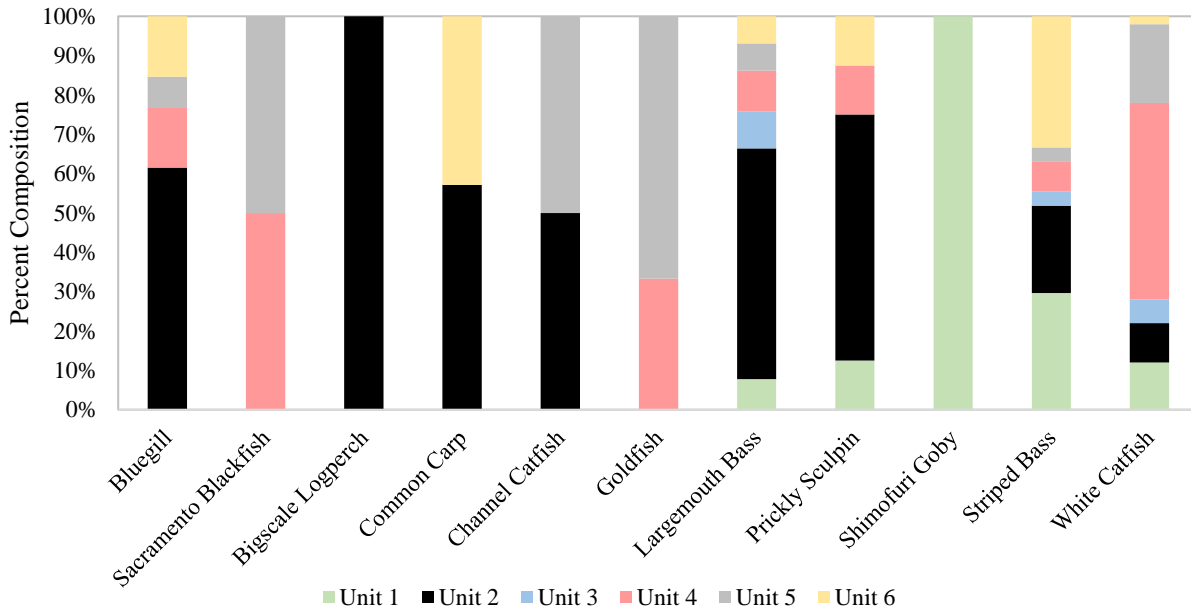
Figure 2.2-2. Percent Composition by Habitat Unit During Boat Electrofishing on Quail Lake

Species composition varied among the six sampled units. Unit 2 produced the most species and Unit 3 the least (8 and 3, respectively). The three most abundant fish species (largemouth bass, striped bass, and white catfish) were found in all six units. Figure 2.2-2 shows the percent composition of fish species by unit.

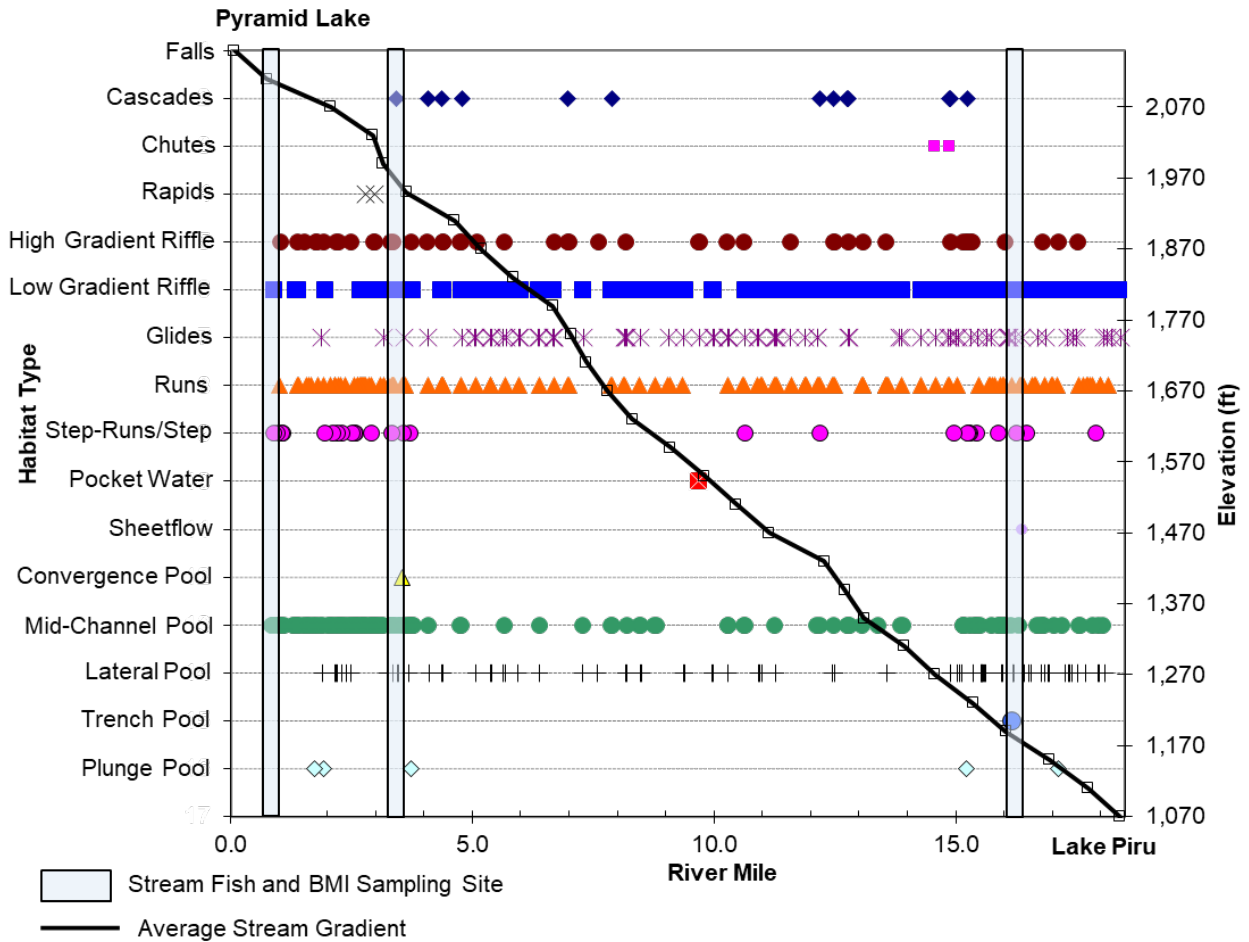
Figure 2.3-1. Mesohabitat Types Identified In Pyramid Reach

Figure 2.3-1 provides the distribution of mesohabitat types identified in Pyramid reach during the habitat mapping effort. In general, habitats typical of lower gradient streams (pools, runs, glides, and low gradient riffles) were the most common.

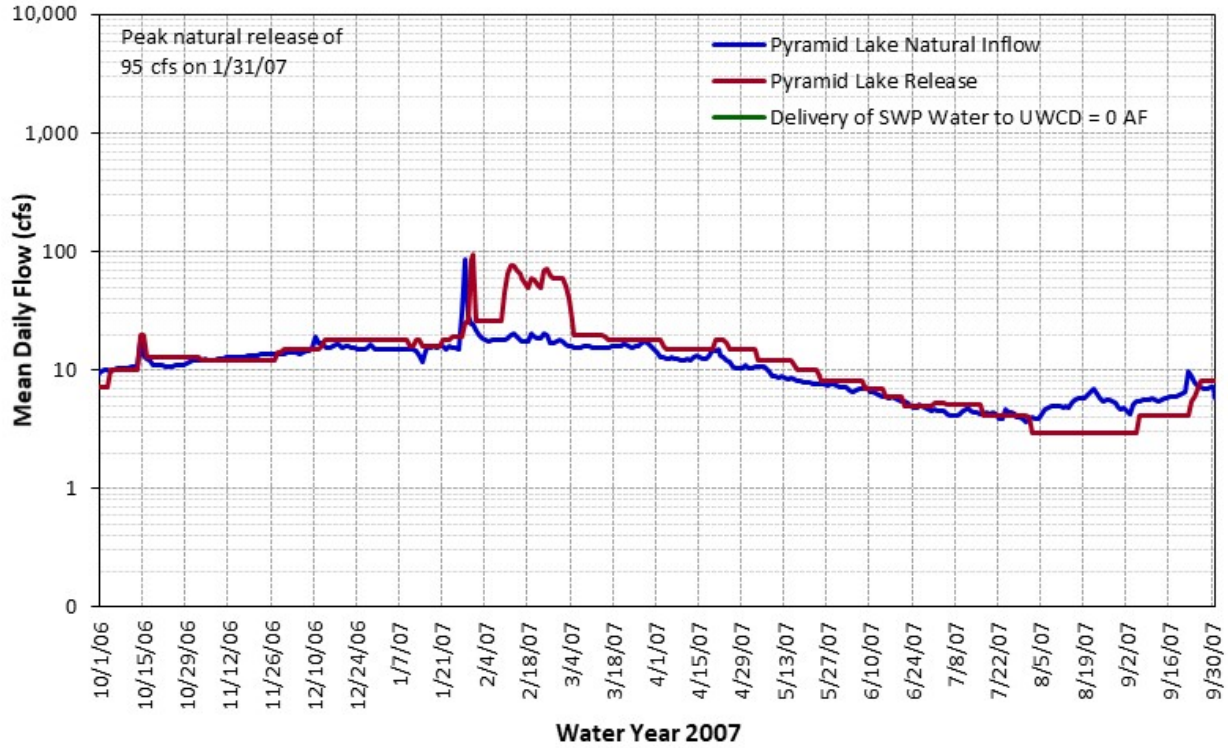
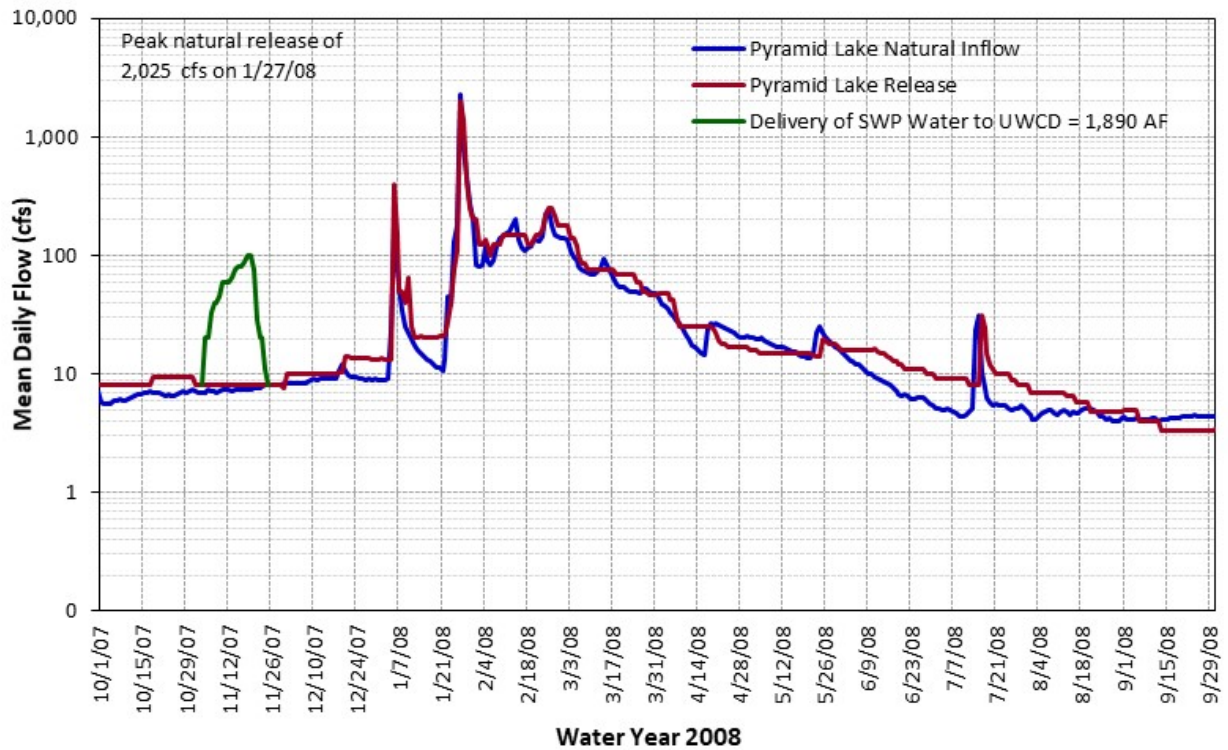
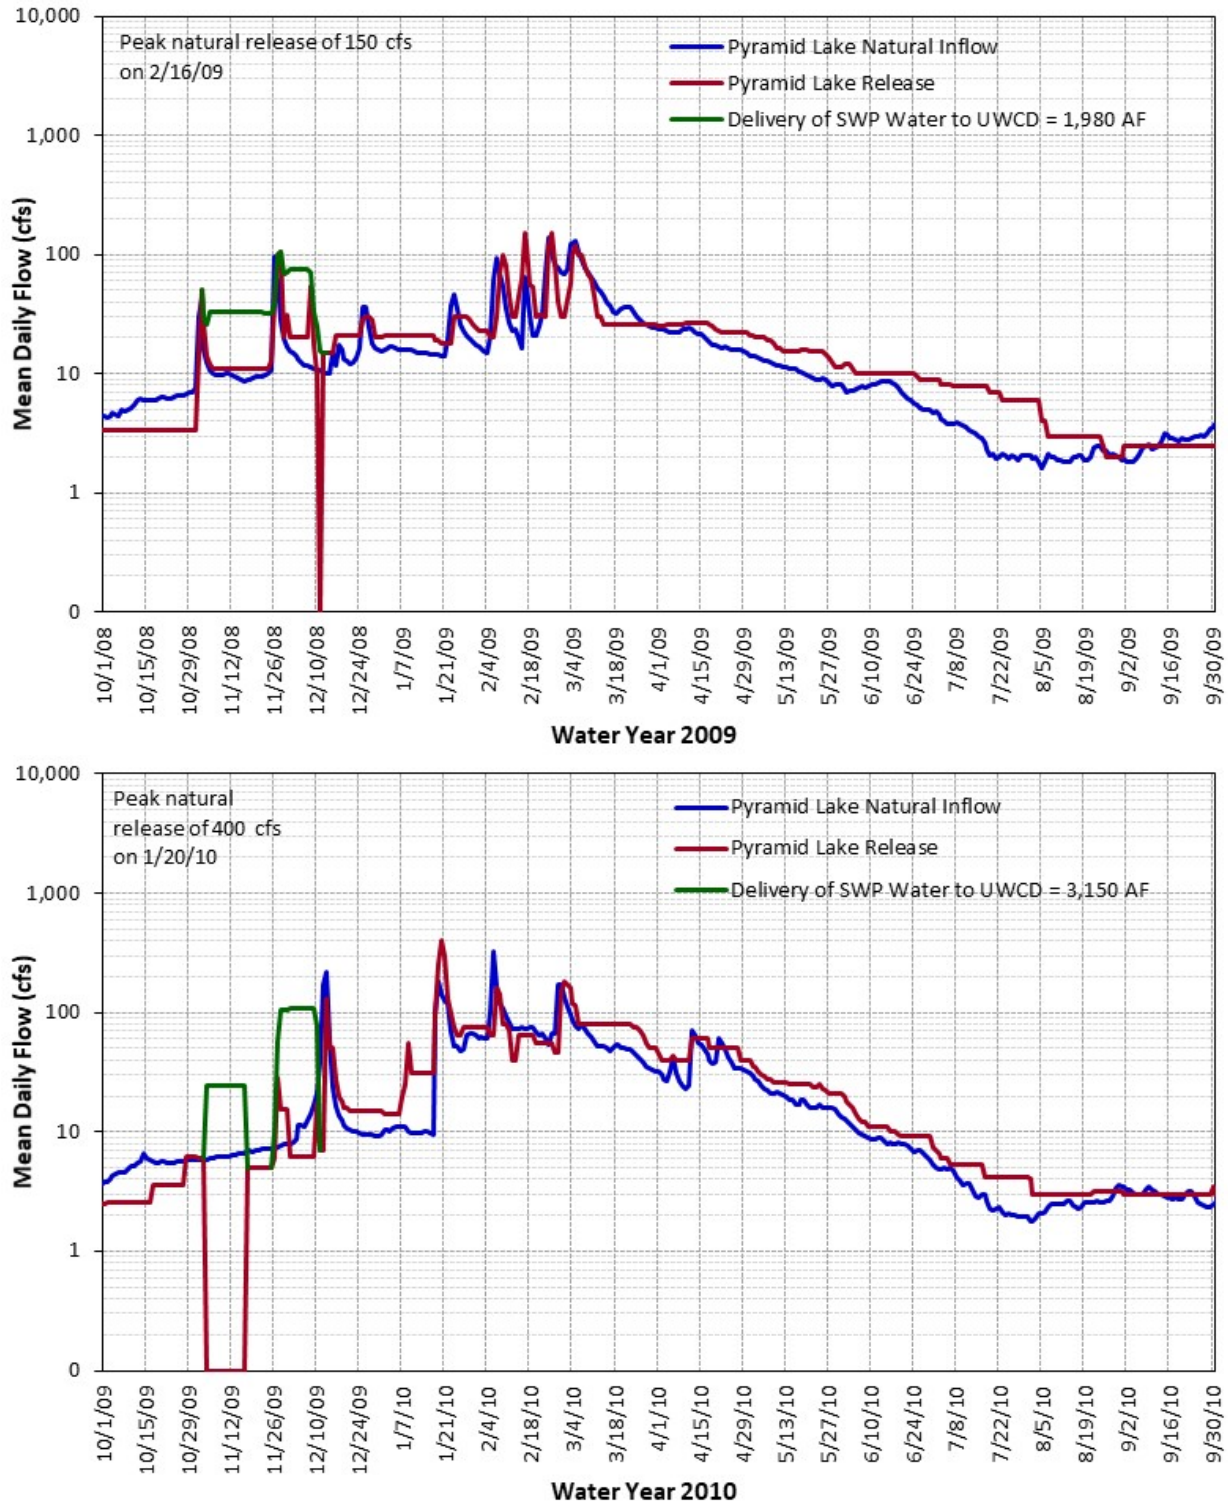
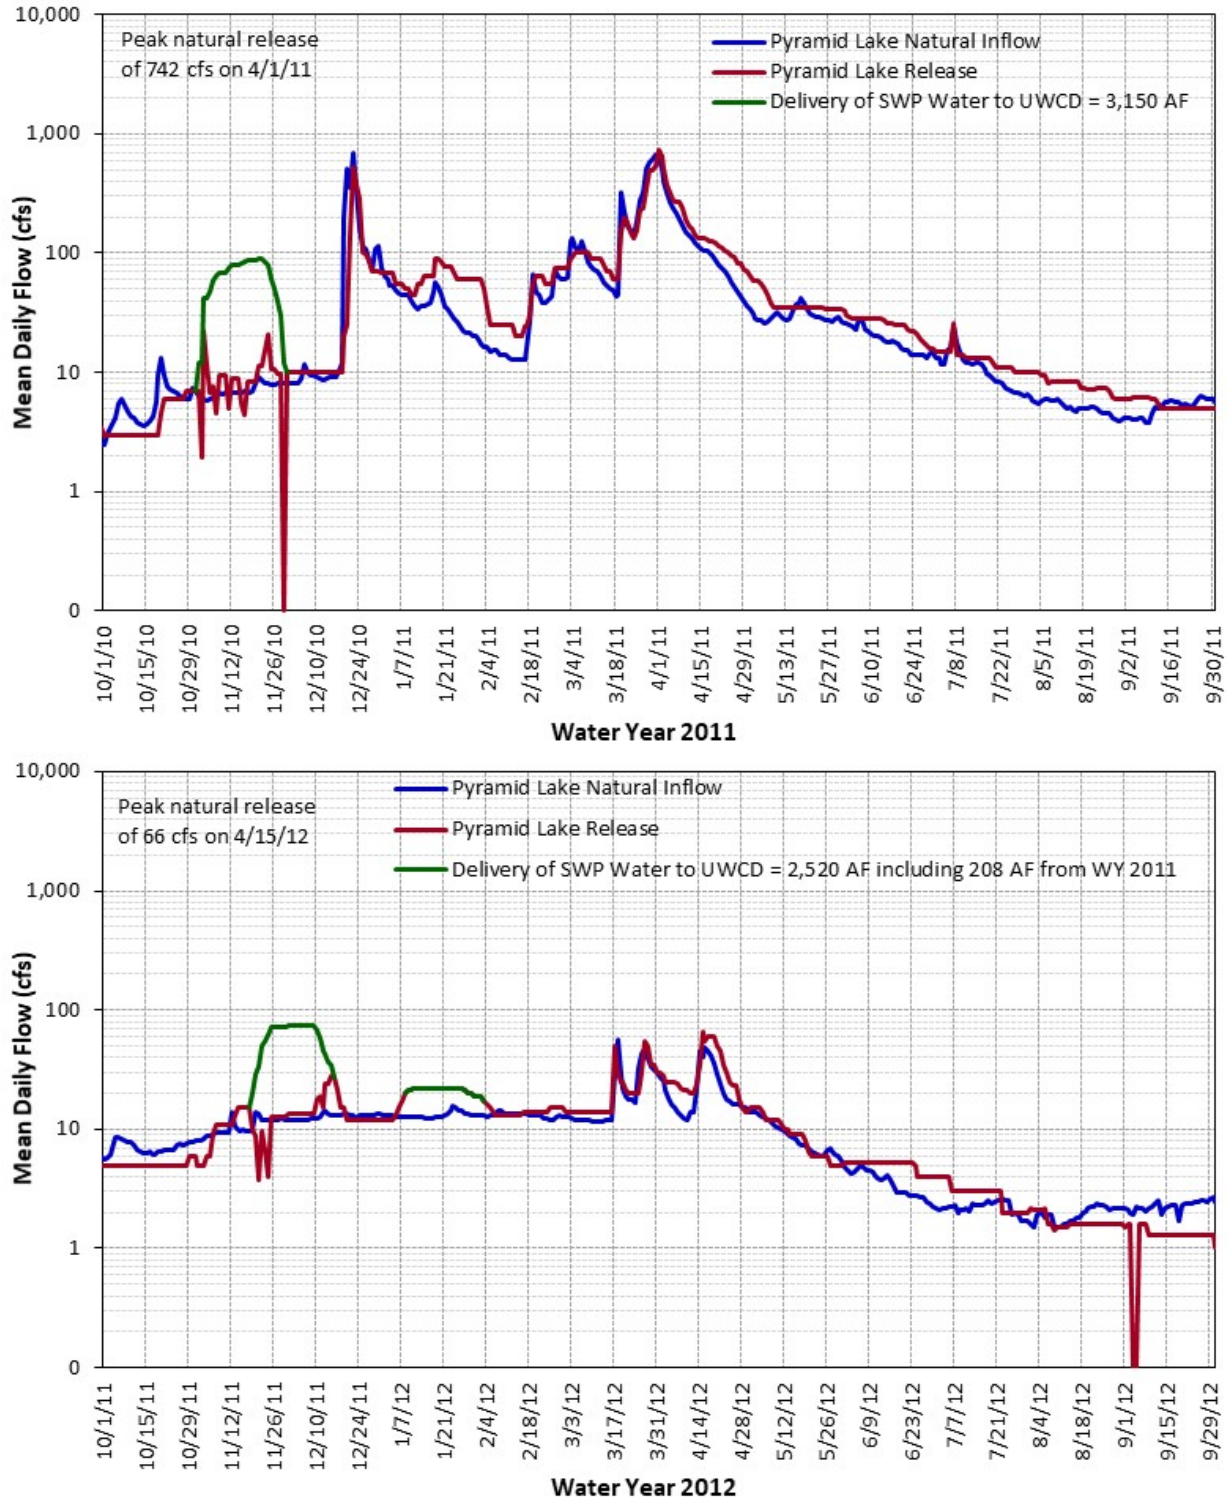
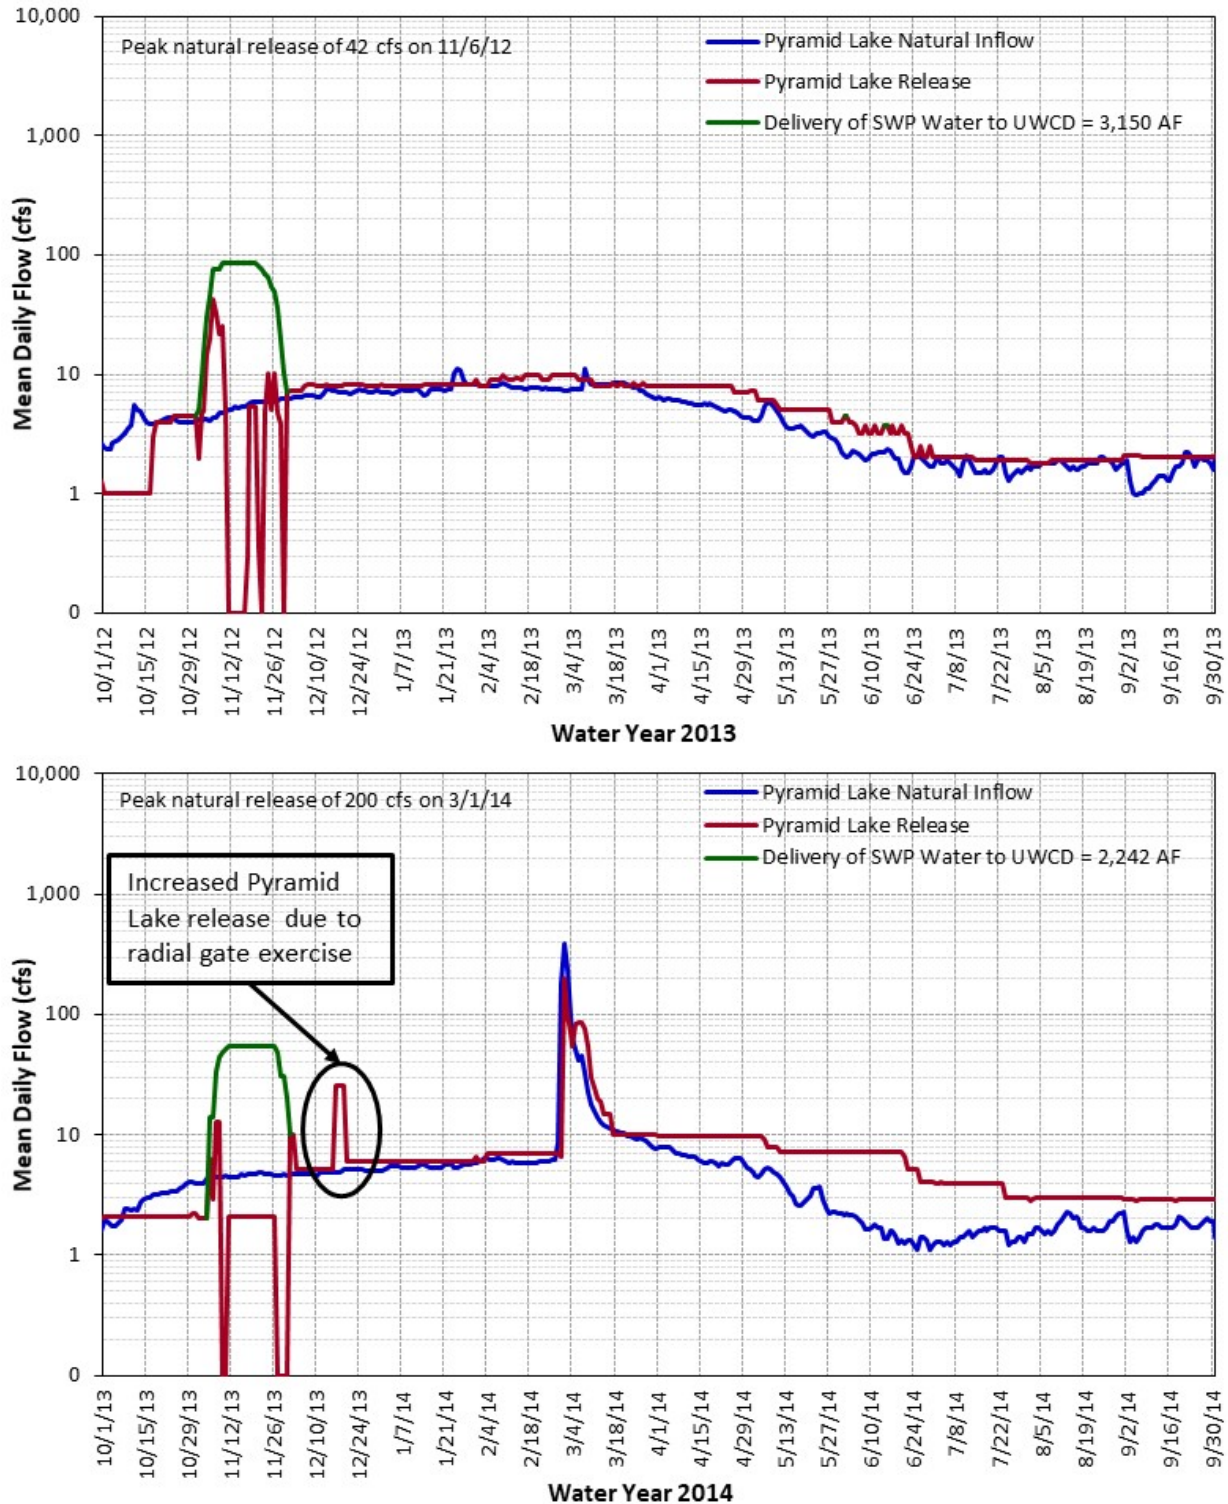
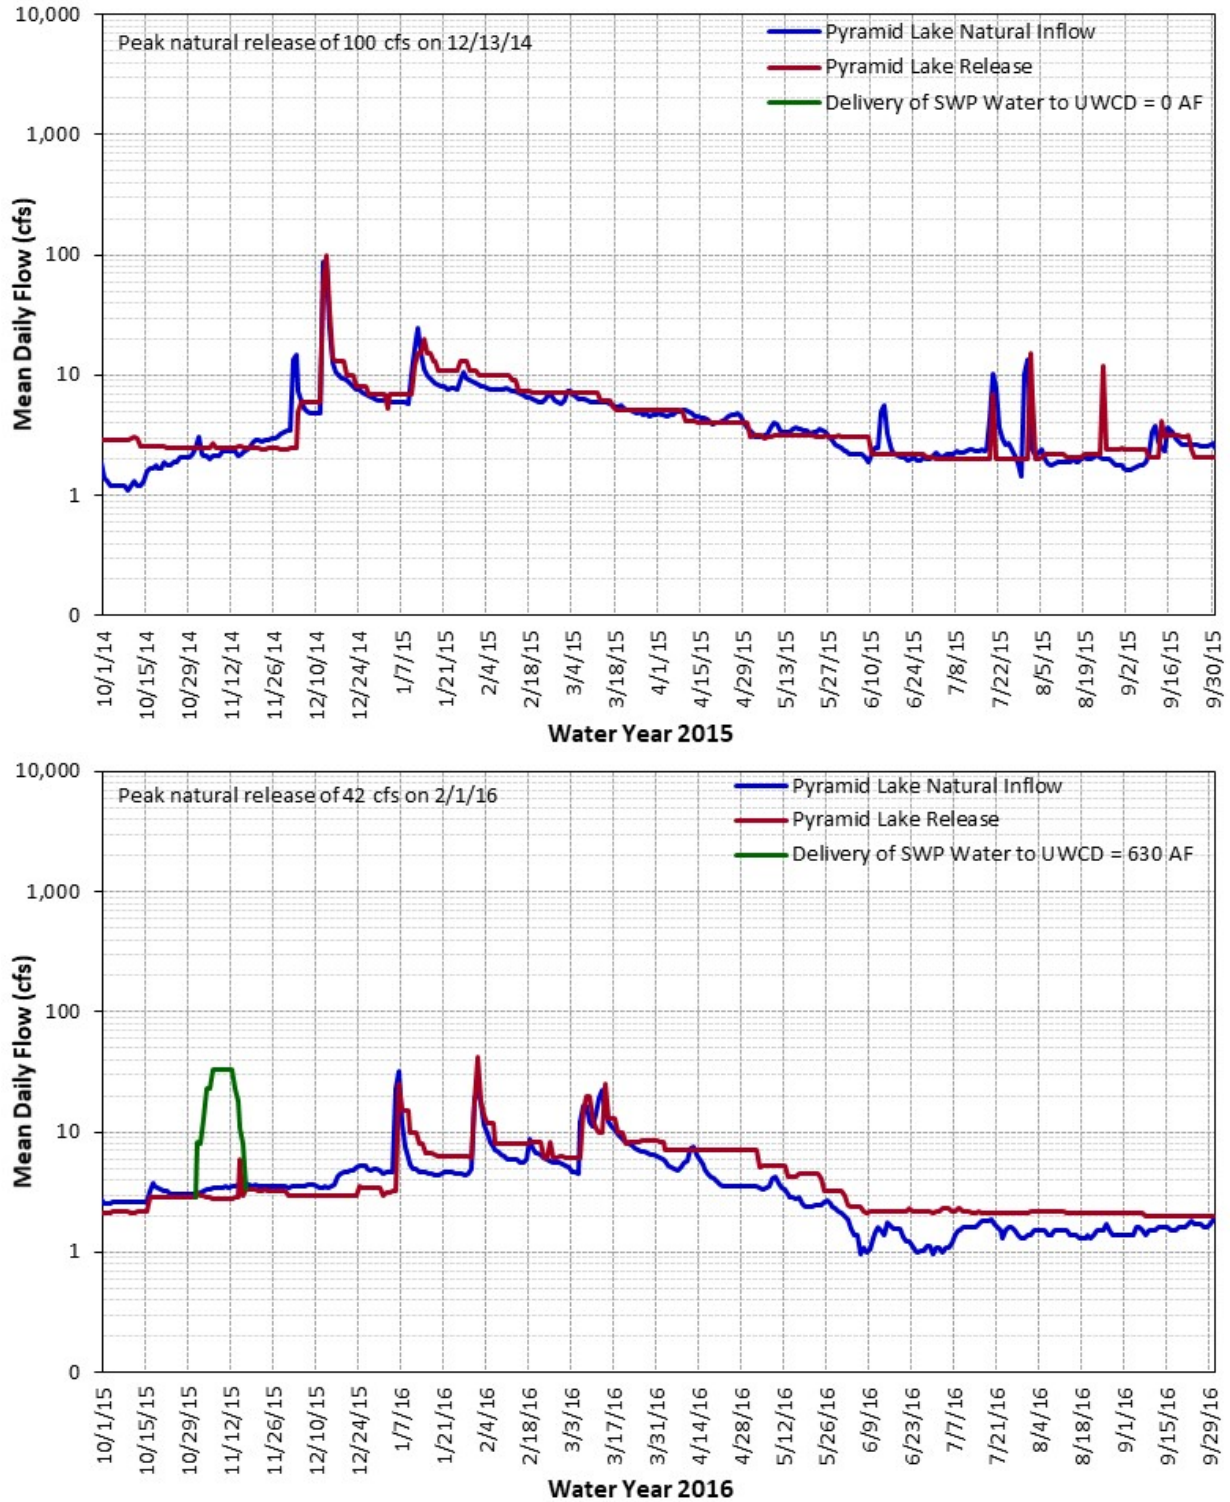
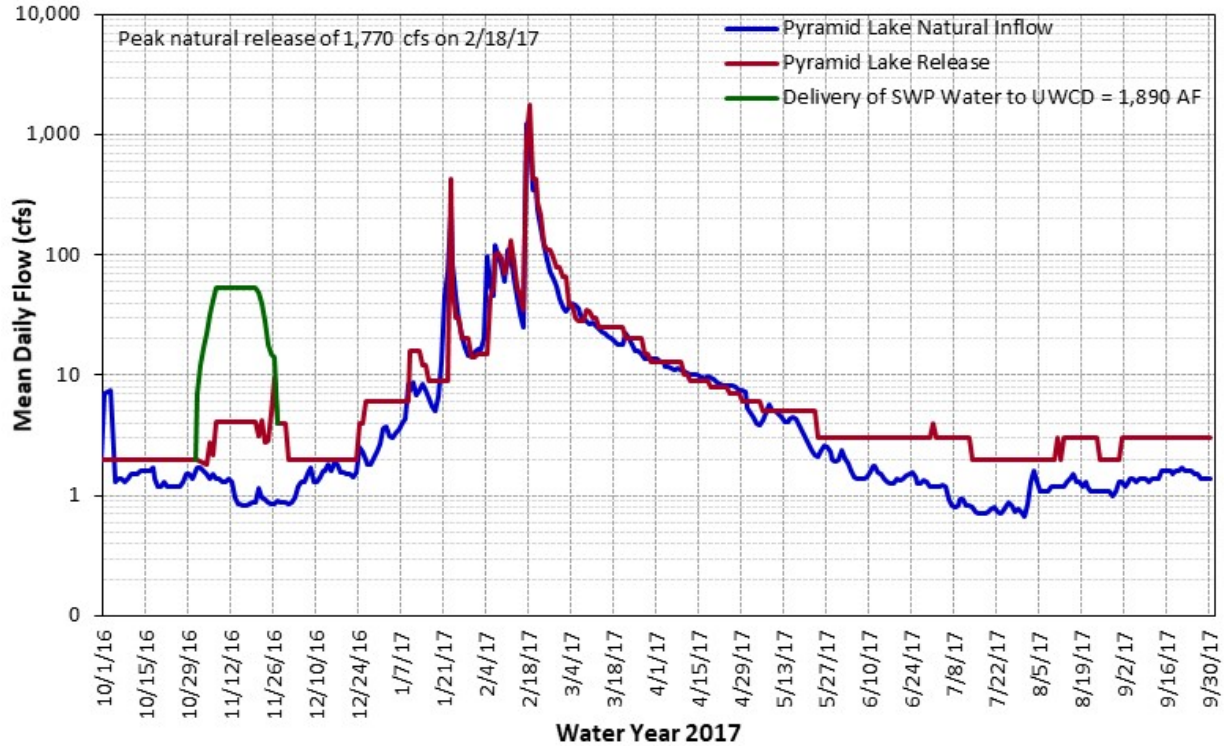
Figure 2.14-1. Average Daily Inflows and Outflows From Pyramid Lake By Year from Water Year 2007 Through Water Year 2017

Note: Flow data are plotted on a logarithmic scale to better show both high and low values.

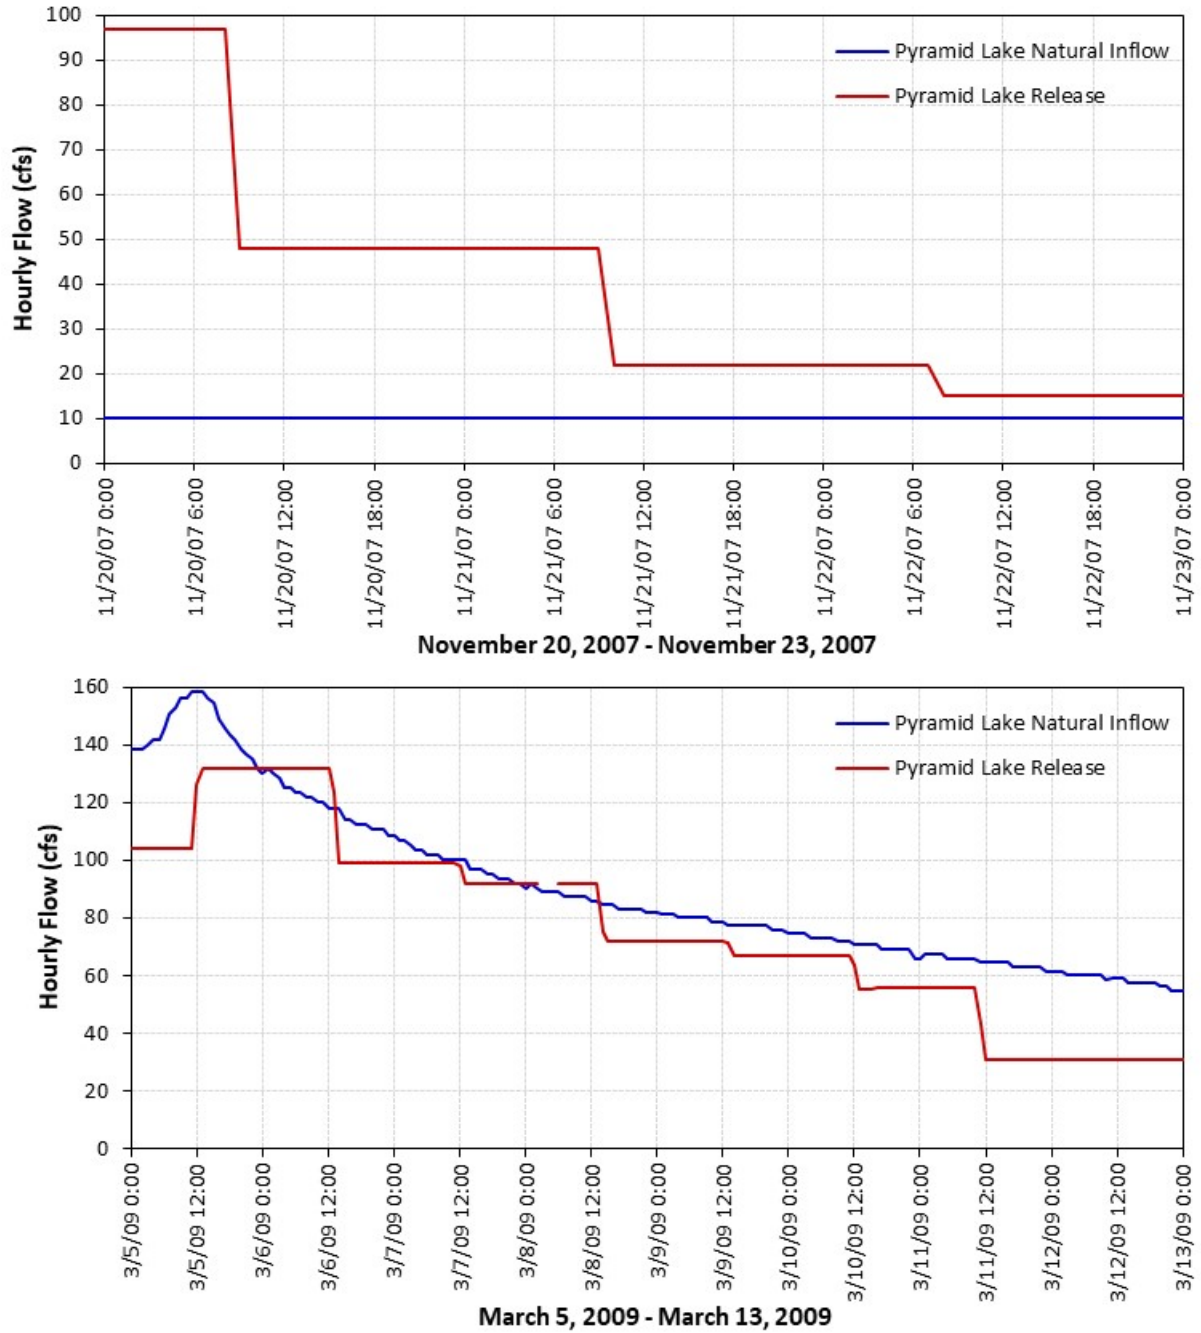
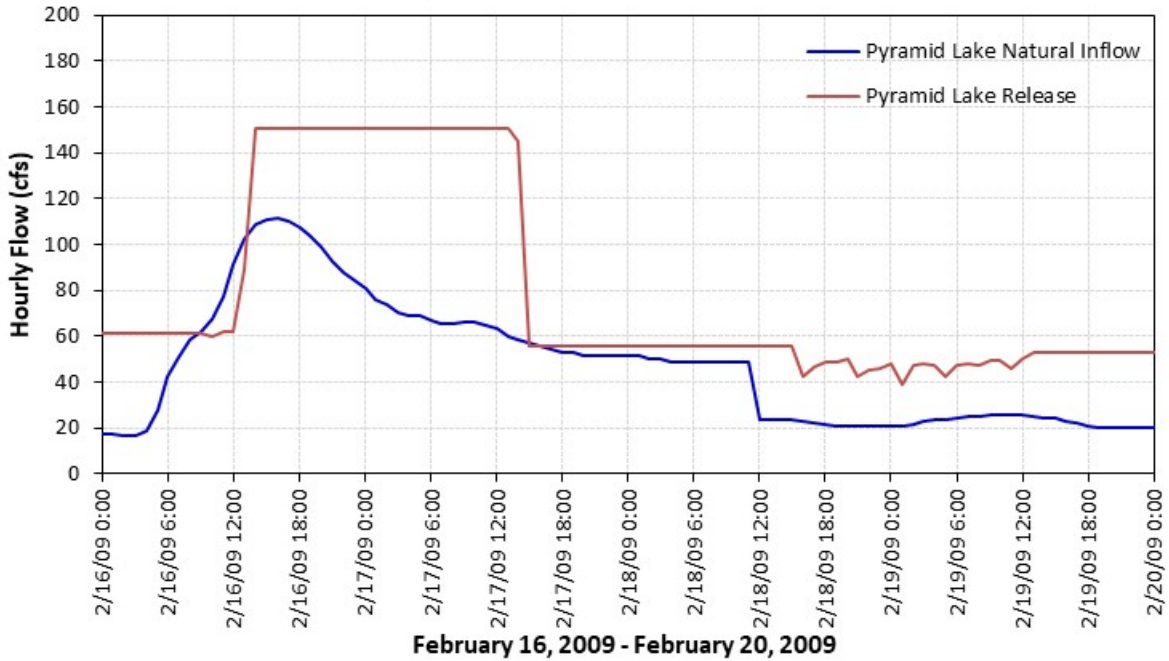
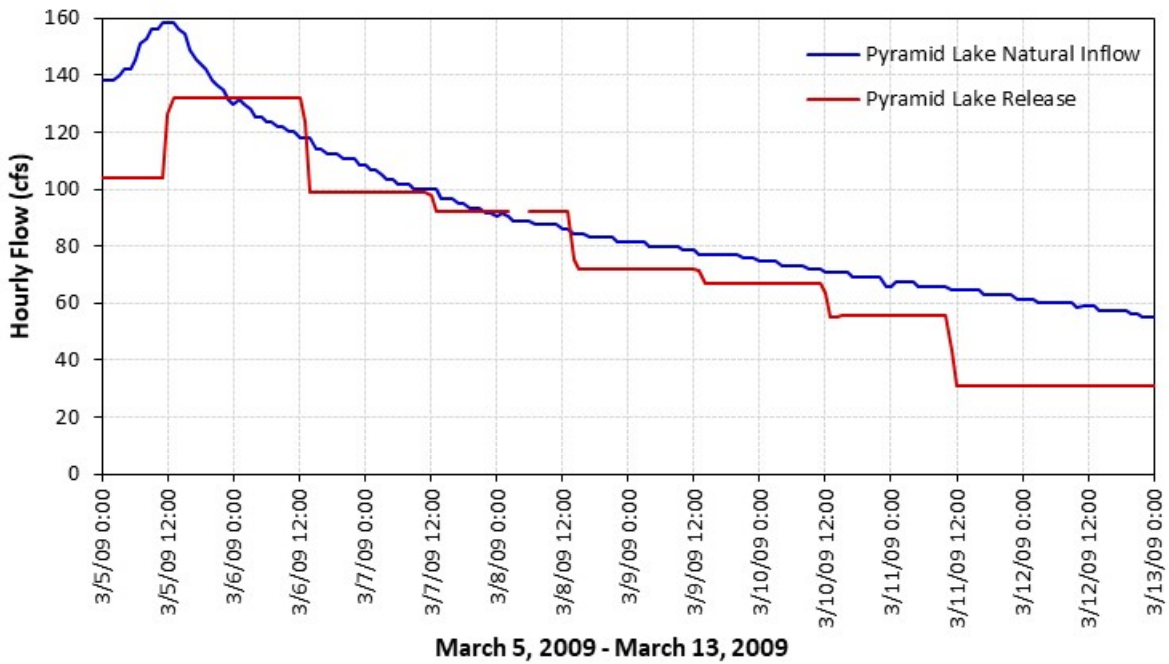
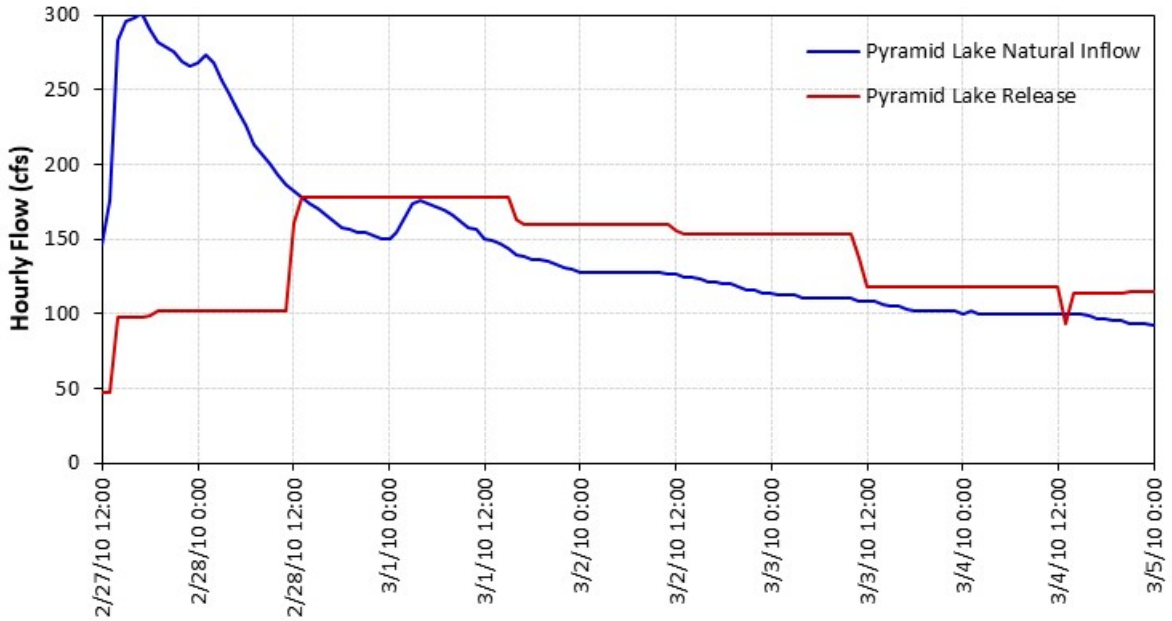
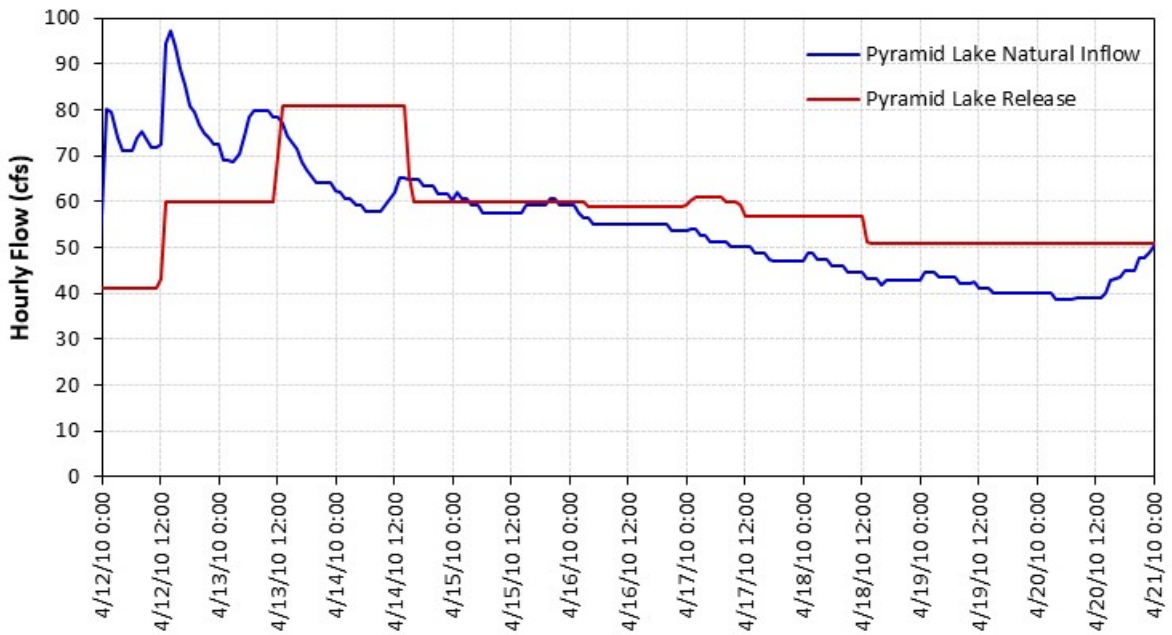
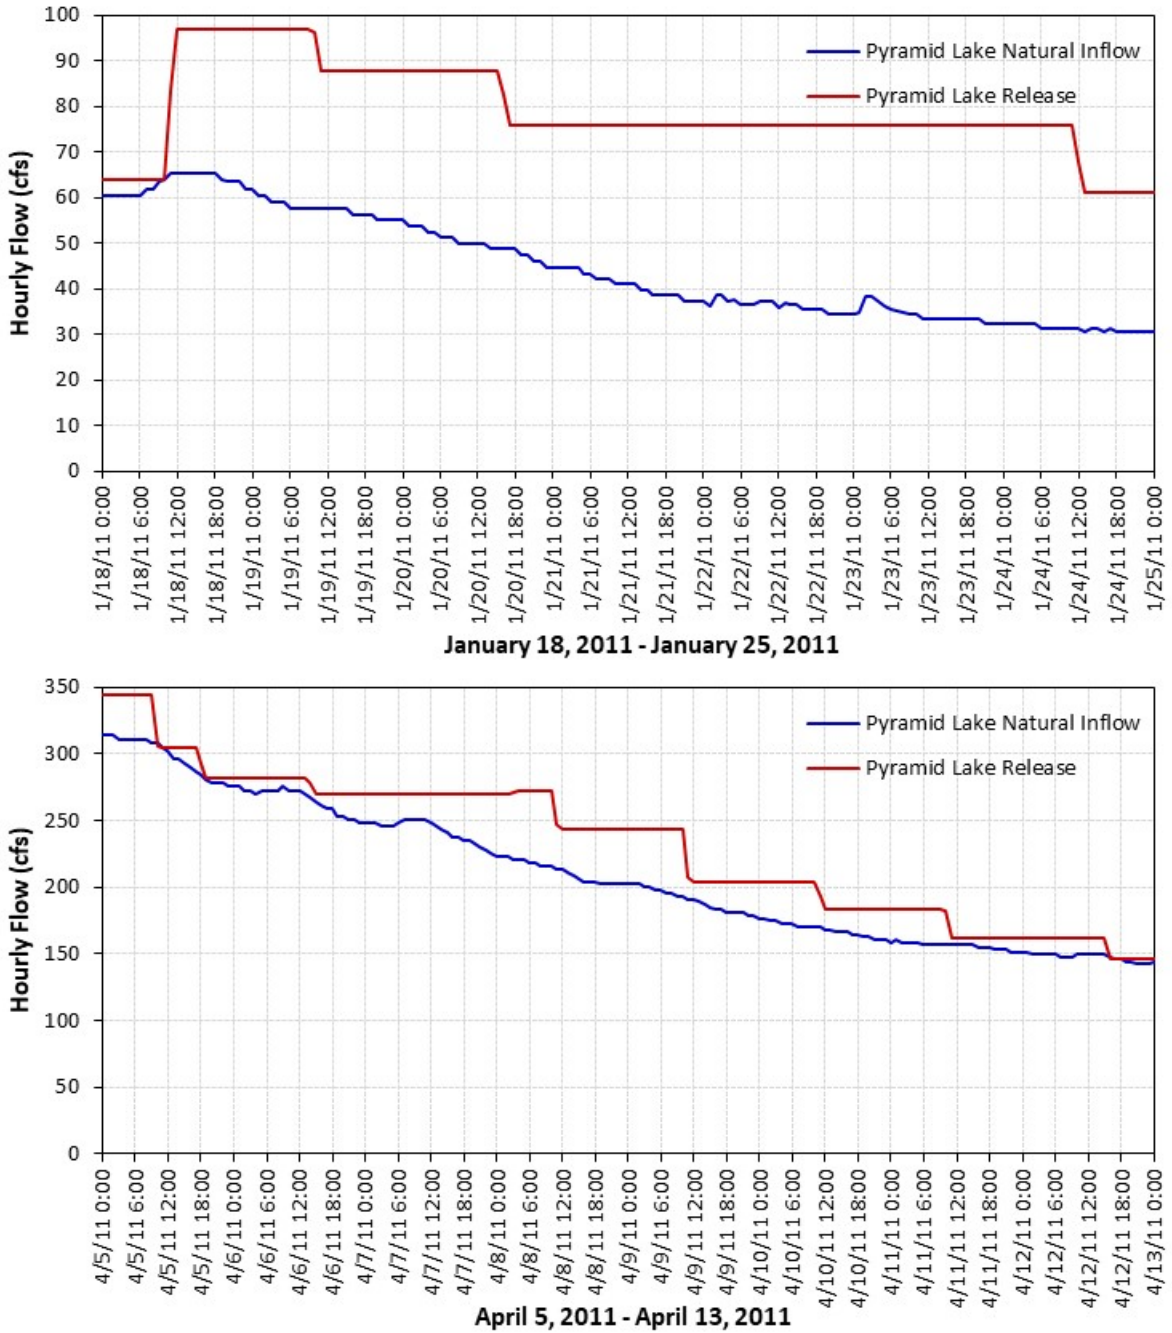
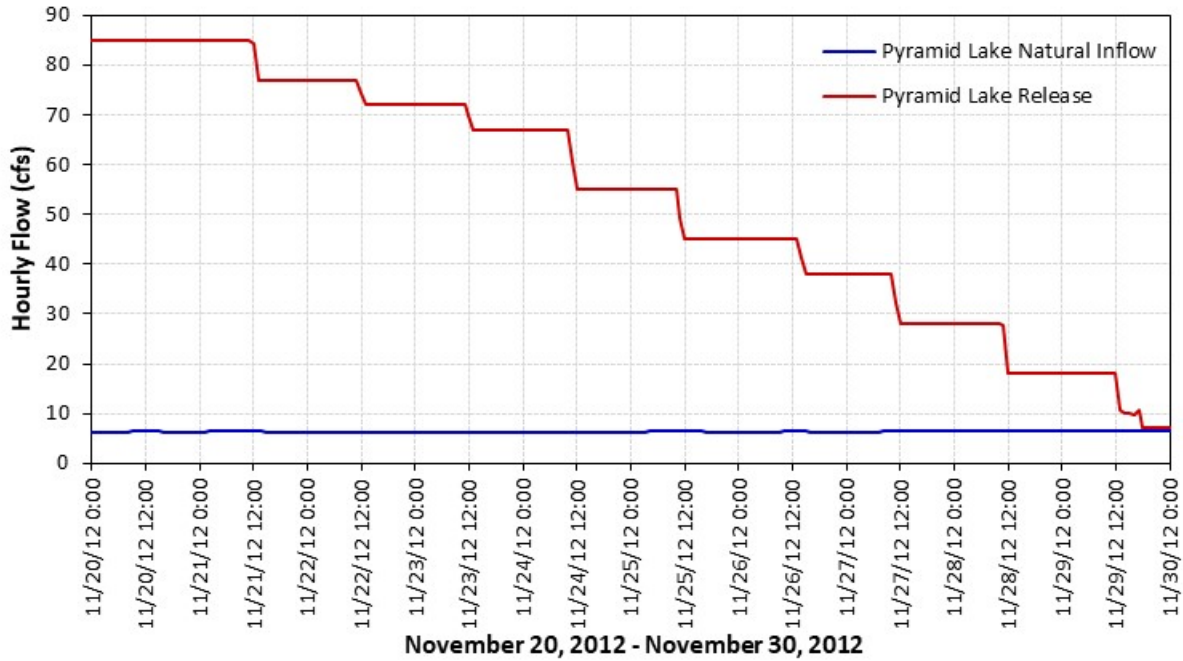
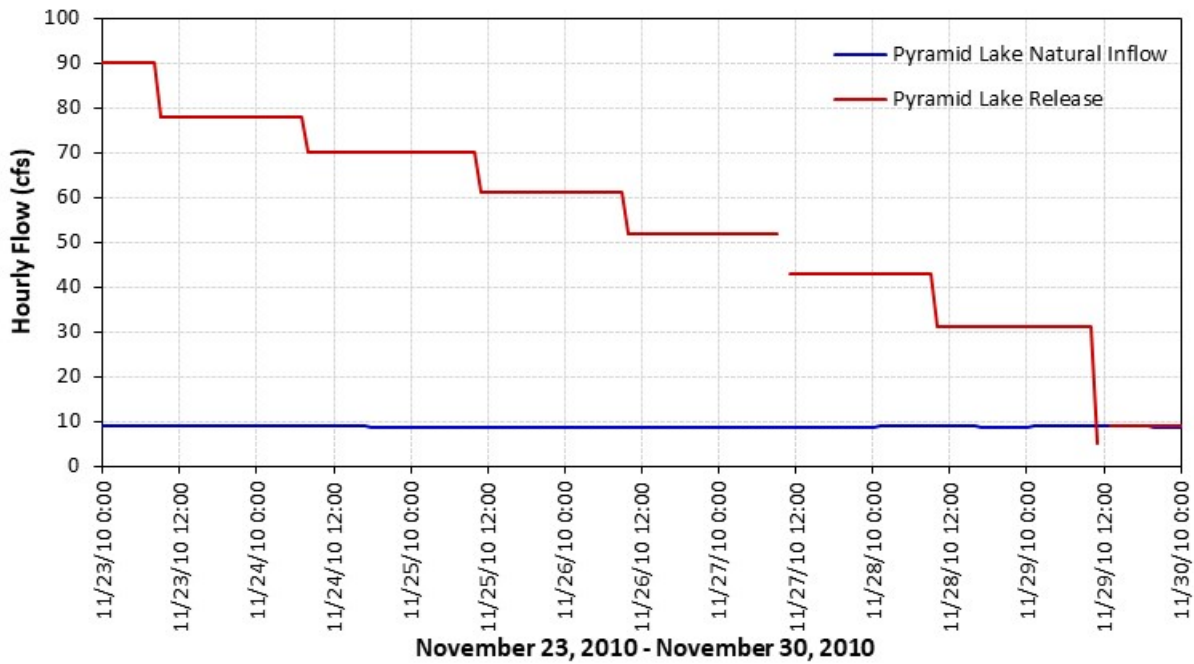
Figure 2.14-2. Hourly Inflows and Outflows from Pyramid Lake – 10 Events Between Water Year 2007 and Water Year 2014

Figure 2.14-2 shows hourly inflows, developed as described above from DWR hardcopy data, and outflows from Pyramid Lake from DWR's digital records and CDEC for 10 events between WY 2007 and WY 2014.

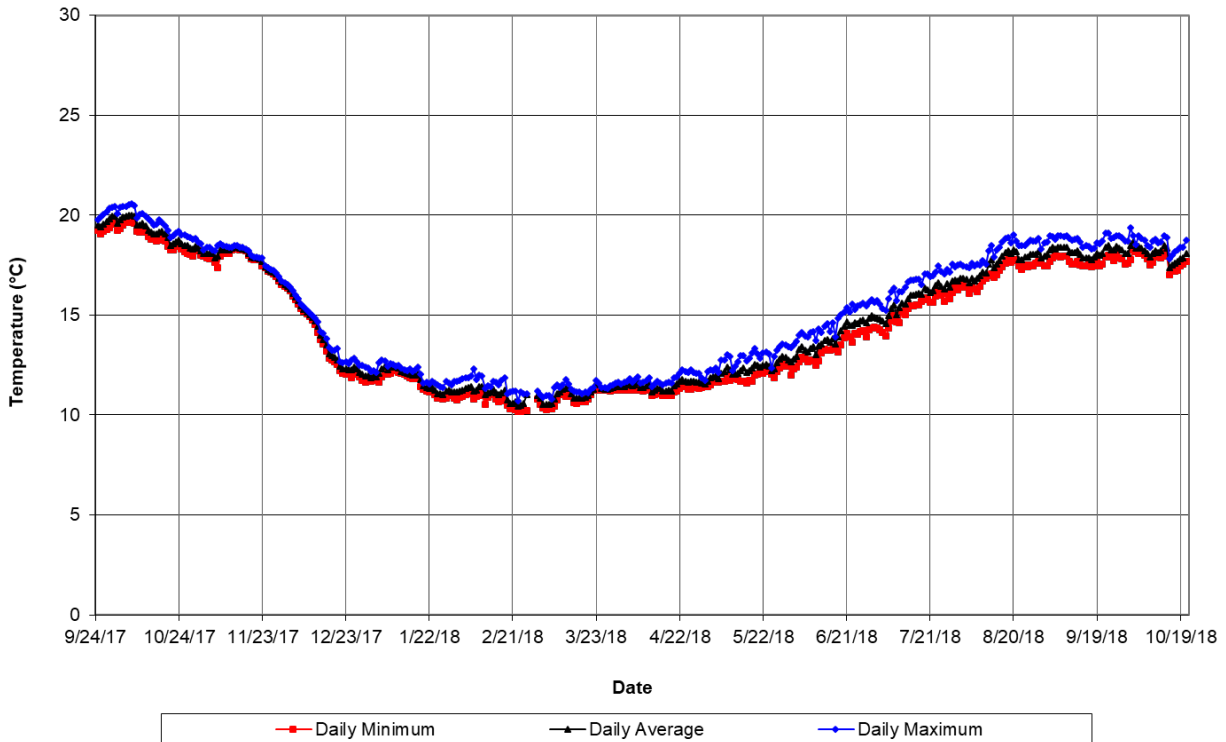
Figure 2.16-5. Daily Minimum, Average, And Maximum Water Temperatures at Pyramid Reach Downstream of Pyramid Dam

Water temperatures in Pyramid reach varied daily and seasonally at all locations. Water temperatures downstream of Pyramid Dam ranged between 10°C and just over 20°C, but showed very little diurnal fluctuation due to the consistent releases from Pyramid Dam (see Figure 2.16-5).

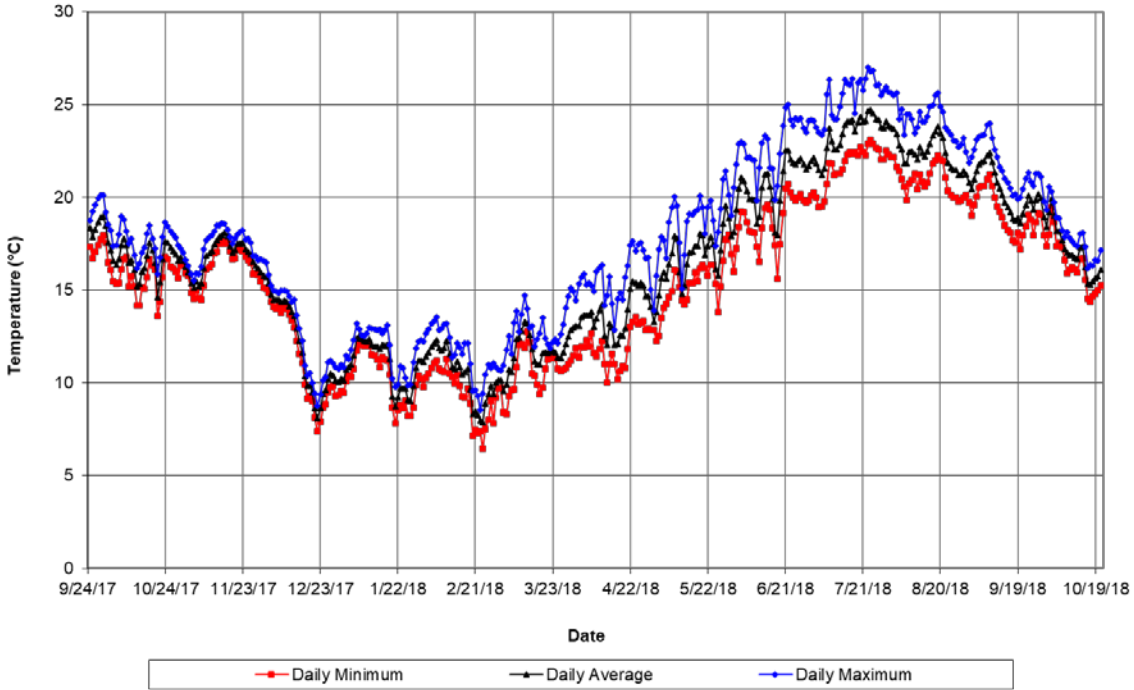
Figure 2.16-6. Daily Minimum, Average, and Maximum Water Temperatures at Piru Creek, 1.5 Miles Downstream of Pyramid Dam

Water temperatures further downstream of Pyramid Dam showed more seasonal and diurnal variation compared to the station near the dam. The two monitoring locations 1.5 and 3.0 miles downstream of Pyramid Dam had very similar water temperatures, ranging between 6°C and 28.5°C (Figures 2.16-6 and 2.16-7). Despite the Licensees' efforts to have no data gaps (e.g., duplicate loggers, hidden from the public, robust housing), there is a data gap of 96 days (February 8, 2018 to May 14, 2018) at the location 3.0 miles downstream of Pyramid Dam, near Frenchmen's Flat (Figure 2.16-7), due to vandalism of the loggers. When the monitoring location was visited on May 14, 2018, both loggers were gone and one broken housing was found. Missing loggers were replaced with new loggers during the same site visit in order to continue data collection and were moved to a more secluded location. Water temperatures observed at the monitoring stations 1.5 and 3.0 miles below Pyramid Dam were very similar, with 98 percent of the daily average temperatures within 1°C and 65 percent of the daily average temperatures within 0.5°C.
