SOUTH SWP HYDROPOWER FERC PROJECT NO. 2426-227

Updated Study Report

From May 1, 2018 through April 30, 2019

**State of California
California Natural Resources Agency
DEPARTMENT OF WATER
RESOURCES
Hydropower License Planning and
Compliance Office**

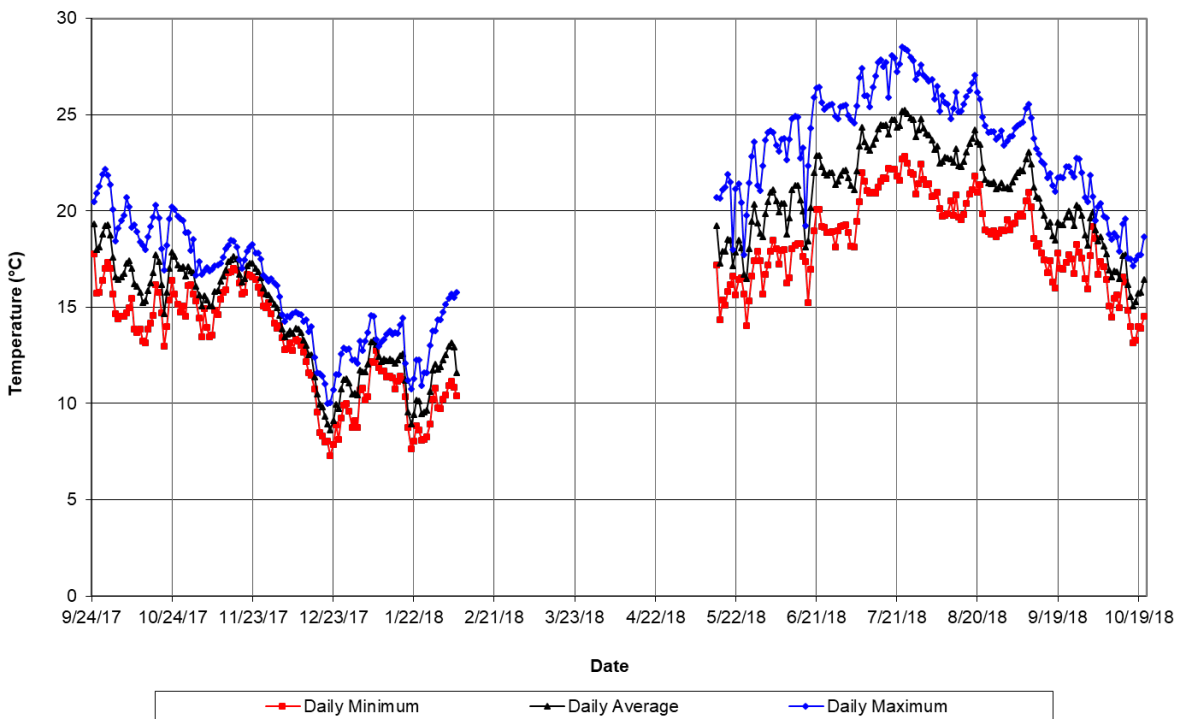
Note: Data gap due to missing or malfunction data loggers.

Figure 2.16-7. Daily Minimum, Average, and Maximum Water Temperatures in Pyramid Reach, 3.0 Miles Downstream of Pyramid Dam, near Frenchmen's Flat

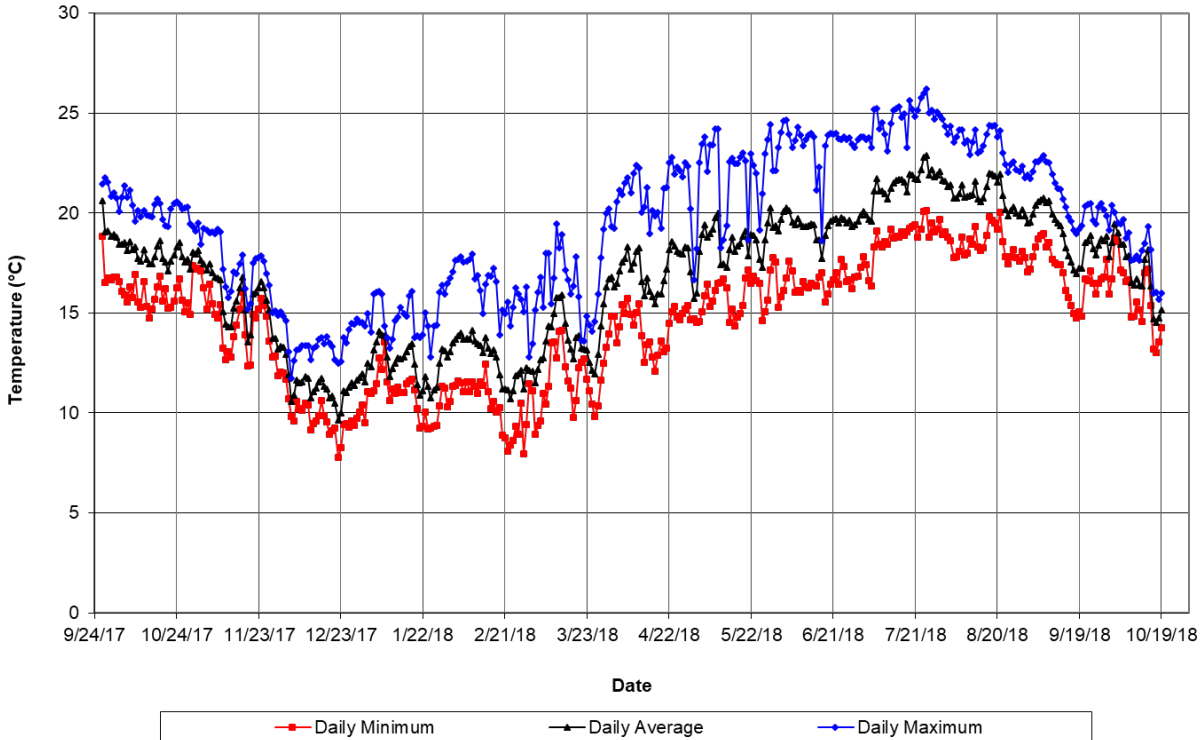
Figure 2.16-8. Daily Minimum, Average, and Maximum Water Temperatures at Pyramid Reach, 18 Miles Downstream of Pyramid Dam, near Blue Point Campground

The most downstream water temperature monitoring location was approximately 18 miles downstream of Pyramid Dam near Blue Point Campground. Water temperatures ranged between 7.9°C and 26°C, and had daily variations up to 9°C during the monitoring period (Figure 2.16-8). While the water temperatures observed at this location showed similar seasonal variation to those observed at the upstream locations, temperatures were cooler than those observed upstream.

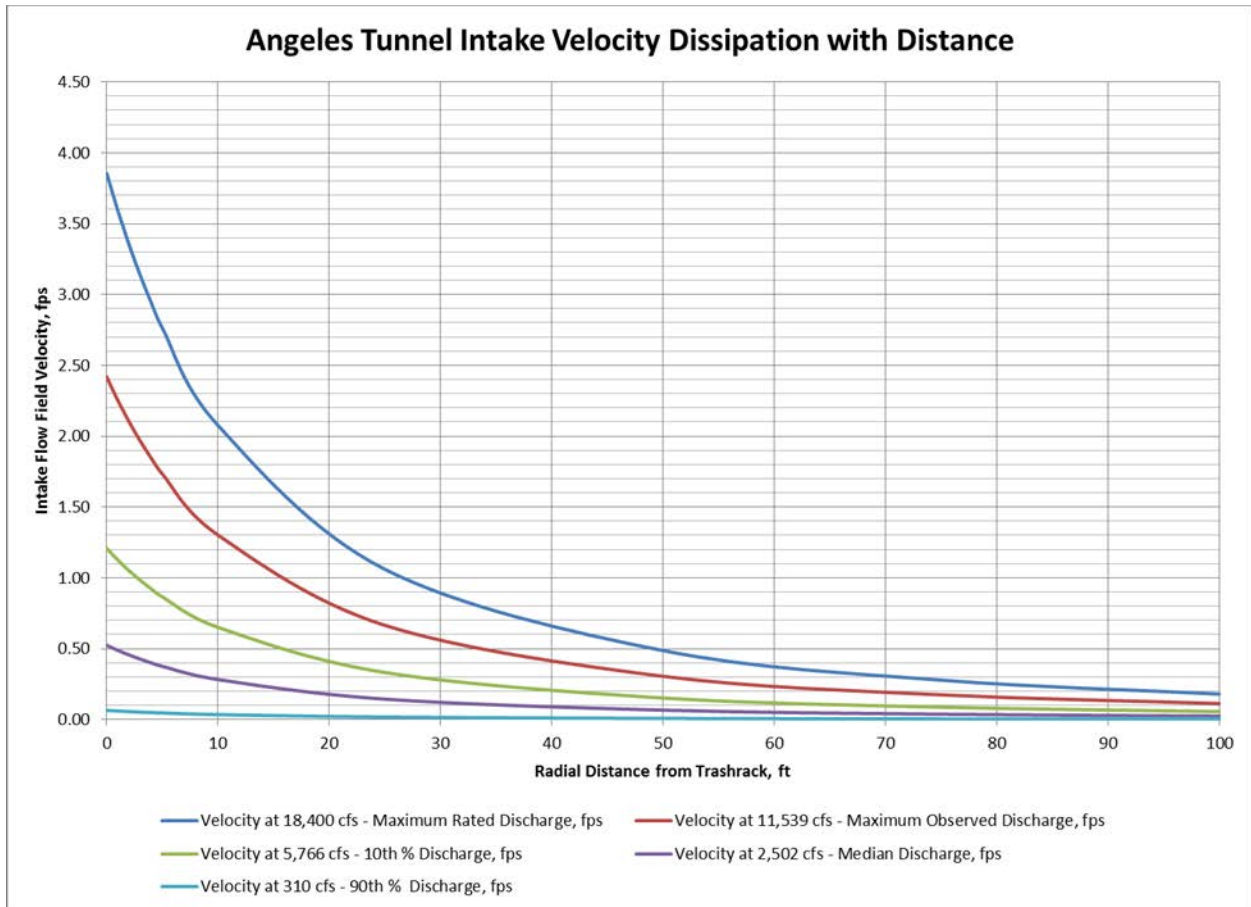
Figure 2.17-1. Angeles Tunnel Intake Velocity Dissipation With Distance

In the very unlikely instance that an adult rainbow trout with burst swim speed ranging from 6.4 to 13.5 fps (Bell 1986) was in the vicinity of the intake structure, it can easily avoid being entrained. Similarly, in the very unlikely instance that an adult largemouth bass with burst swim speed of greater than 4.34 fps (Beamish 1978) was in the vicinity of the intake structure, it can easily avoid being entrained.

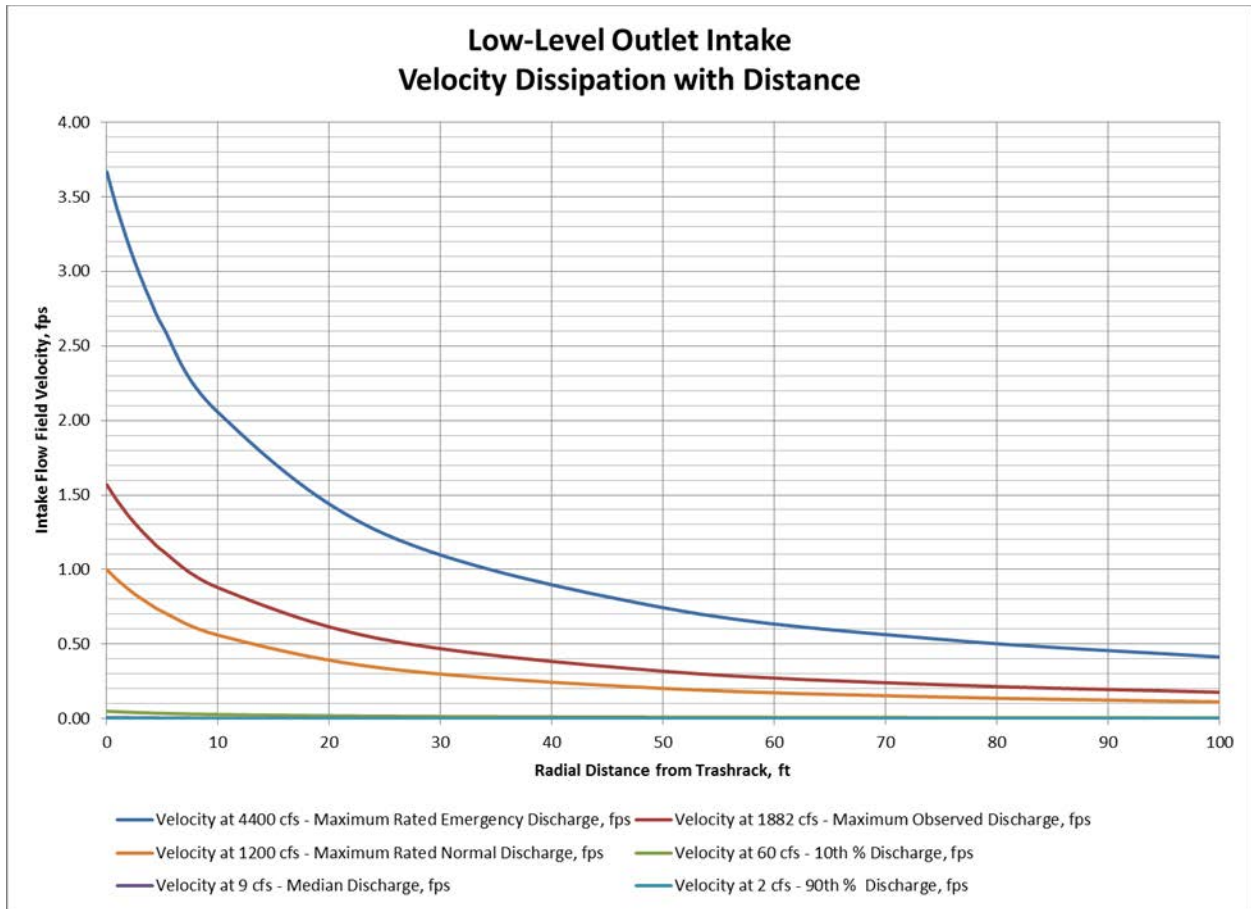
Figure 2.17-2. Low-Level Outlet Intake Velocity Dissipation With Distance

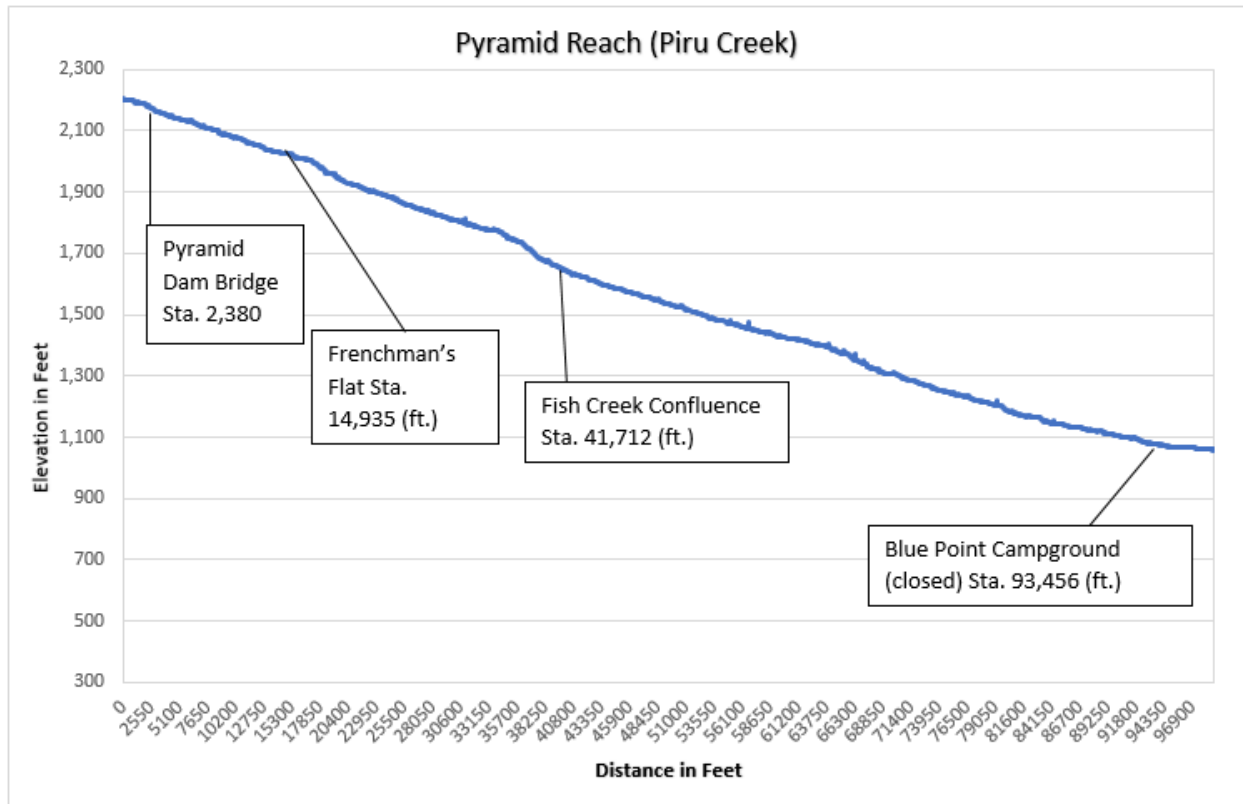
Note: Elevation in feet above mean sea level on Y axis, with distance downstream from Pyramid Dam in feet on X axis
Key:
ft.= feet
Sta. = Station

Figure 2.19-1. Gradient Profile of Pyramid Reach

Maps that were prepared to identify the Project reach relative to the routes of access and other important features (e.g., Project dam/diversion, developed recreation facilities, and wilderness boundaries) can be found as the associated data file labeled “SSWP_Whitewater_Overview_Map.” The gradient profile of Pyramid reach (Figure 2.19-1) shows that the creek drops from approximately 2,200 feet to about 1,055 feet in just over 18 miles. This represents a gradient of roughly 58 feet per mile.

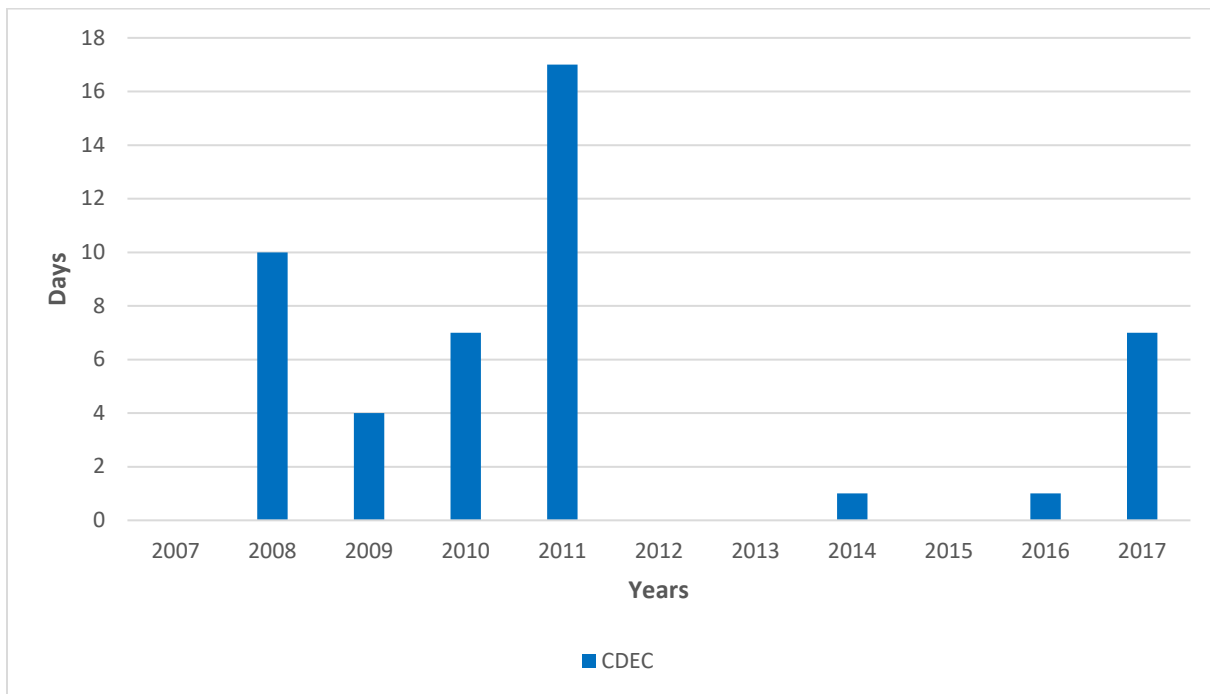
Figure 2.19-2. Annual Number of Days with 200 Cubic Feet per Second Flows Released at Pyramid Dam (2007 through 2017)

As shown in Figure 2.19-2, from 2007 through 2017, some years presented no opportunities for boating, while in other years, as many as 16 boating days may have been possible.

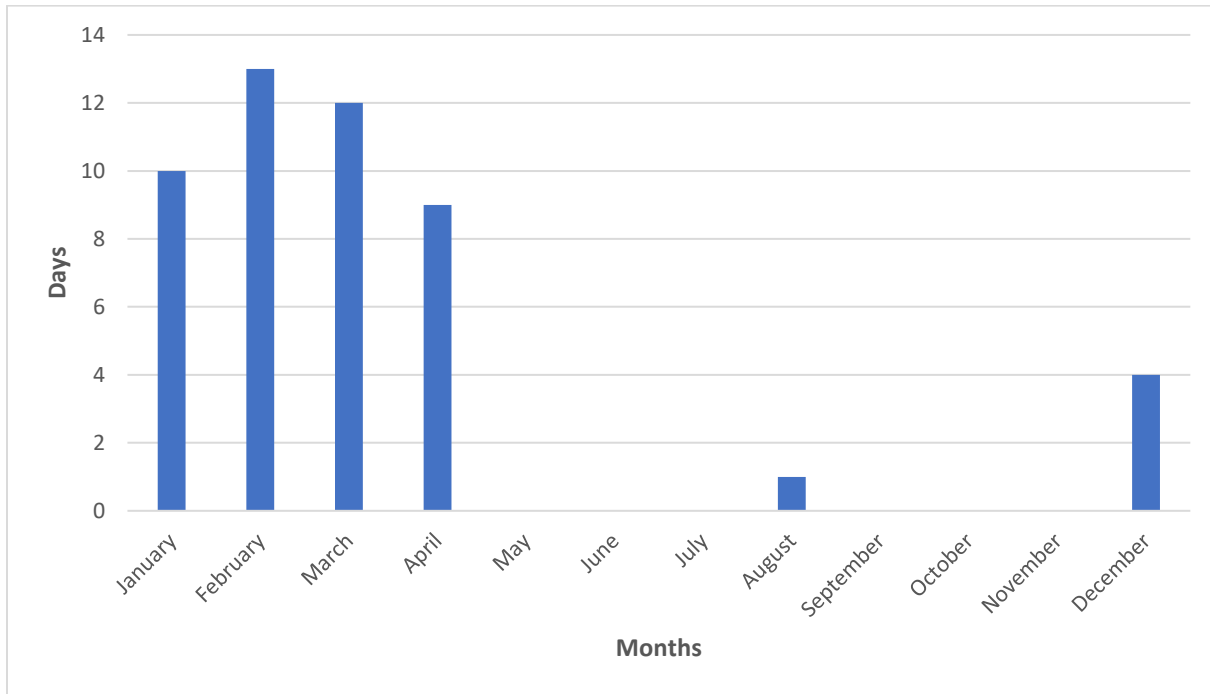
Figure 2.19-3. Total Number of Days with 200 Cubic Feet per Second Flows Released at Pyramid Dam by Month (2007 through 2017)

Figure 2.19-3 presents the distribution of potentially boatable days by month for 2007 through 2017.

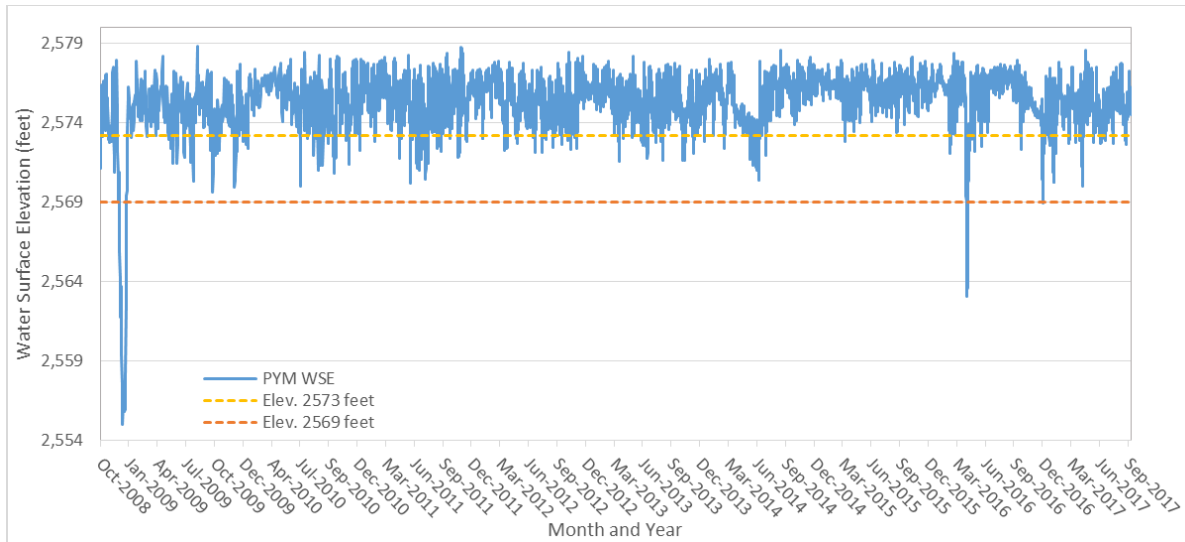
Figure 2.22-1. Pyramid Lake Water Surface Elevations (National Geodetic Vertical Datum 29) from October 2, 2008 to October 1, 2017

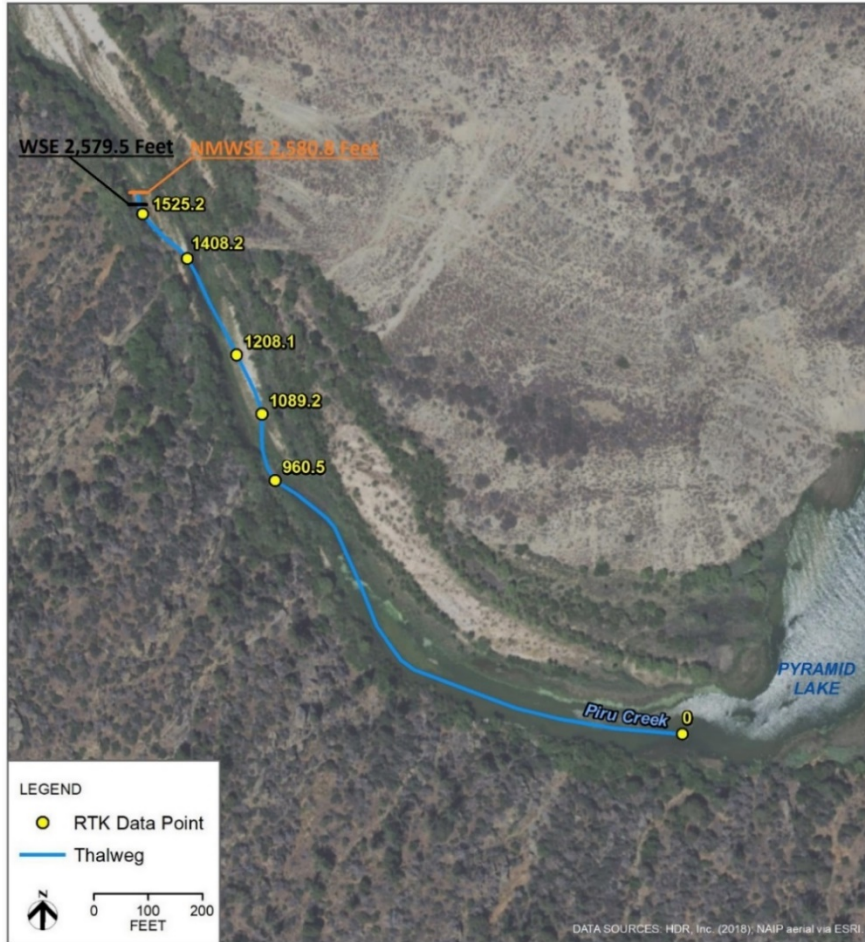
Note:
 The majority of the section of stream surveyed (from Station 0 to Station 1,537) was mapped in the wet with a maximum depth of about 2.5 feet.

Figure 2.22-2. Piru Creek Area Surveyed on July 24, 2018, Including Thalweg Centerline and Longitudinal Profile Stationing

No barriers to upstream fish passage were identified in the area surveyed in Piru Creek. Surveyors mapped approximately 1,564 feet of the thalweg, from a low of 2,577.2 feet to a high of 2,580.8 feet NAVD 88. During the survey, the stream channel was dry from the WSE to the NMWSE. Approximately 1,537 feet were mapped in the wet, and 27 feet in the dry. The average gradient of the entire surveyed reach was 0.2 percent, with a high gradient of 4.8 percent at station 1,525 near the NMWSE. Sand was the exclusive substrate through all of the survey area. In the wetted portion of the channel surveyed, stream width was approximately 35 feet to 95 feet; whereas in the dry portion of the channel surveyed, stream width was estimated to be 2 feet to 5 feet. Much of the survey area in the wet was bordered by thick riparian vegetation consisting of willow (*Salix* sp.) and alder (*Alnus* sp.) with common reed (*Phragmites australis*) and other hydrophilic plants along the margins. The dry part of the survey area was bordered by thick patches of willow. No fish were observed in the wetted area surveyed. A map detailing the area surveyed is provided in Figure 2.22-2, below. A longitudinal profile of Piru Creek, including the measured WSE for the section of the stream surveyed, is presented in Figure 2.22-3. Representative photographs of the area surveyed in the wet and in the dry are provided in Figure 2.22-4 and Figure 2.22-5, respectively.

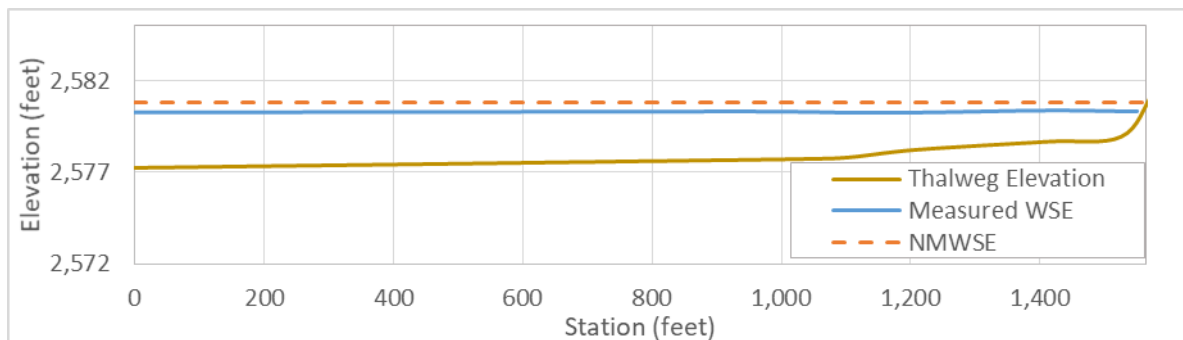
Figure 2.22-3. Piru Creek Longitudinal Profile, Including Measured Water Surface Elevation for Section of Stream Surveyed

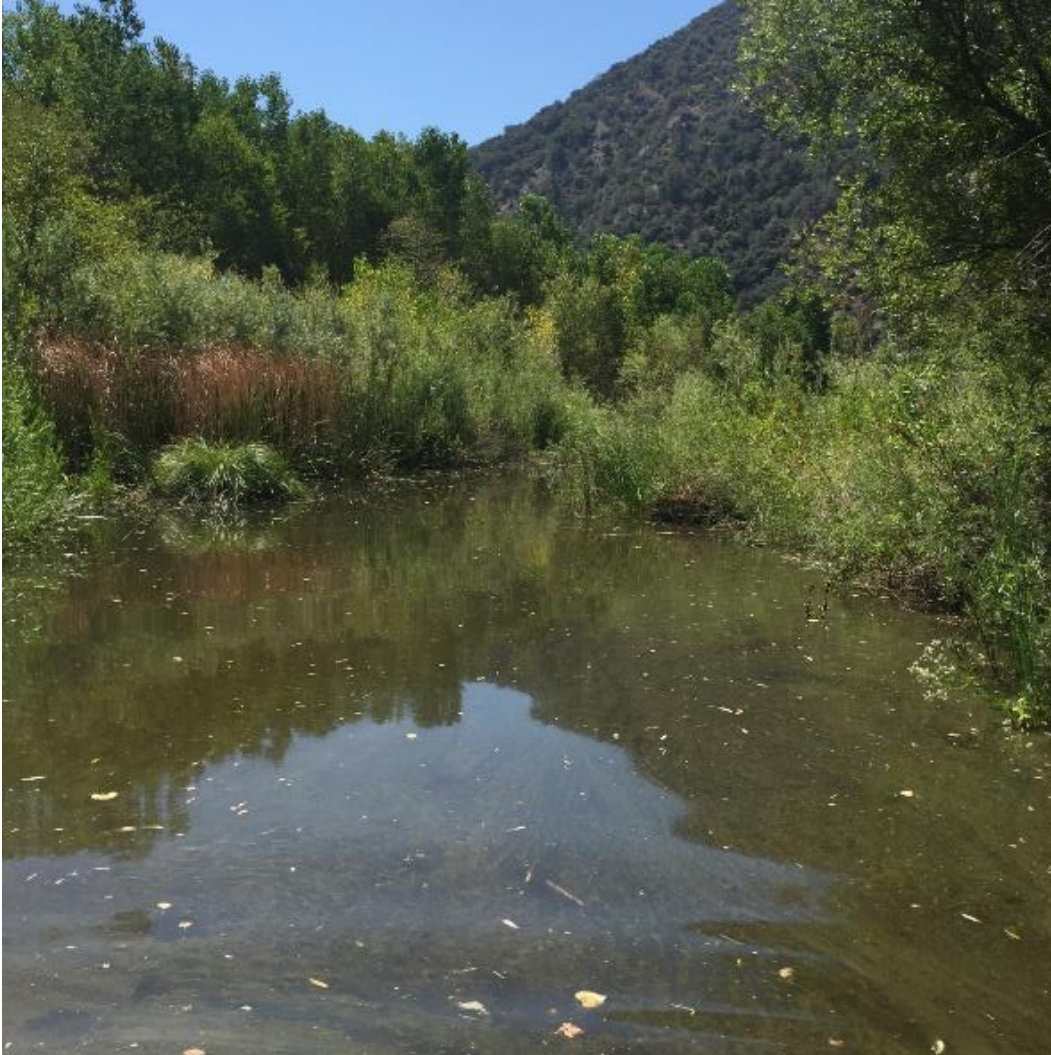
Figure 2.22-4. Representative Photograph Showing the Section of Piru Creek Below Pyramid Lake's Normal Maximum Water Surface Elevation Mapped in the Wet

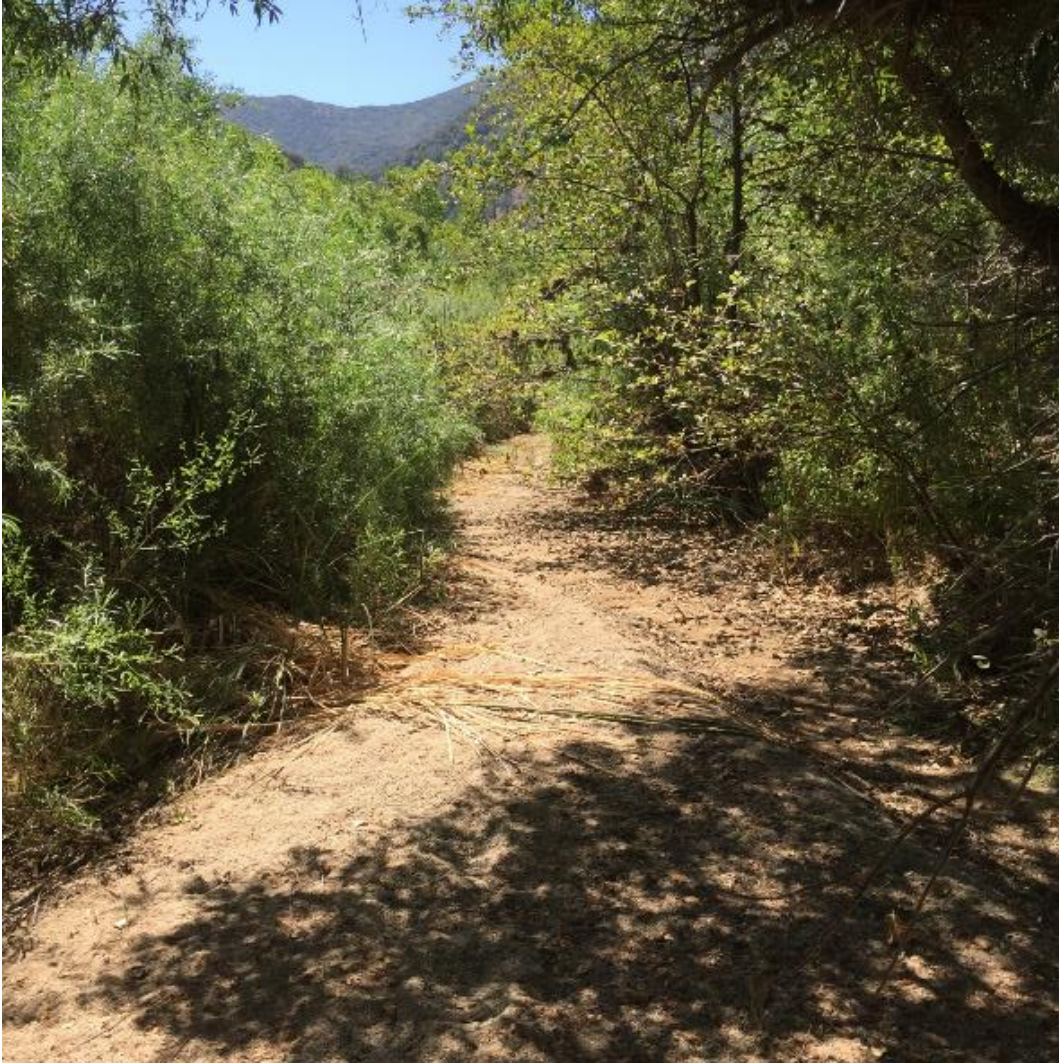
Figure 2.22-5. Representative Photograph Showing the Section of Piru Creek Below Pyramid Lake's Normal Maximum Water Surface Elevation Mapped in the Dry

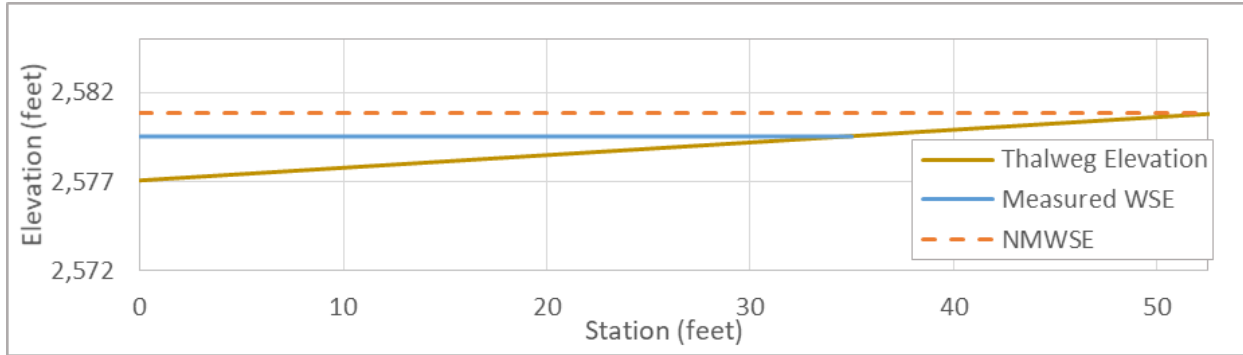
Figure 2.22-6. Carlos Canyon Longitudinal Profile Including Measured Reservoir Water Surface Elevation

No barriers to upstream fish passage were identified in the area surveyed in Carlos Canyon. Surveyors mapped 52.5 feet of the thalweg below the reservoir NMWSE, from a low of 2,577.1 feet NAVD 88. Approximately 34.2 feet were mapped in the wet, and 18.3 feet in the dry. The average gradient was 7.1 percent and remained constant. Sand was the exclusive substrate within the survey area. During the survey, the stream channel was dry from the WSE to the NMWSE. No fish were observed in the wet area surveyed. Figure 2.22-6 shows the Carlos Canyon longitudinal profile, including the measured reservoir WSE. Representative photographs of the area surveyed in the wet and in the dry are provided in Figure 2.22-7 and Figure 2.22-8, respectively.

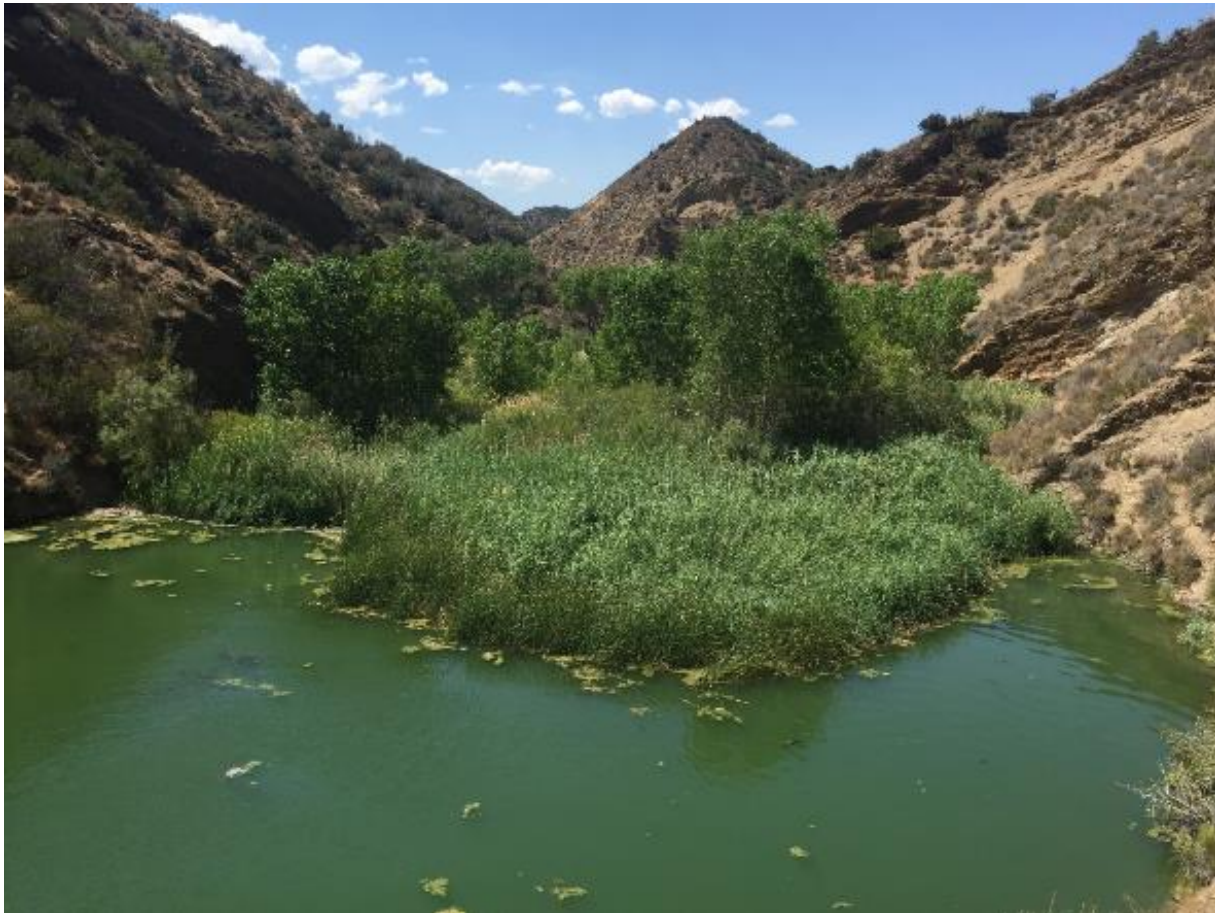
Figure 2.22-7. Representative Photograph Showing the Section of Carlos Canyon Below Pyramid Lake's Normal Maximum Water Surface Elevation Mapped in the Wet

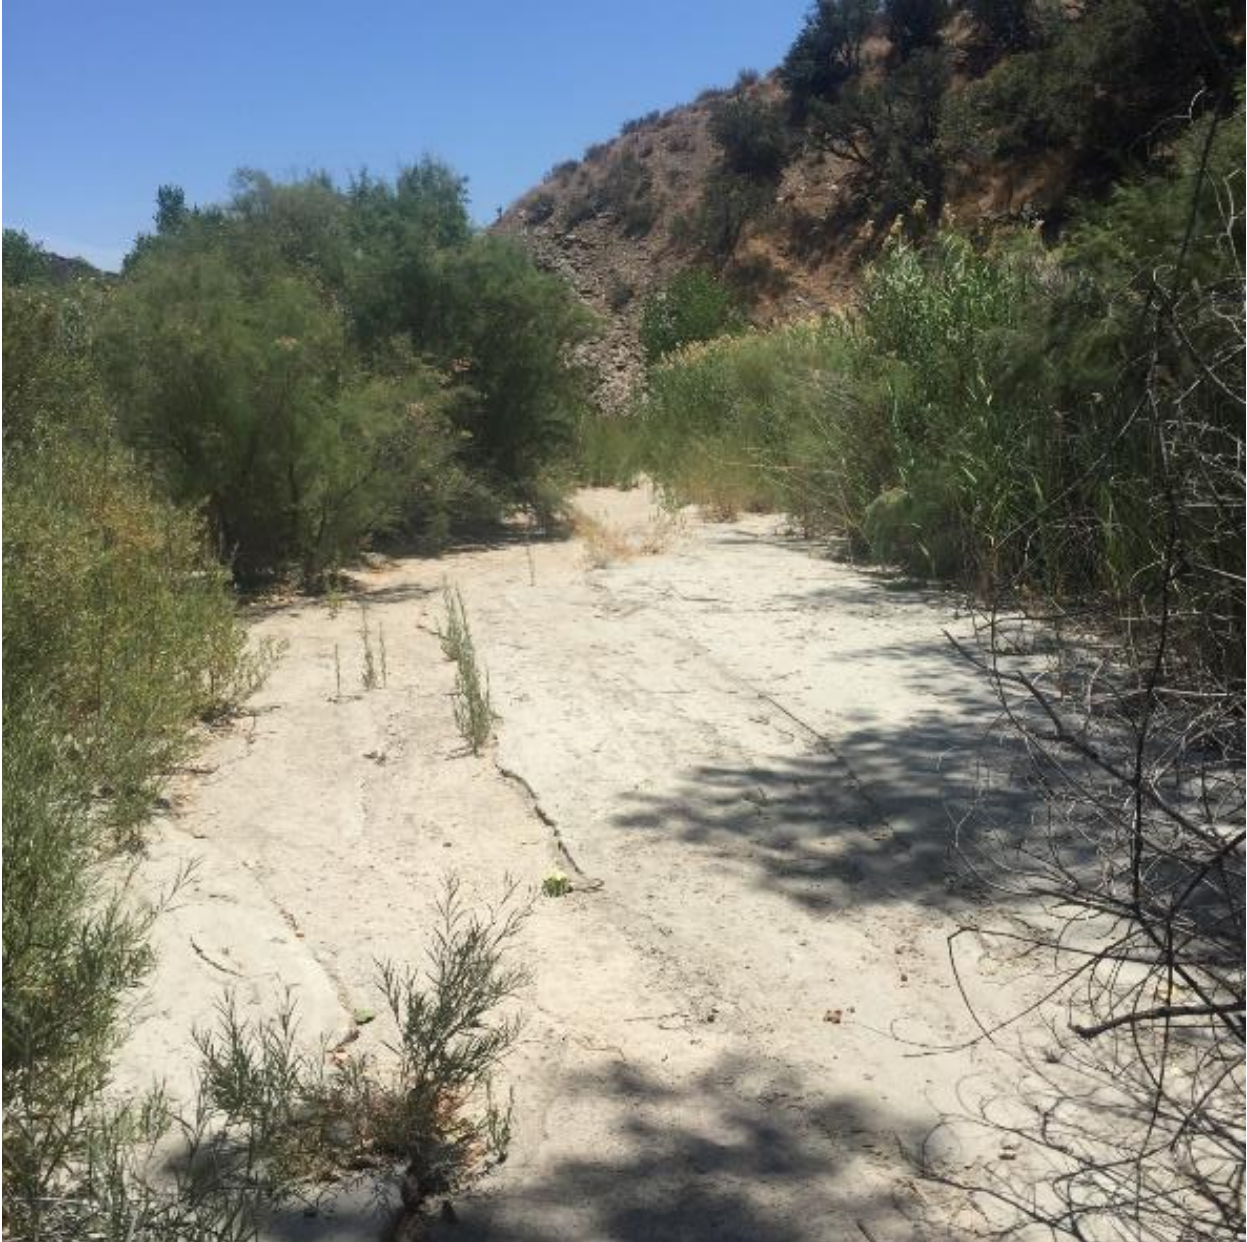
Figure 2.22-8. Representative Photograph Showing the Section of Carlos Canyon Below Pyramid Lake's Normal Maximum Water Surface Elevation Mapped in the Dry

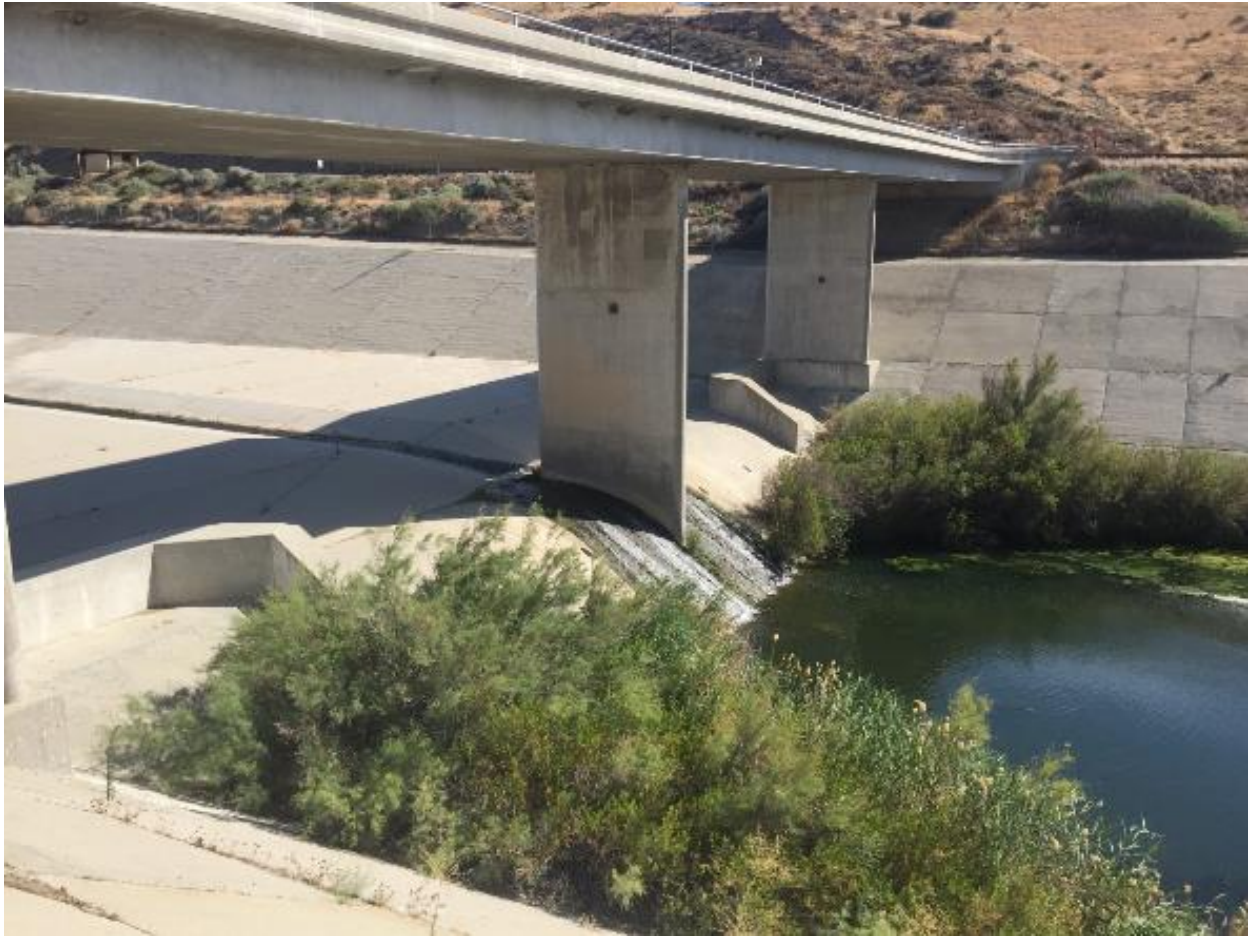
Figure 2.22-9. Representative Photograph Showing the Section of Gorman Creek below Pyramid Lake's Normal Maximum Water Surface Elevation Mapped in the Wet

0.5 cfs of stream flow was present in the tributary at the time of the survey. This flow fanned out over the drop structure and RTK GPS measured WSE is not discernable graphically from the channel thalweg. No fish were observed.

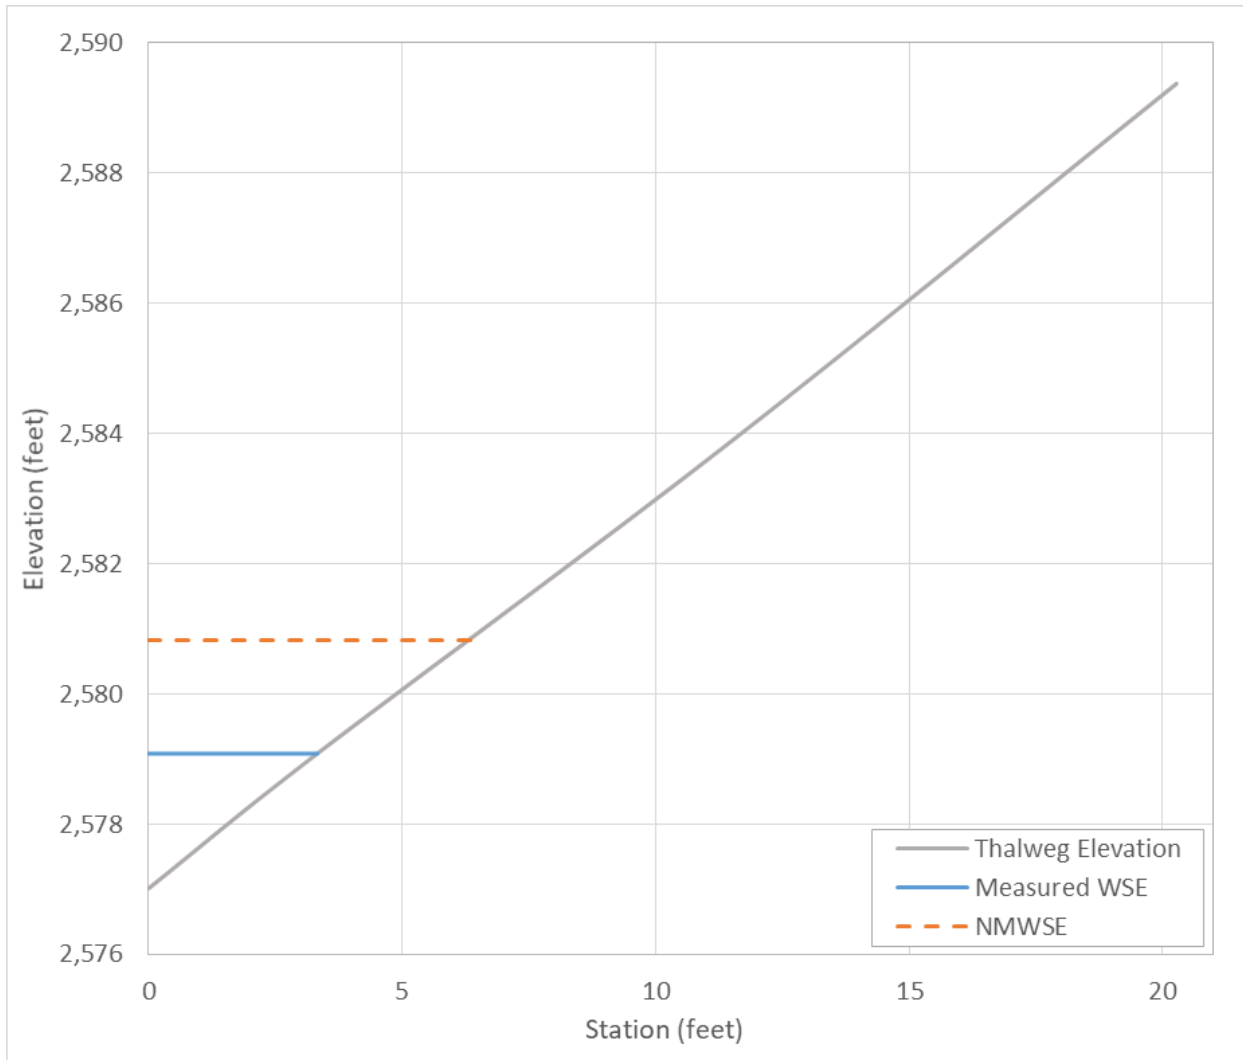
Figure 2.22-10. Gorman Creek Longitudinal Profile, Including Measured Reservoir Water Surface Elevation
